Forensic Investigation of Pavement Failures

Richard Boyd Smith

Bachelor of Engineering (Civil)

Submitted: October, 2004

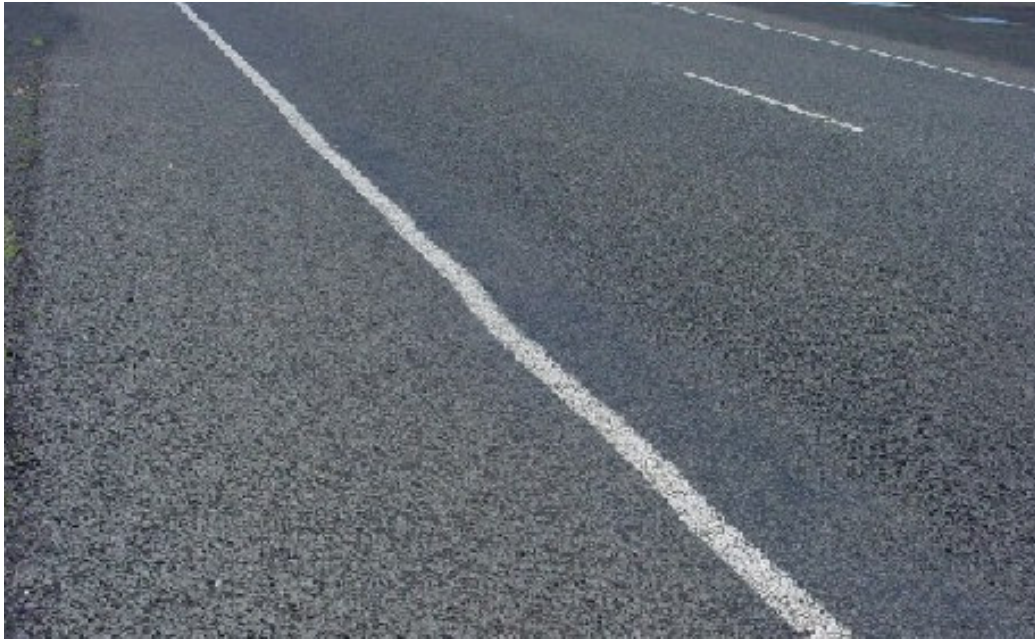
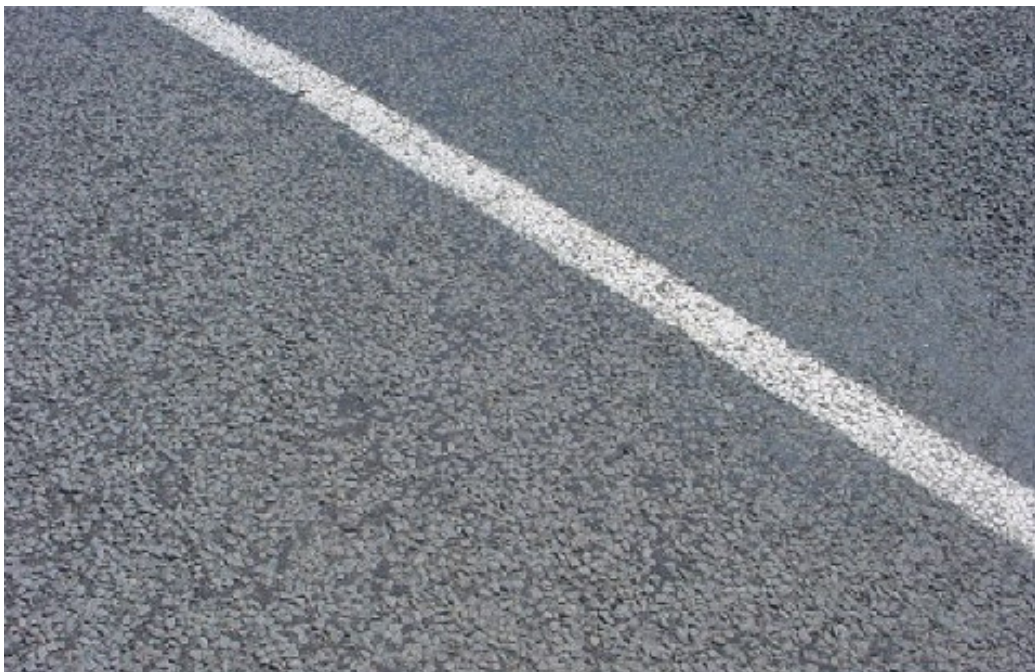
Figure 4.1 – Bowenville-Dalby:

In June-July 2003 (about 7 months after the completion of the construction), and after a period of constant steady rain, the project showed signs of premature failure. This consisted of bleeding/fatty depressions and shoving along the edgelines of the traffic lanes. These early failures continued to deteriorate, and necessitated the rehabilitation of outer widths of the entire section in June 2004.

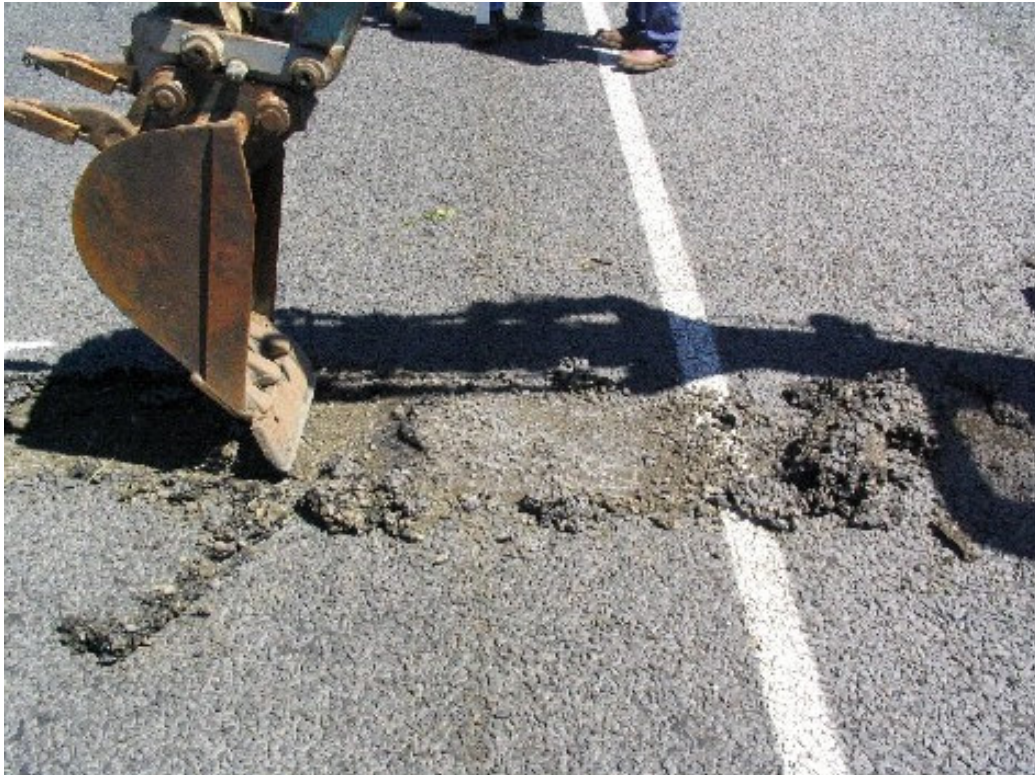
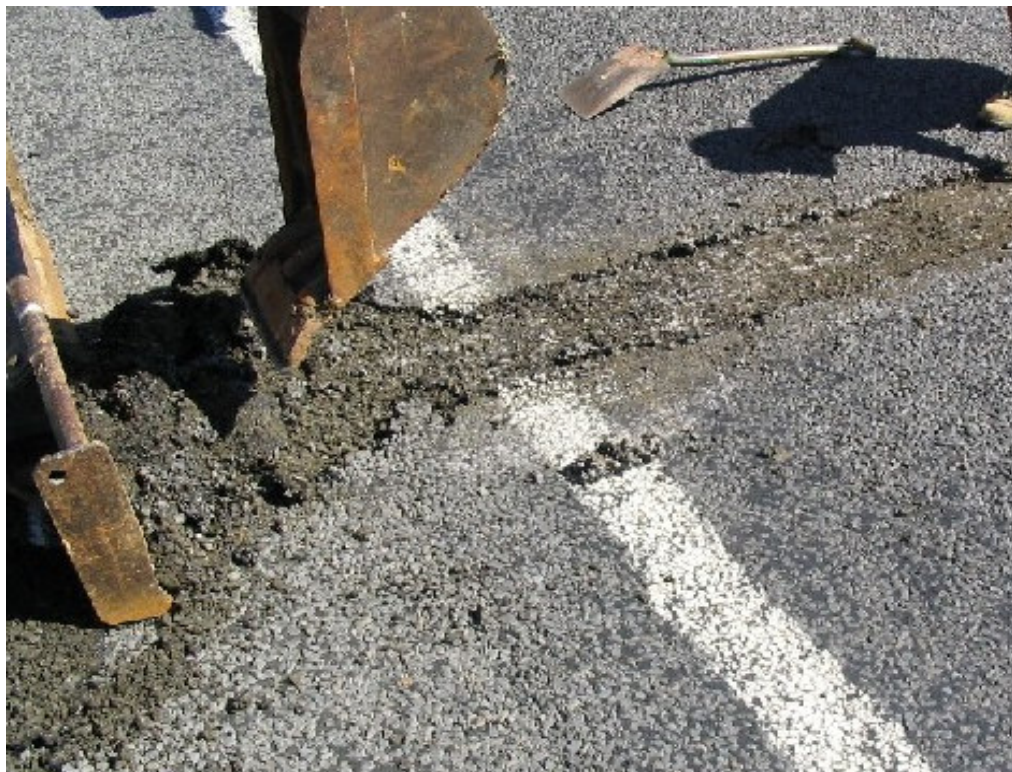
Figure 4.4 – Trenching Part 1:

Two sites were selected for trenching of the pavement. One site was in a failed section, while the other was in a section currently experiencing no failure. This enabled a comparison to be made between the two sites.

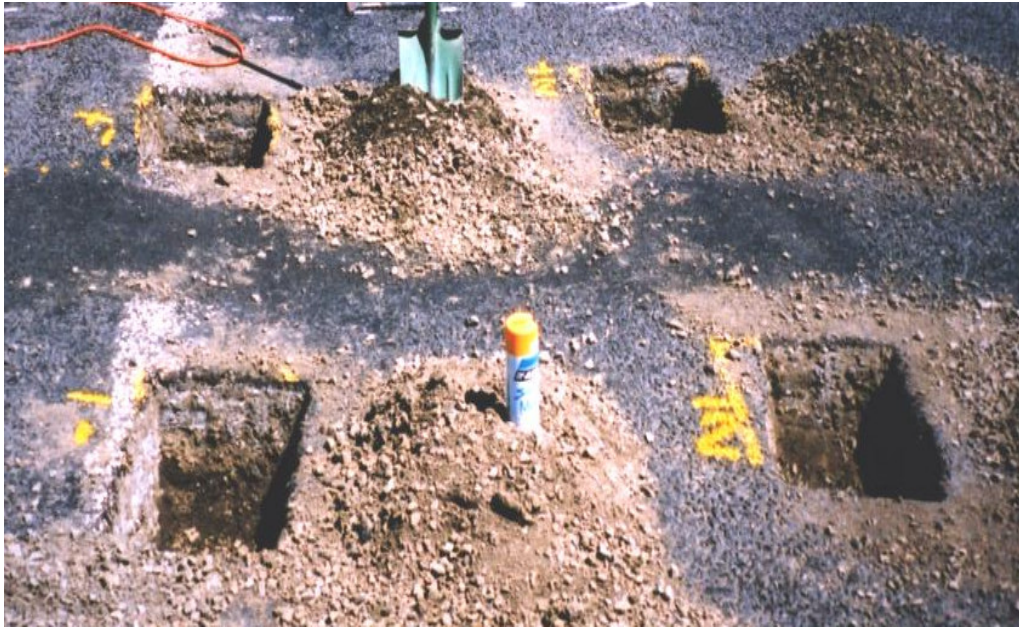
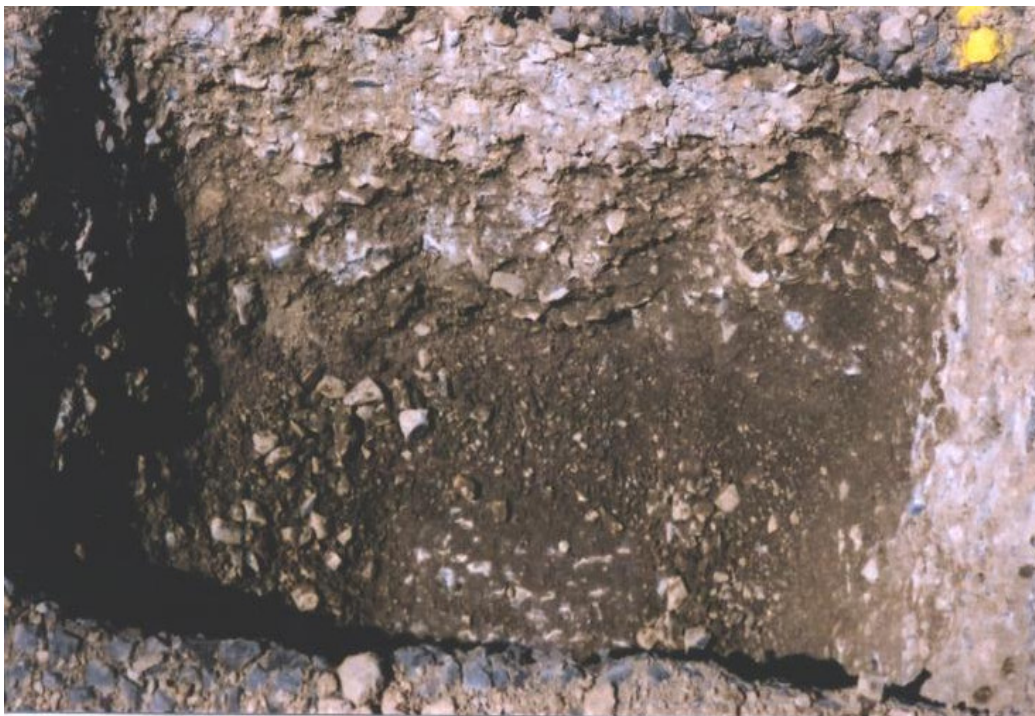
Figure 4.5 – Trenching Part 2:

As can be seen, the results of the grading testing indicate that the grading was changing in the top 50 mm with more fines being present. Interestingly, in contrast to the previous grading results, more fines were generally present at 2.2 m from the centreline, not at 3.8m where the failure is occurring.

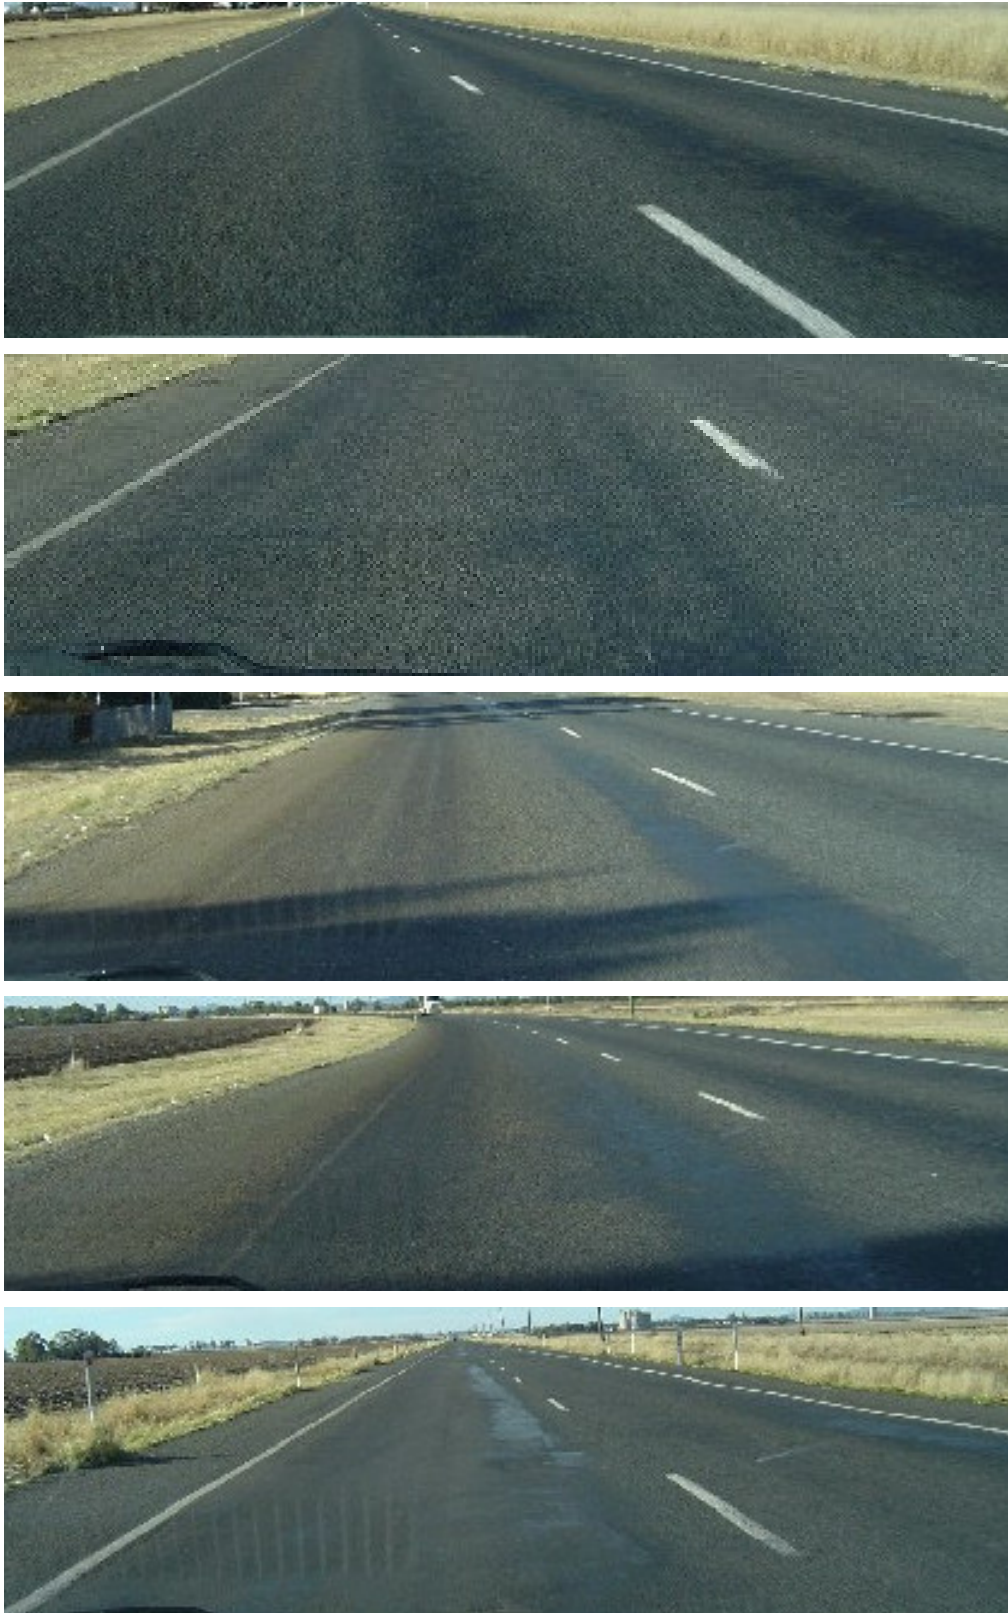
The failure consisted of flushing/bleeding of the pavement, mostly within the wheelpaths, with rutting also beginning to increase in some places. In addition, some roughness was noted to be due to isolated failures, such as depressions. The following information regarding the flushing/bleeding was noted.

Figure 4.7 – A series of pictures illustrating the variability of bleeding along the section

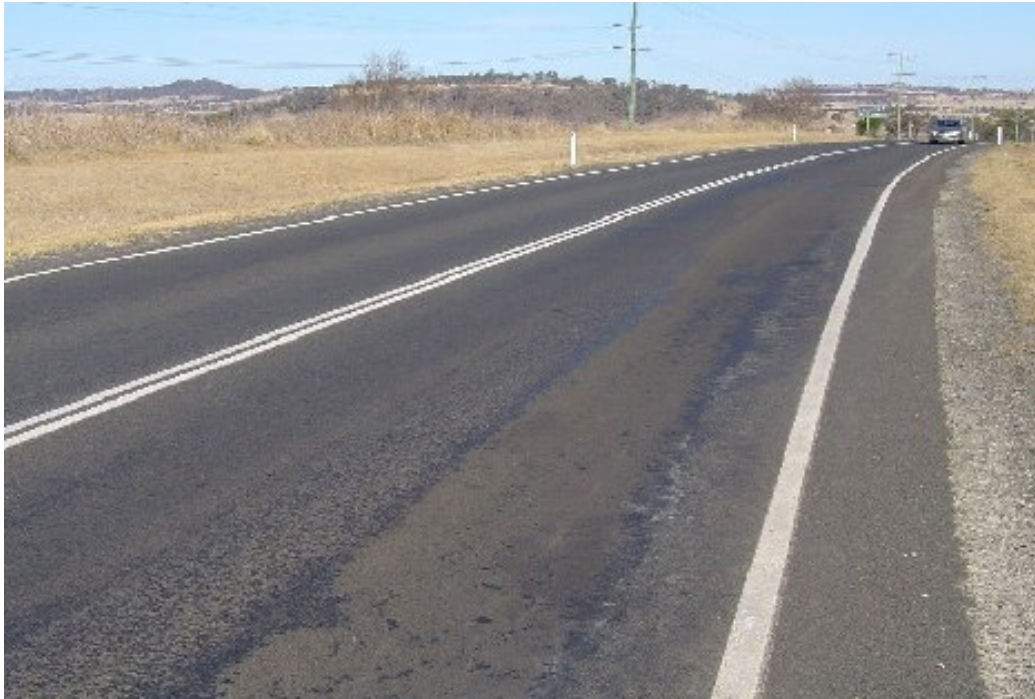
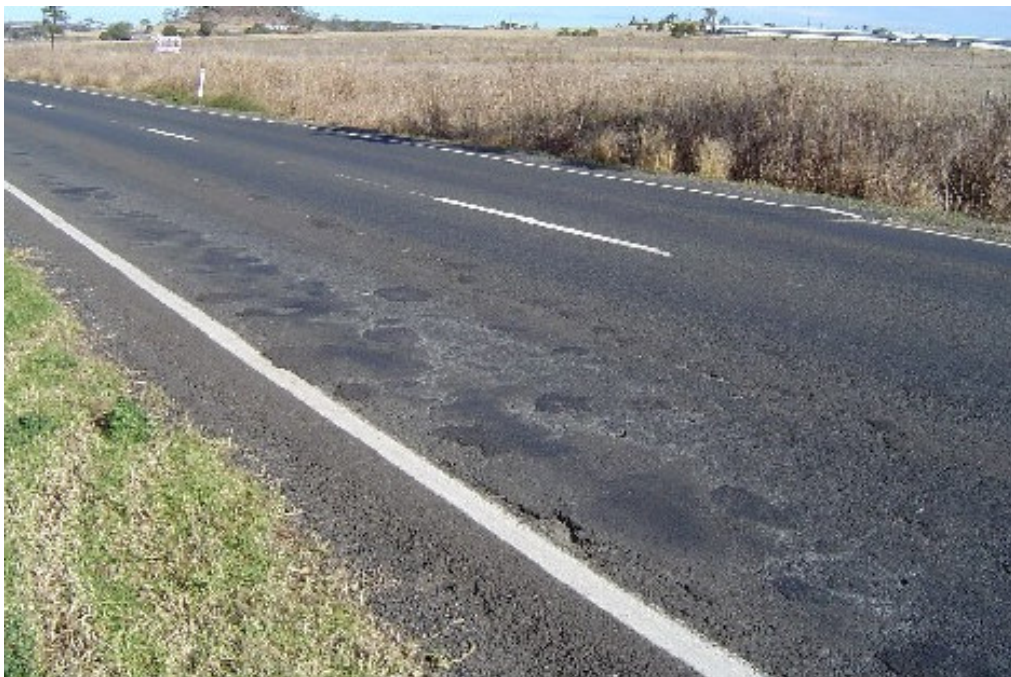
Figure 4.8 – Drayton Connection Road:

- 4.8 Drayton Connection Road: a) A patch where in-situ stabilisation was carried out. Failure is still occurring, b) A patch that has failed through potholing, necessitating further patching work, and resulting in a rough surface

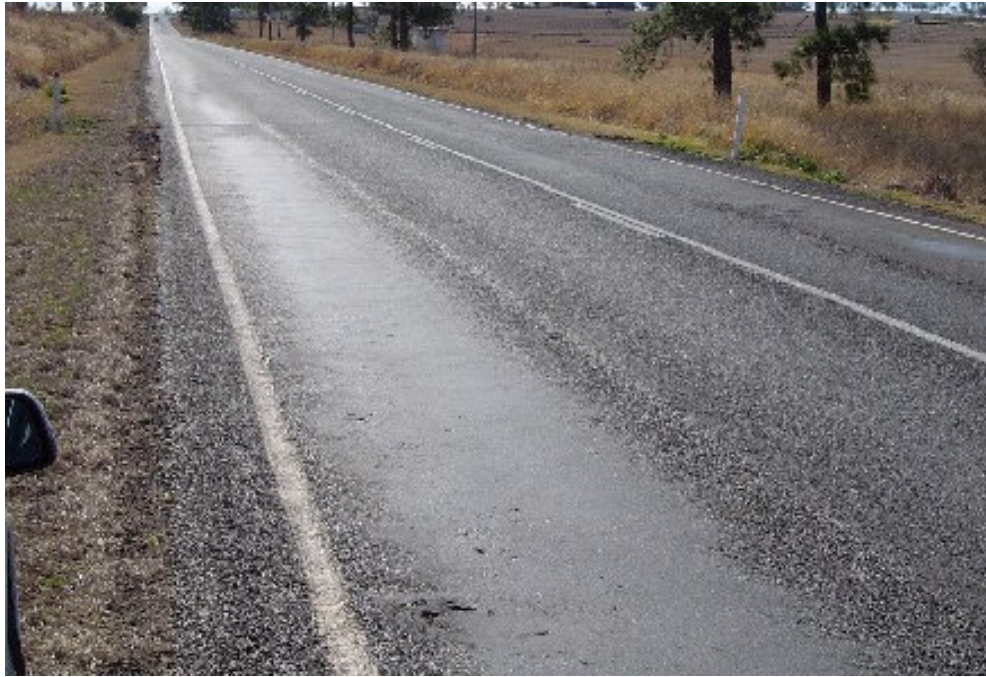
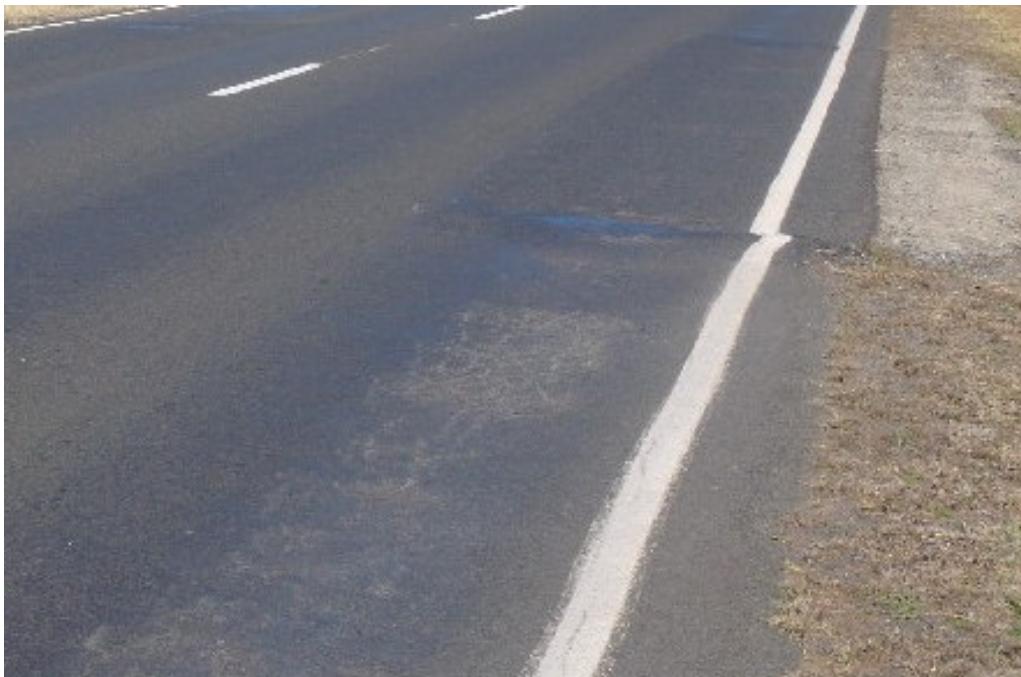
Figure 4.9 – Drayton Connection Road:

- 4.9 Drayton Connection Road: a) A view of the considerable bleeding that occurs along much of the road, b) Fatigue cracking is starting to occur in this area

These patches were observed to be undergoing deterioration such as potholes, rutting and depressions that had been fixed with further maintenance work, indicating that the original work had been unsuccessful in reducing the cost and extent of routine maintenance work required.

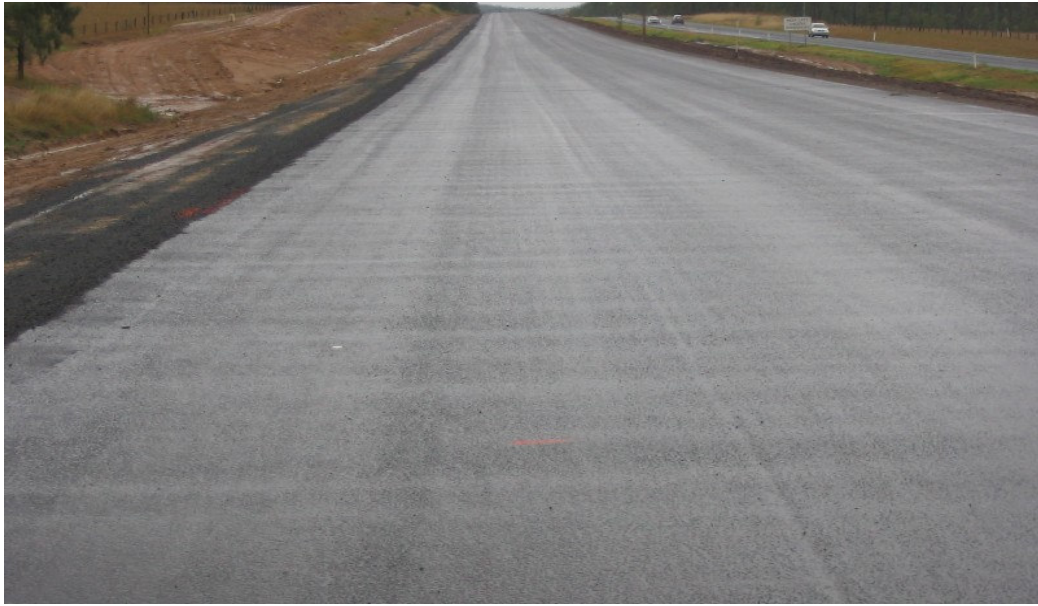
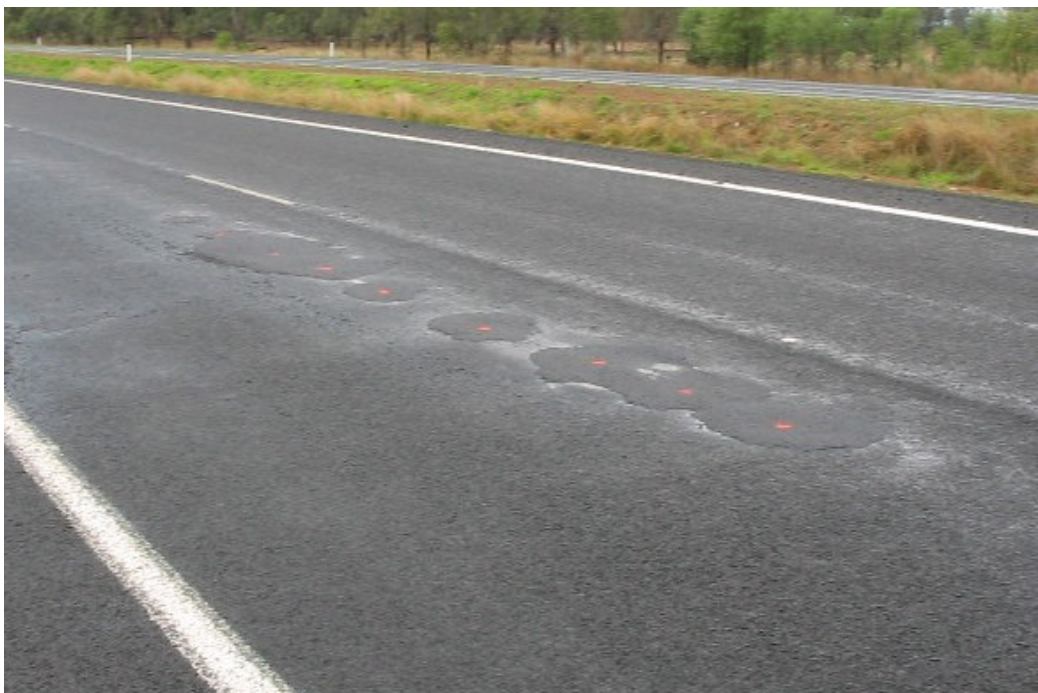
Figure 4.11 – Gatton Bypass:

- a) 'Rippling' of the pavement occurred in some sections, due to the paver that was laying the material being bumped by delivery vehicles**
- b) This rippling led to some isolated failures that had to be fixed**

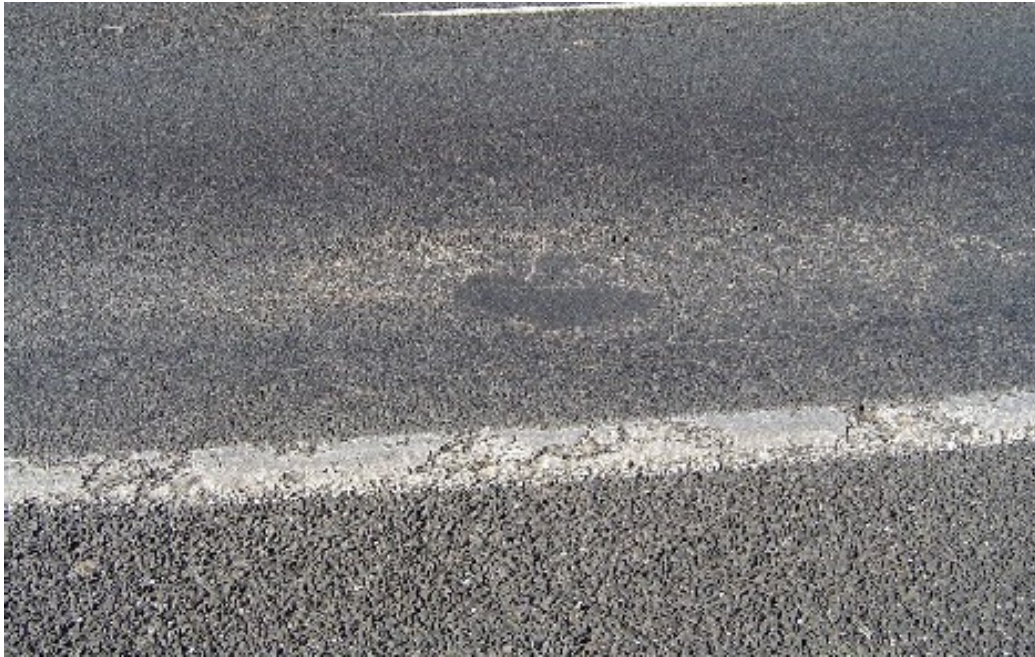
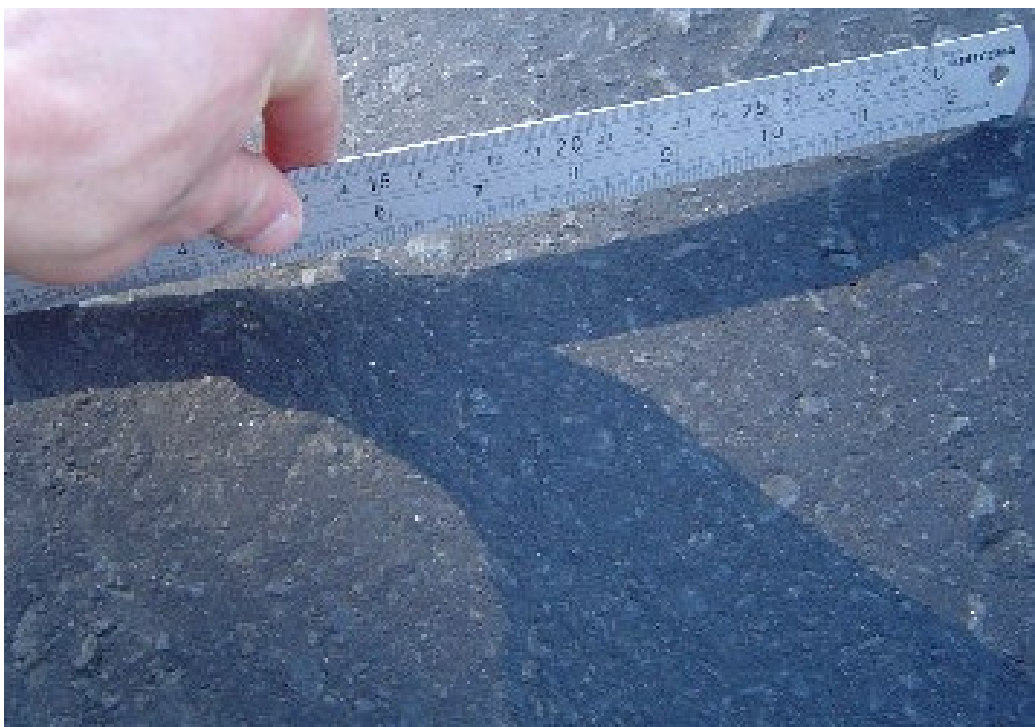
Figure 4.15 – Tabletop Turnoff:

The use of a 30cm straightedge to measure the rutting confirmed the rather large magnitude of failure, with the rutting under the straightedge being about 20-30mm. This magnitude means rehabilitation will probably be required in the future.

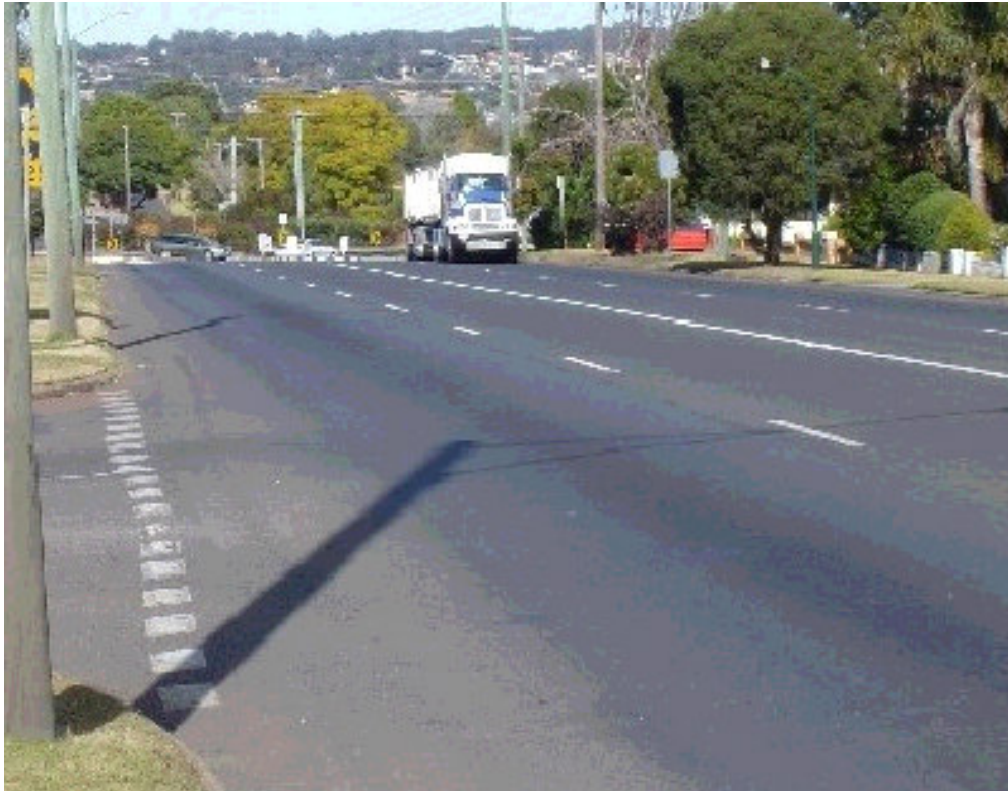
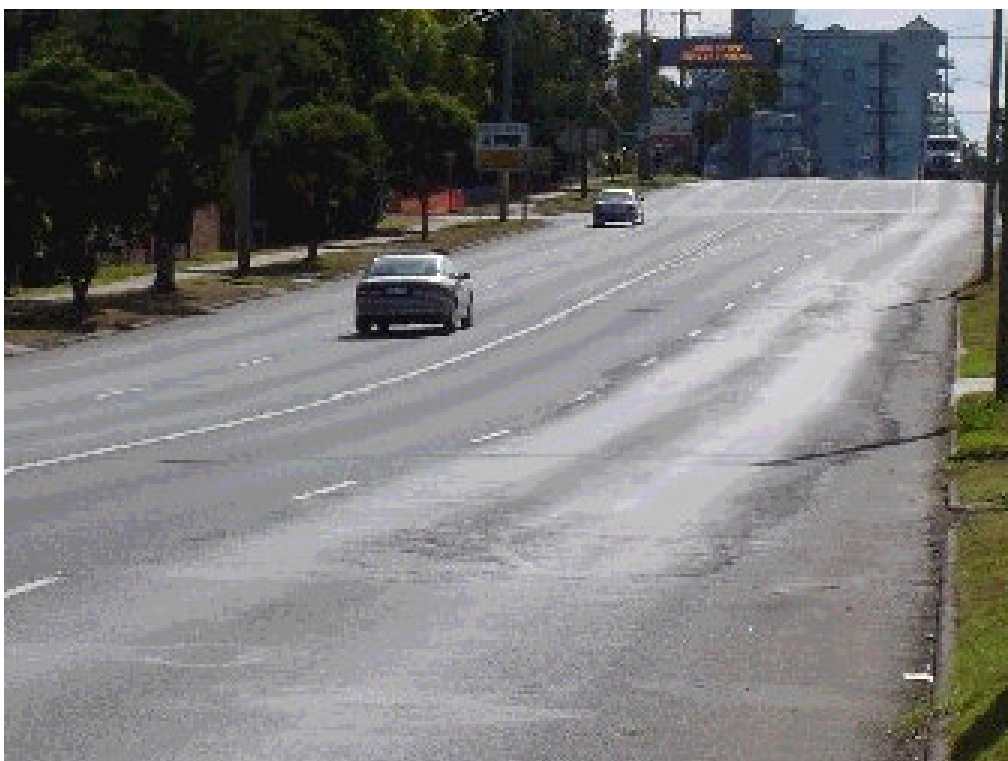
Figure 4.18 – Warrego Highway 18A, along Cohoe Street:

The existing asphalt overlay along much of this section was placed in 1989, with rejuvenation treatments being carried out in 1993. The pavement is generally fatigued with rutting and cracking, with the outer lanes being worst.

b) Looking north, showing some asphalt placed to correct rutting in the outer lane

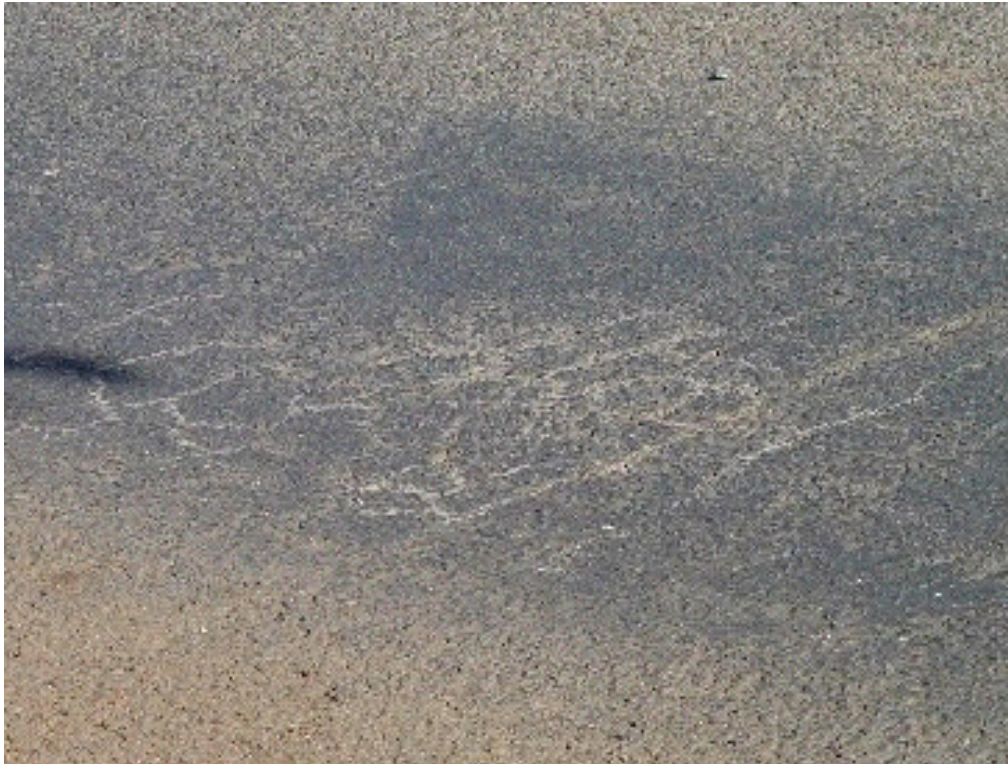
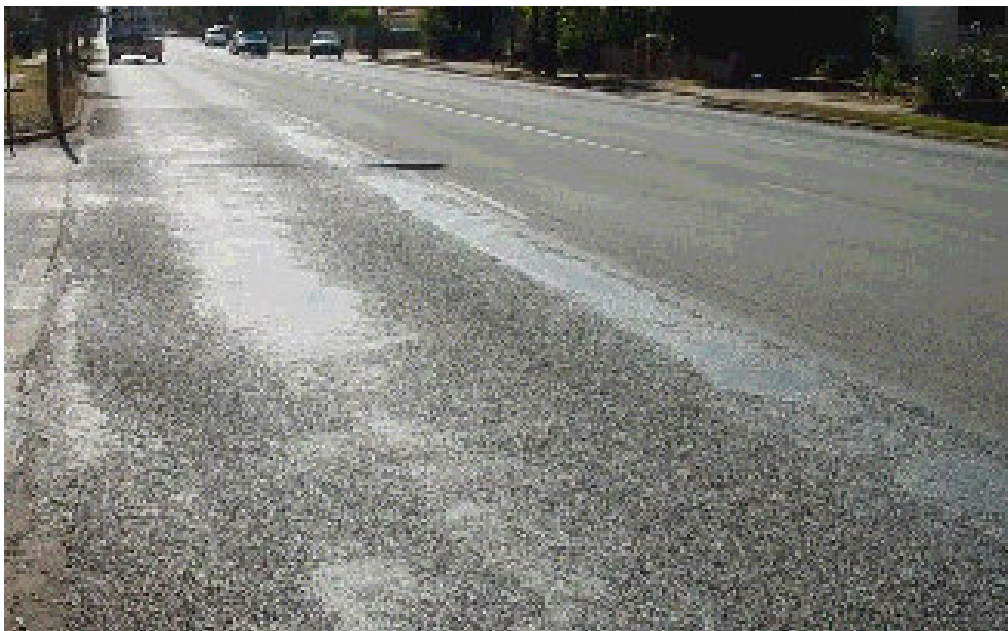
Figure 4.21 – Warrego Highway 18B, along Tor Street north of Taylor Street:

- a) Typical fatigue cracking in the outer lane**
- b) Bleeding occurring in the outer northbound lane**

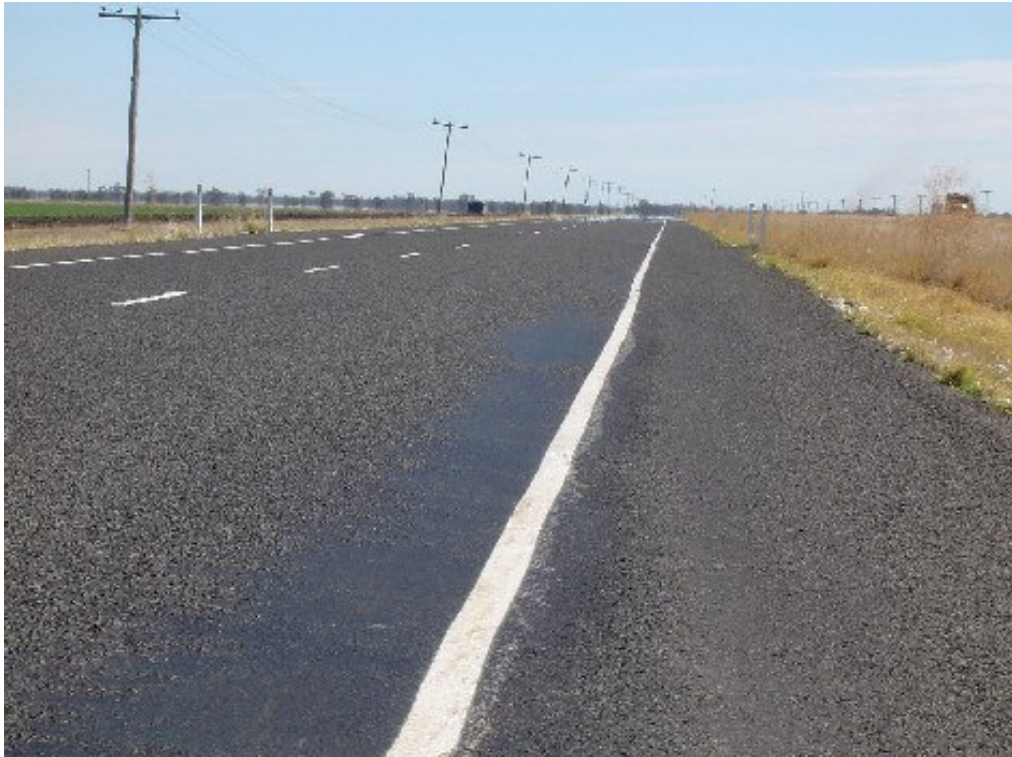
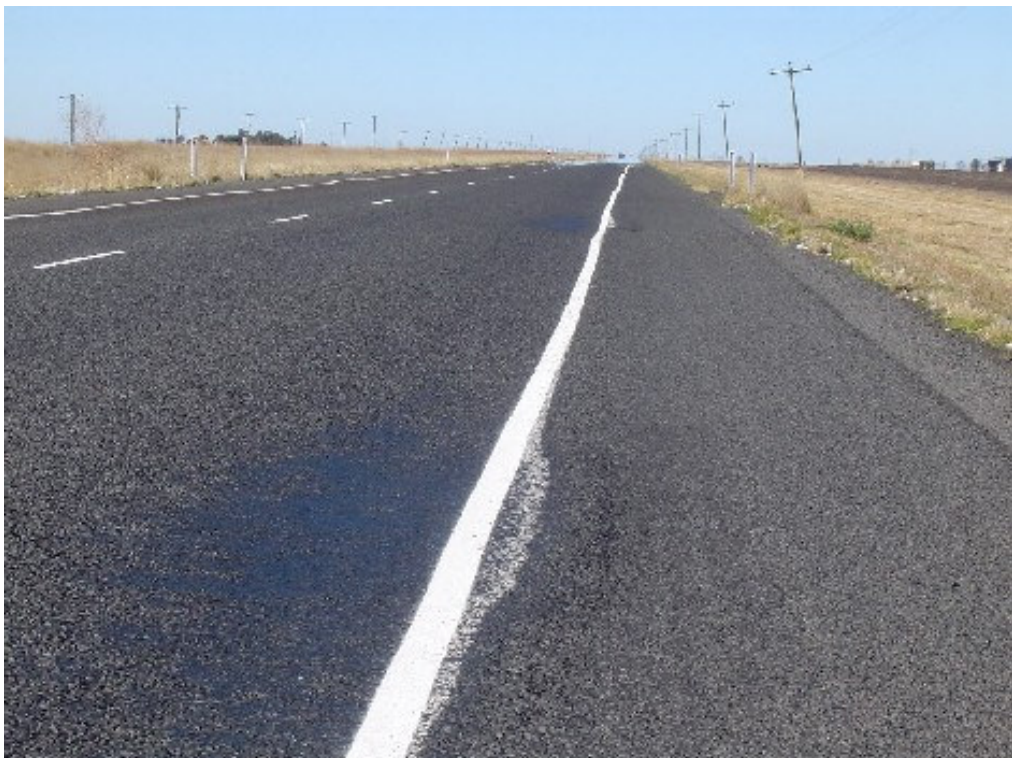
Figure 4.23– Yaralla Deviation:

- 4.23 Yaralla Deviation: a) A view of a failure in the outer wheelpath, b) A view of two isolated failures
- 4.24 Yaralla Deviation: a) and b) Views of the water ponding occurring in the outer wheelpath due to rutting and changes in the crossfall of the pavement
- 4.25 Change in Pavement Crossfall: a) Location where crossfall had reduced from 3% down to 0.6%, b) Level device is being held at design 3% crossfall, illustrating the reduced pavement crossfall, leading to water ponding
- 4.26 Yaralla Deviation: a) A typical location with bleeding in the outer wheelpaths, b) A shot illustrating how material in the outer wheelpaths has been shoved sideways, with ridging that hinders the drainage of water off the road surface
- 4.27 Yaralla Deviation trenches: a) Unfailed location, b) 'Failed' location

Since the completion of the project, there had been signs of failure along the length of the project, including bleeding of the surfacing and some pavement deformation of the outer wheelpaths, including rutting that allows water ponding in the outer wheelpaths. If these failures continue to worsen, rehabilitation may be necessary in the future.

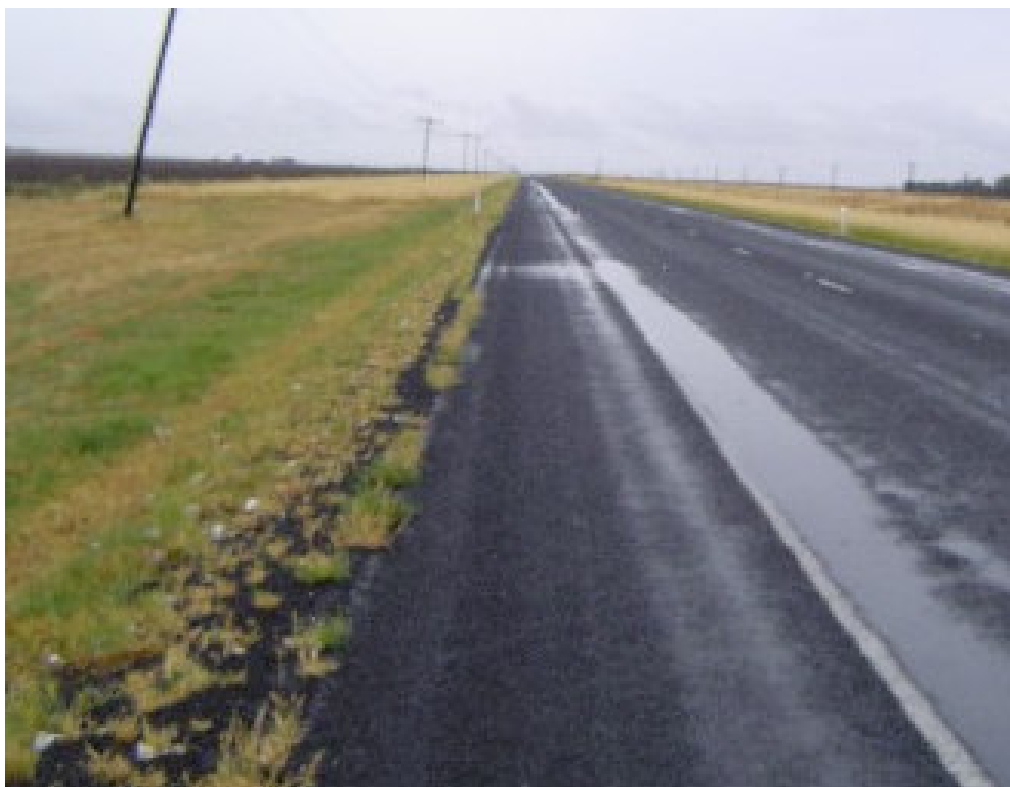
Figure 4.24 - Yaralla Deviation:

The failures varied in both length and extent, with some failures being tens of metres long and other being less than a metre long. The base material near the surface appeared to be getting shoved sideways, and with associated rutting and bleeding.

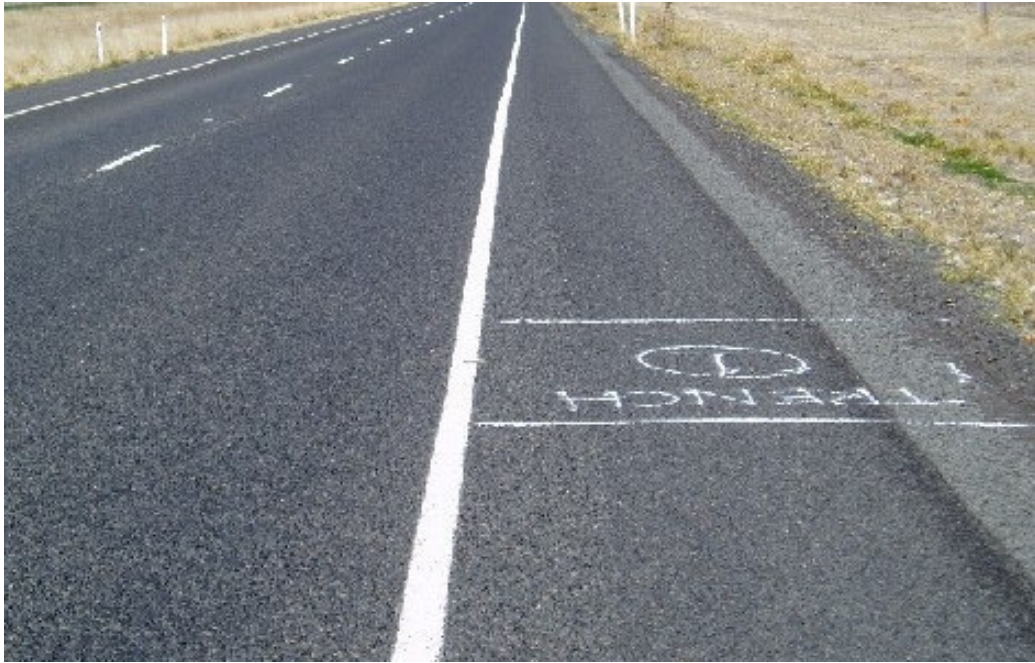
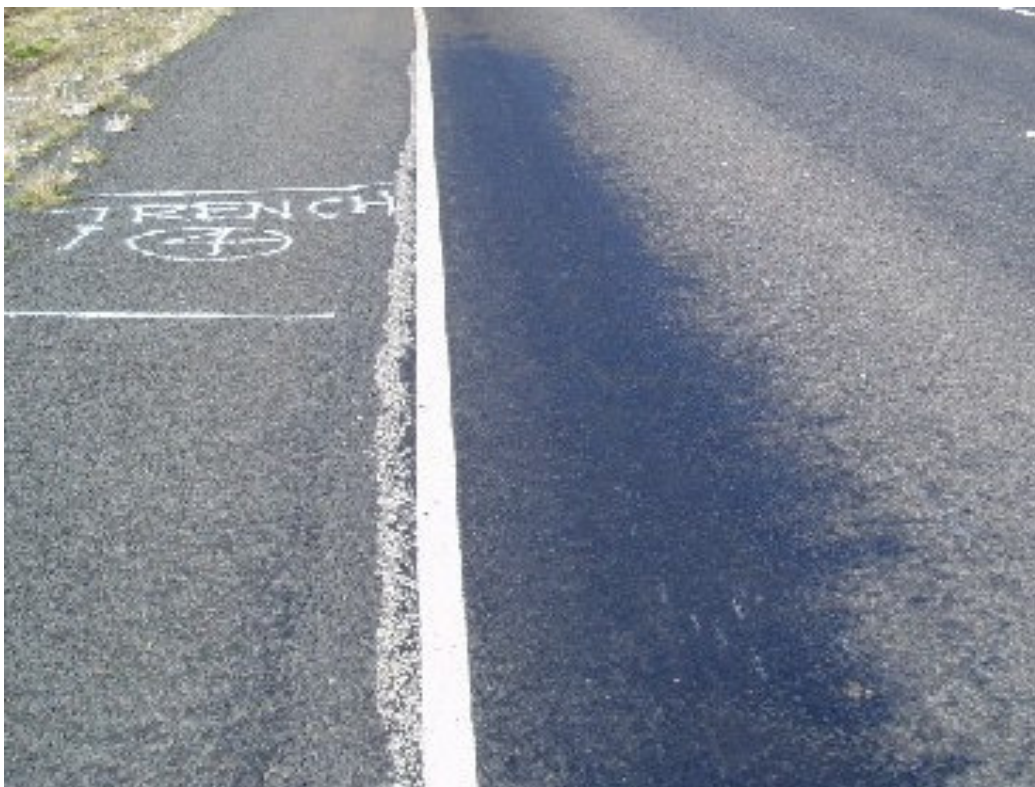
Figure 4.27 – Yaralla Deviation trenches:

During the excavation of the trenches, it was observed that the base gravel appeared to not be overly wet, but did appear to be wetter in the failure area. The type 4.5 white rock material used for the subbase had a consistency similar to plasticine, while the lime stabilised black soil subgrade seemed to be very hard.

- a) Unfailed location**
- b) 'Failed' location**

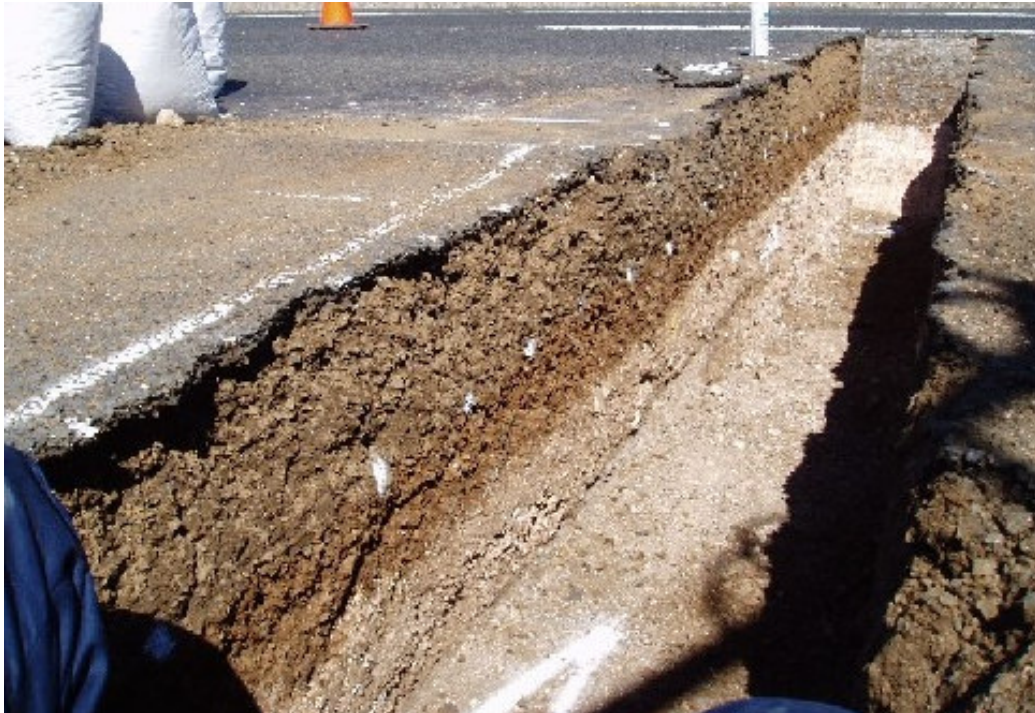
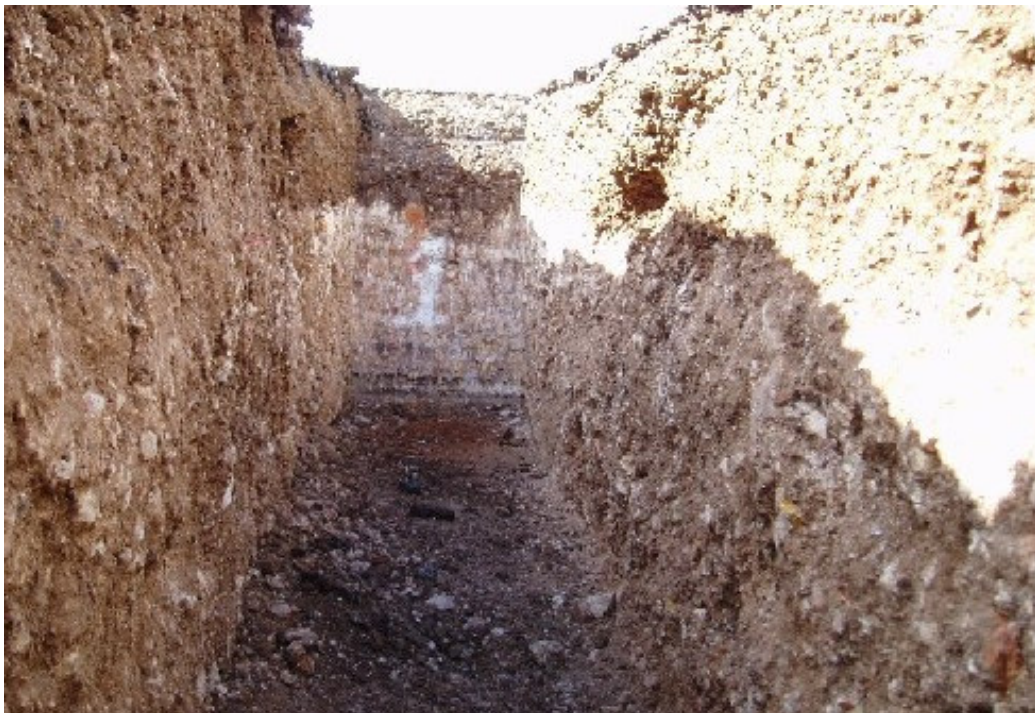
Figure 4.28 - Yaralla Deviation Trenches:

- 4.28 Yaralla Deviation Trenches: a) Trench 4 ('failed') with different pavement layers easily visible, b) Trench 1 ('unfailed')
