Forensic Investigation of Pavement Failures

Richard Boyd Smith

Bachelor of Engineering (Civil)

Submitted: October, 2004

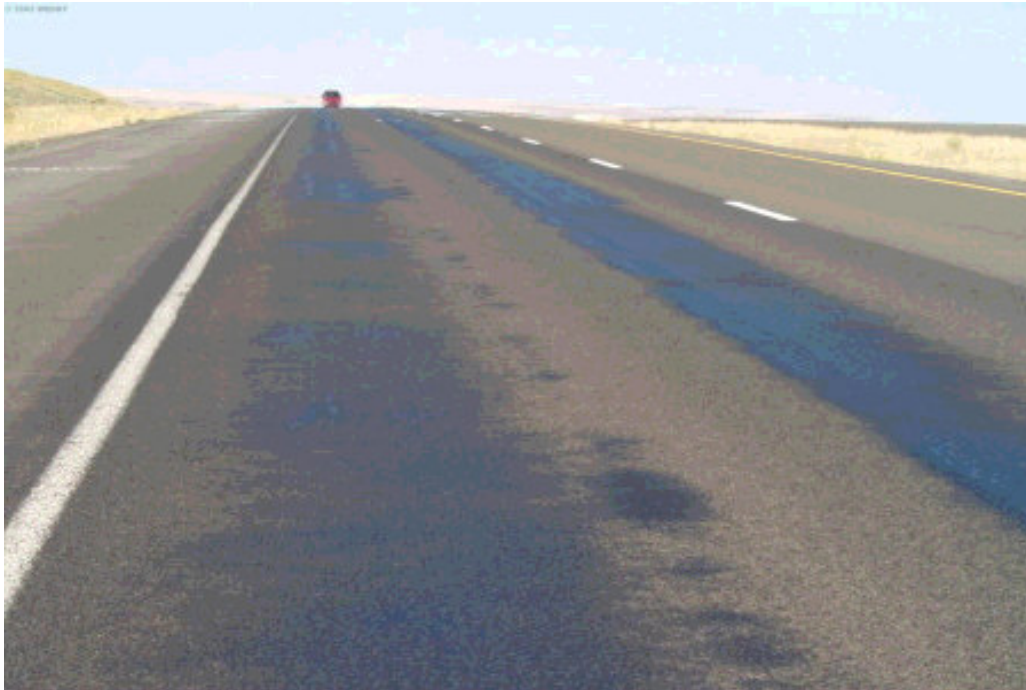
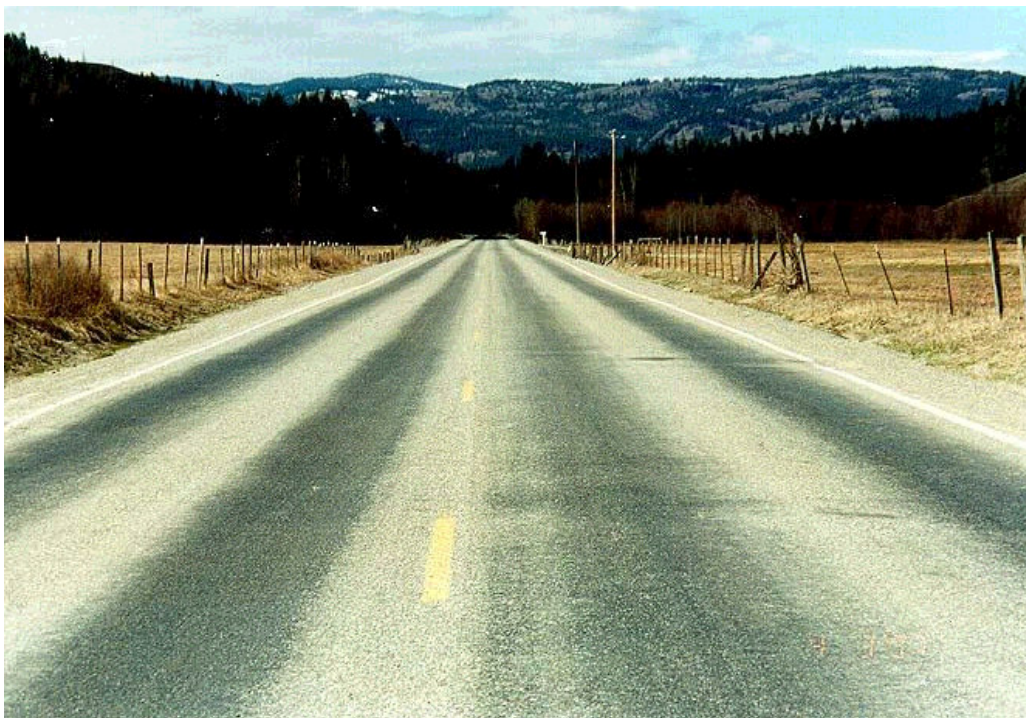
Figure 2.3 – Bleeding and flushing:

Breakdown of the surface aggregate will result in smaller dimensions, allowing binder to cover the aggregate. If there is poor spreading of the surface aggregate, some areas will not be covered adequately, leading to binder levels being too high for this. In an asphalt surfacing, over-filled voids mean that there will be excessive binder, and over time this will rise to the surface.

The rate of binder that should be sprayed is dependent on the size of the aggregate, specifically the average least dimension of the particles. Consequently, if the aggregate has a lack of size compared to that used in the design, this will lead to it being covered with binder.

- a) Within the wheelpaths on a newly completed asphalt surfacing**
- b) On a rural road**

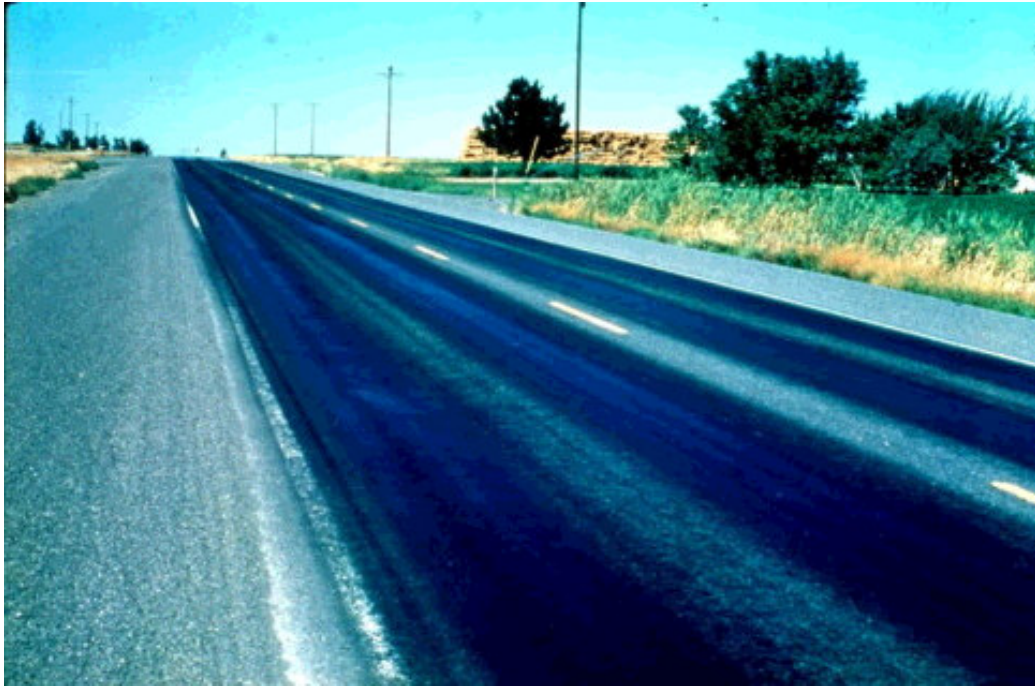
Figure 2.4 – Heavy bleeding in a spray seal

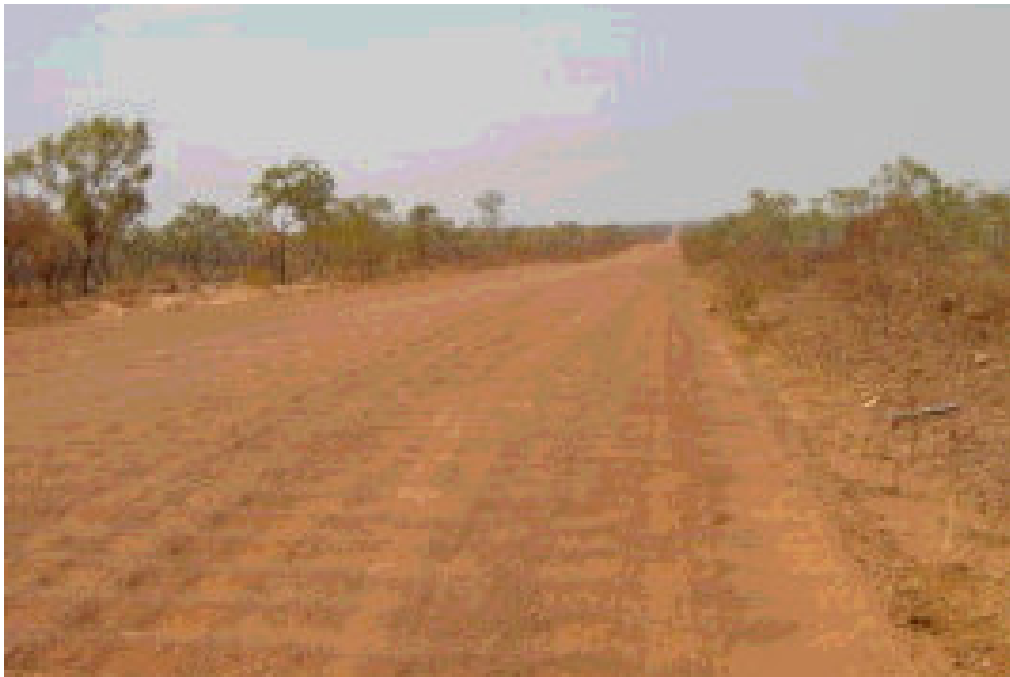
Figure 2.5 – Corrugations on a low volume road in Outback Australia

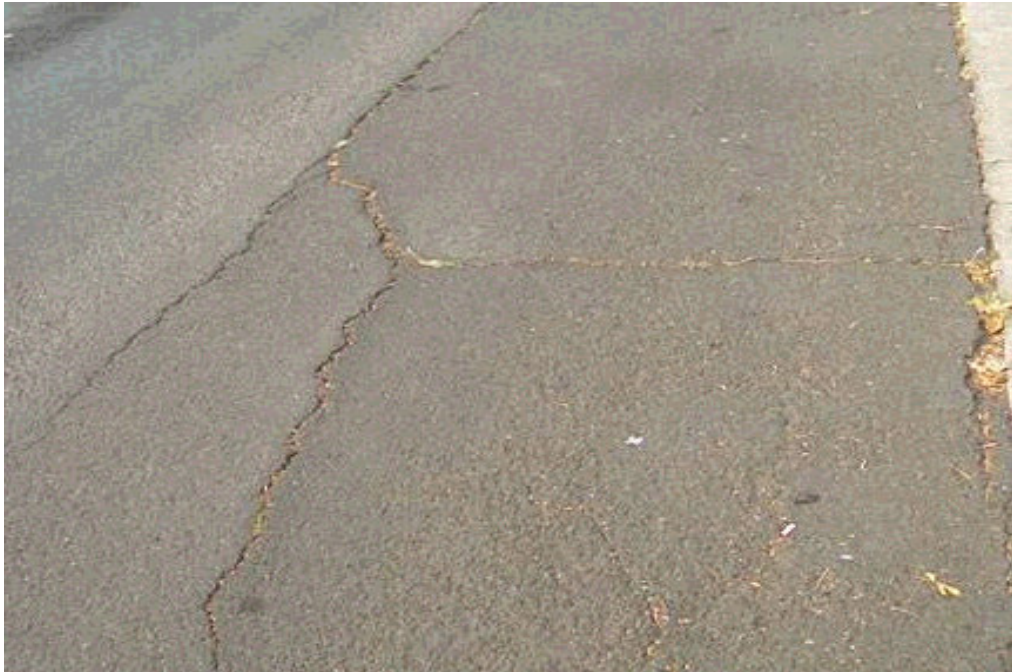
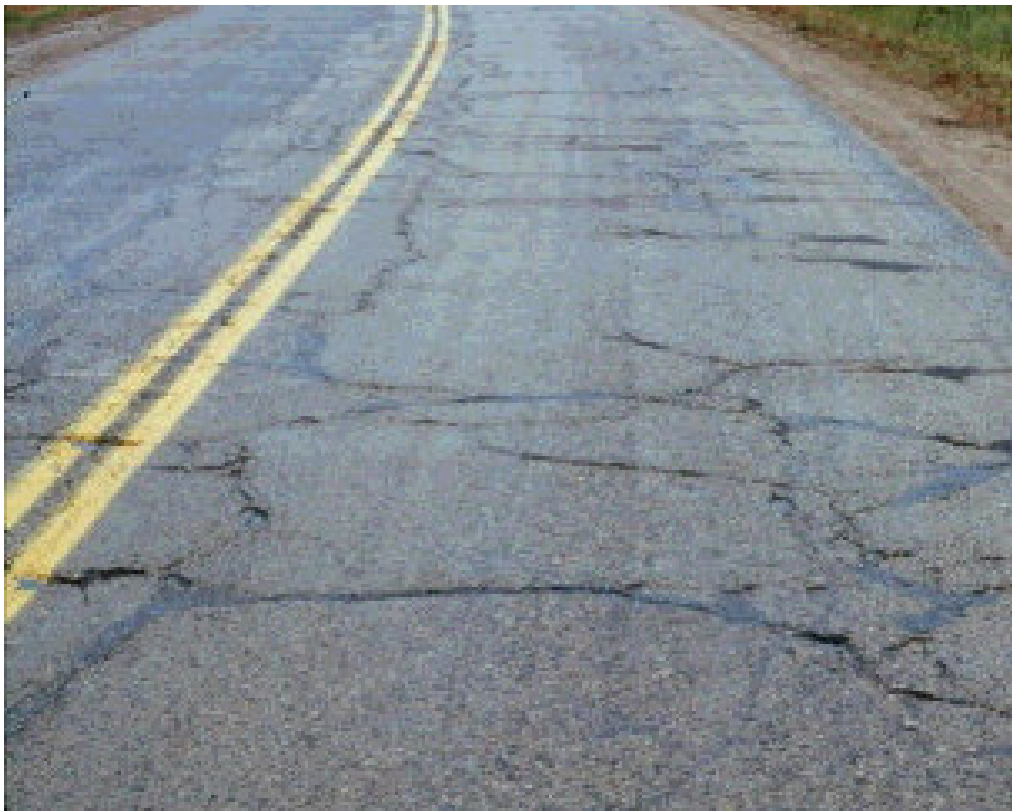
Figure 2.6 – Block cracking:

a) In a parking lane

b) Over the entire pavement

Block cracking is where interconnected cracks divide the pavement up into large blocks. It may sometimes occur only in non-traffic areas. It is mainly caused by an inability of the surfacing to expand and contract with daily temperature fluctuations due to either ageing of the binder or a binder that is too stiff.

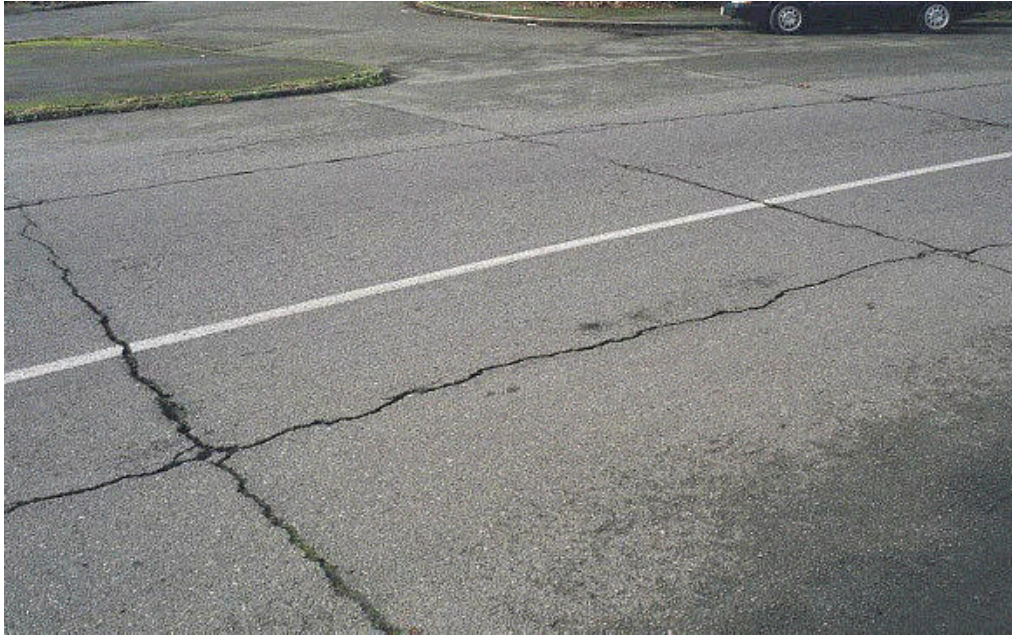
Figure 2.7 – Joint reflection cracking on an arterial road

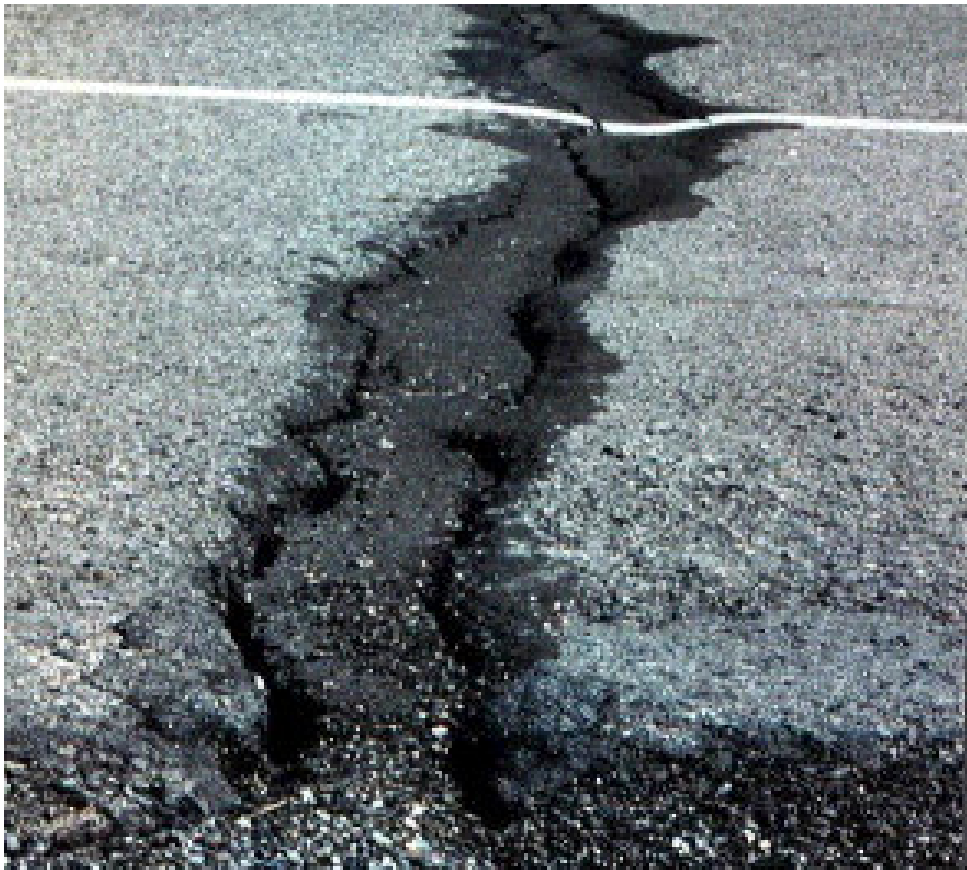
Figure 2.8 – Cold temperatures led to volume change of the pavement materials, and resulted in ‘thermal’ cracking

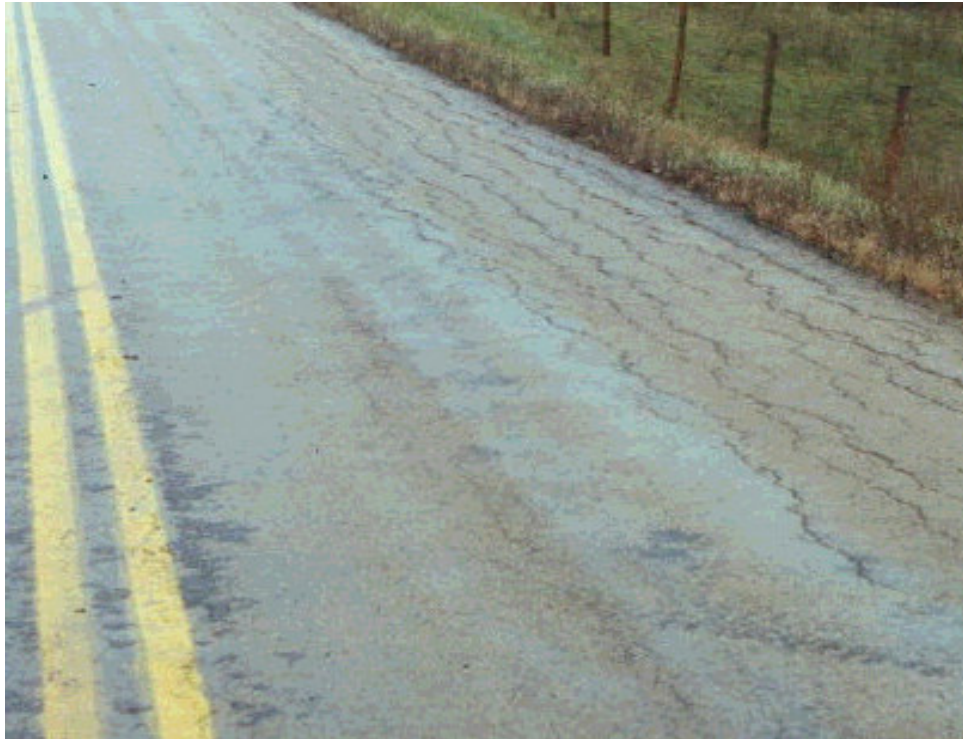
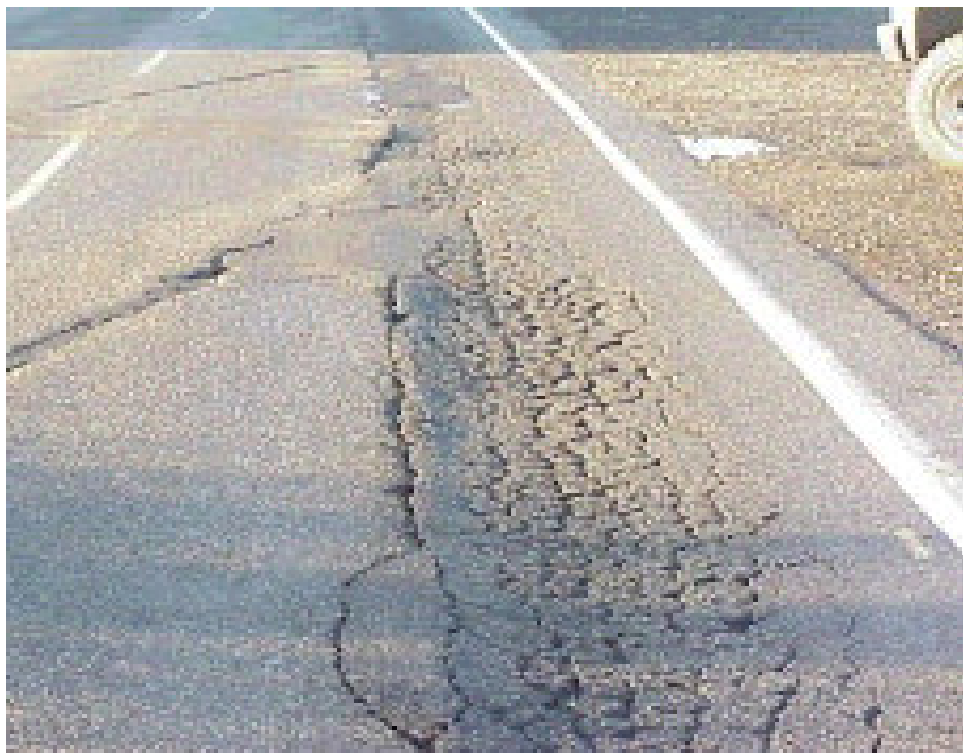
Figure 2.9 – Fatigue/structural cracking:

It may reflect permanent severe deformation of the subgrade due to repetitive loading, instability in the upper pavement layers or repeated deflection causing fatigue in the surfacing. This fatigue may also be due to a pavement thickness that is inadequate for the traffic loading. Poor construction practices, including poor compaction, may also be a cause of this type of failure, especially on relatively new jobs.

a) Due to inadequate edge support

b) On a poorly supported road widening, accompanied by rutting

If surface distortion is also present, excessive moisture is probably the cause. Poor drainage may result in a wet base and/or subgrade. Water may be getting to the base and/or subgrade from cracks or holes in the surface or from moisture coming up through the subgrade. If excessive moisture due to poor drainage is implicated, then this must be corrected.

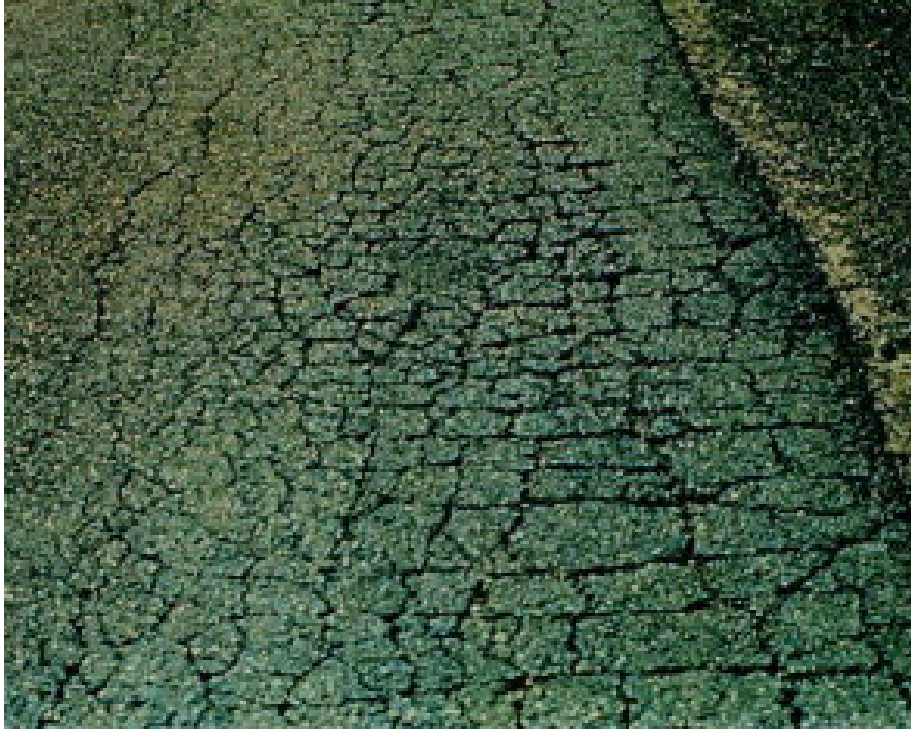
Figure 2.10 – Severe structural cracking, allowing easy moisture entry into the pavement

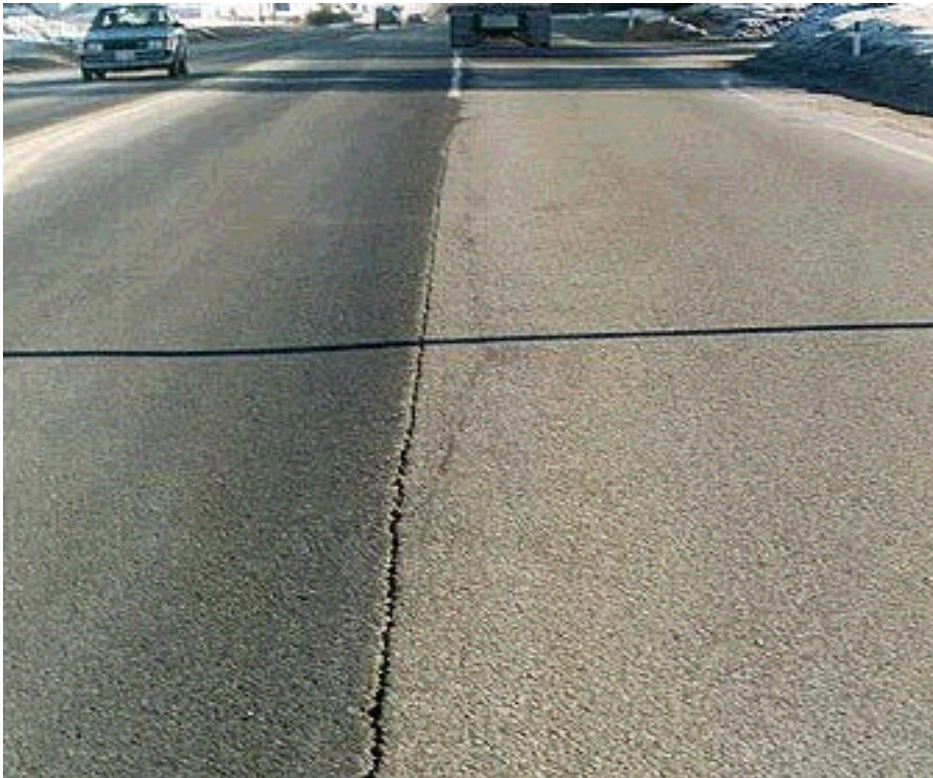
Figure 2.11 – Joint cracking due to poor joint location and construction practices

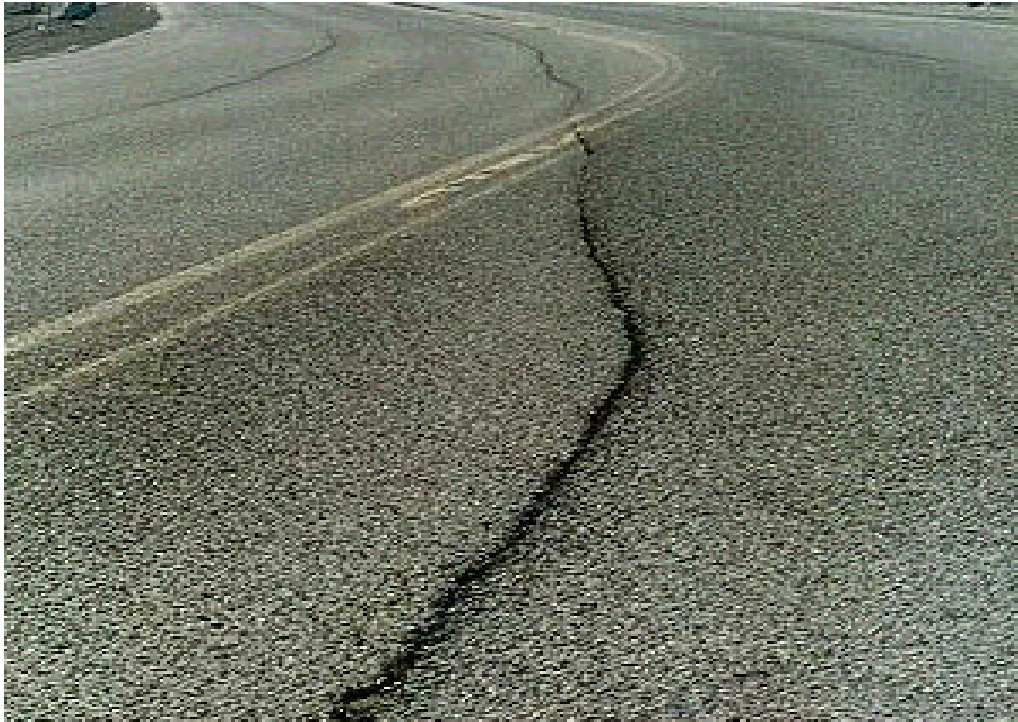
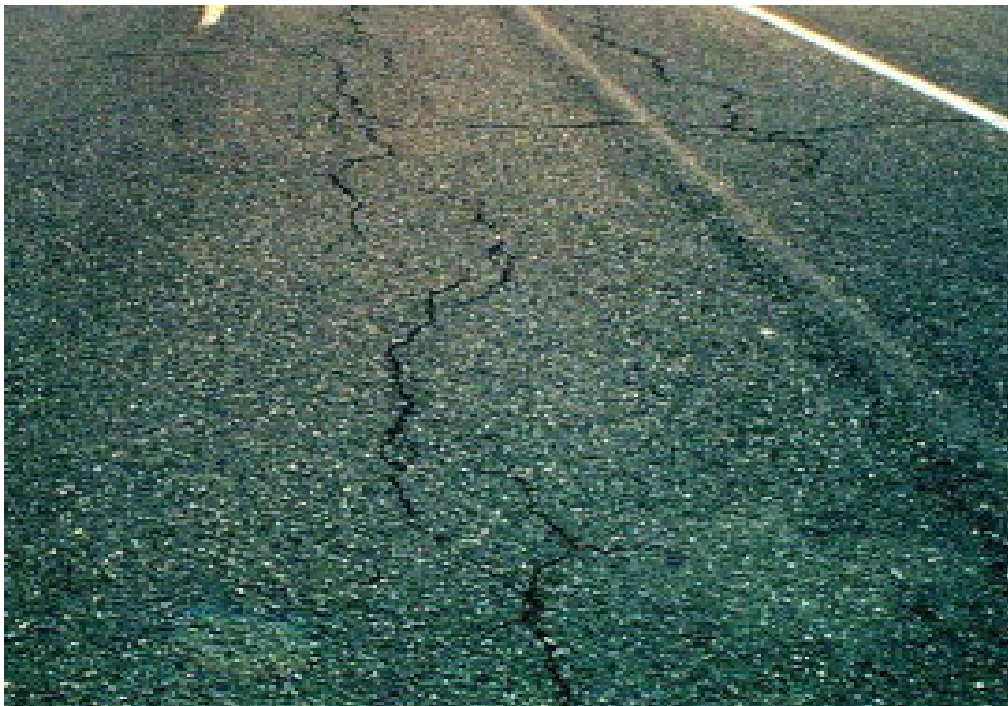
Figure 2.12 – Longitudinal cracking:

- a) Possibly caused by ground movement**
- b) In the wheelpaths, as an onset to structural cracking**

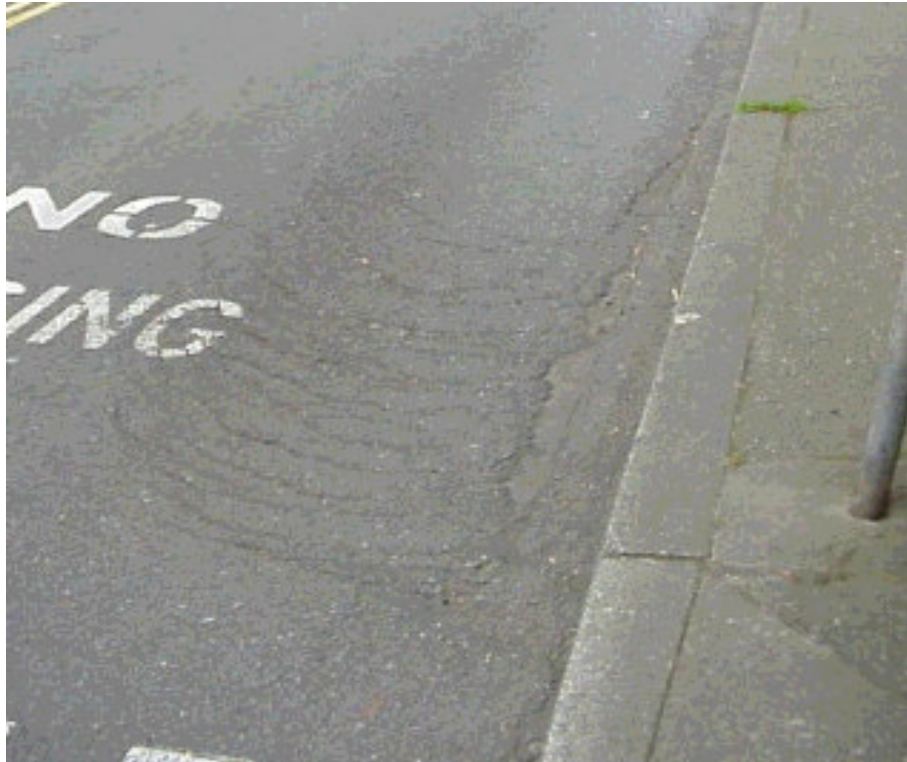
Slippage cracks are crescent-shaped cracks that usually point in the direction of traffic movement. They may be the result from insufficient bond between the surface and underlying courses, caused by dust, oil, rubber, dirt, water, or no tack coat between the two courses.

Figure 2.13 – Slippage cracking near to a bus stop, caused by acceleration and braking

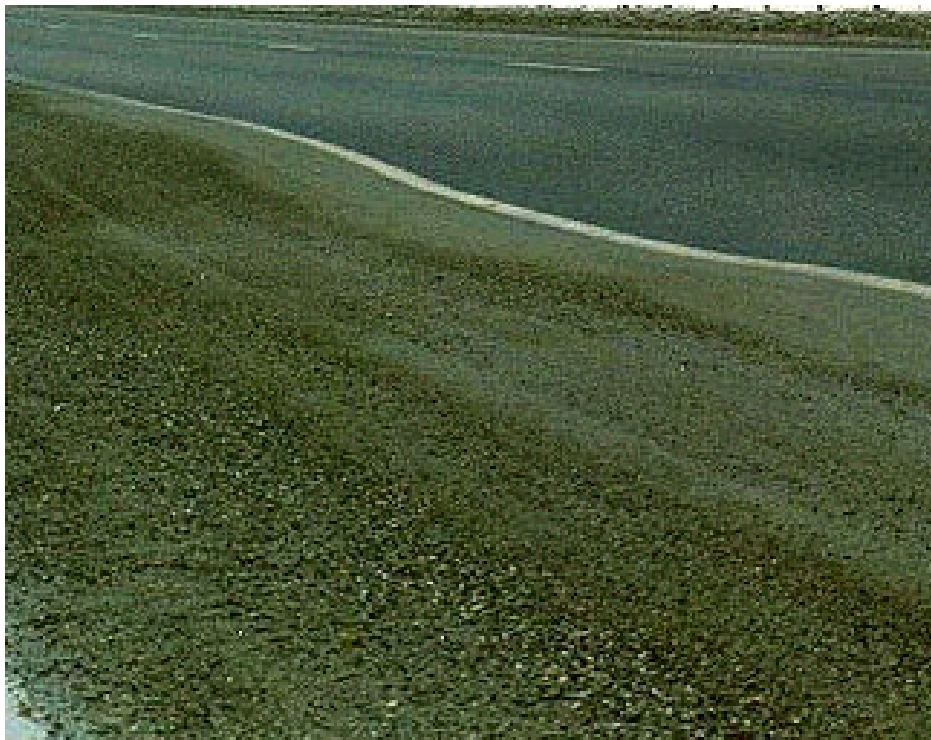
Figure 2.14 – A depression in the shoulder of a road, probably due to local moisture entry resulting in weakness of the pavement and subgrade

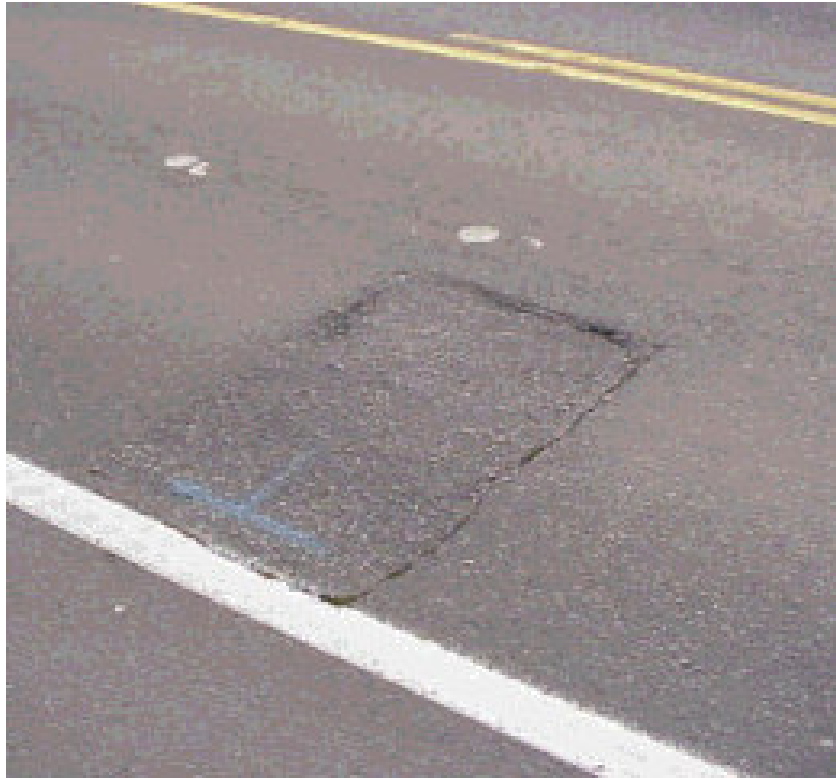
Figure 2.15 – A patch placed over an area of localised pavement distress

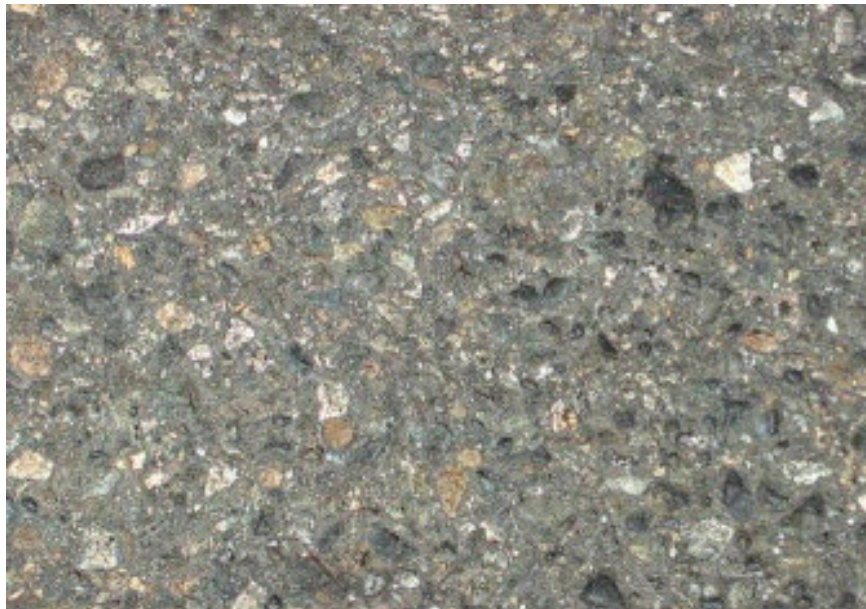
Figure 2.16 – Polishing of a surfacing. There seems to be a lack of surface texture, but no excess binder.

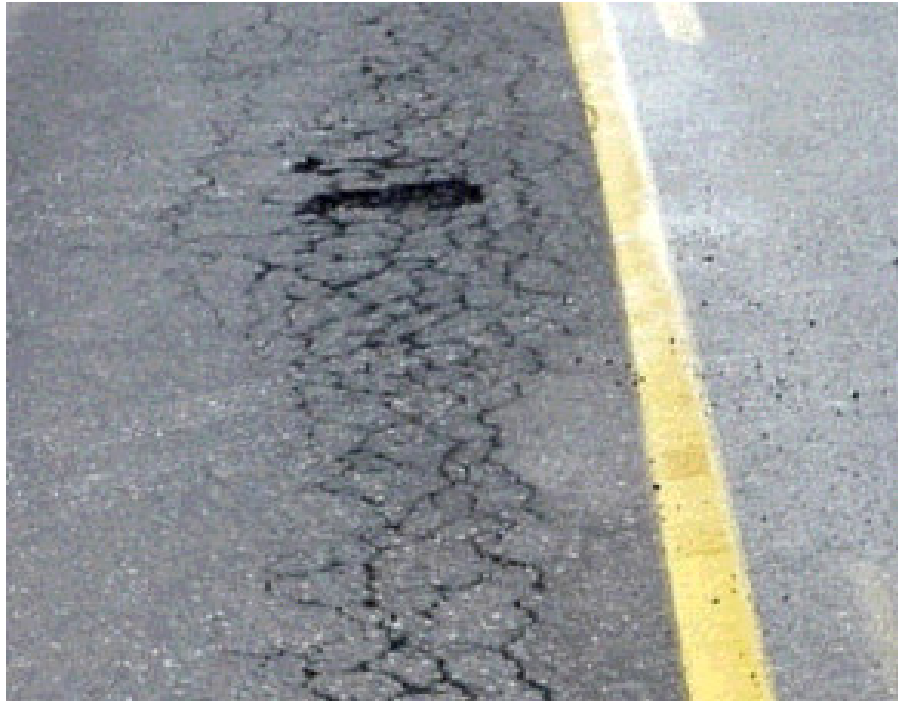
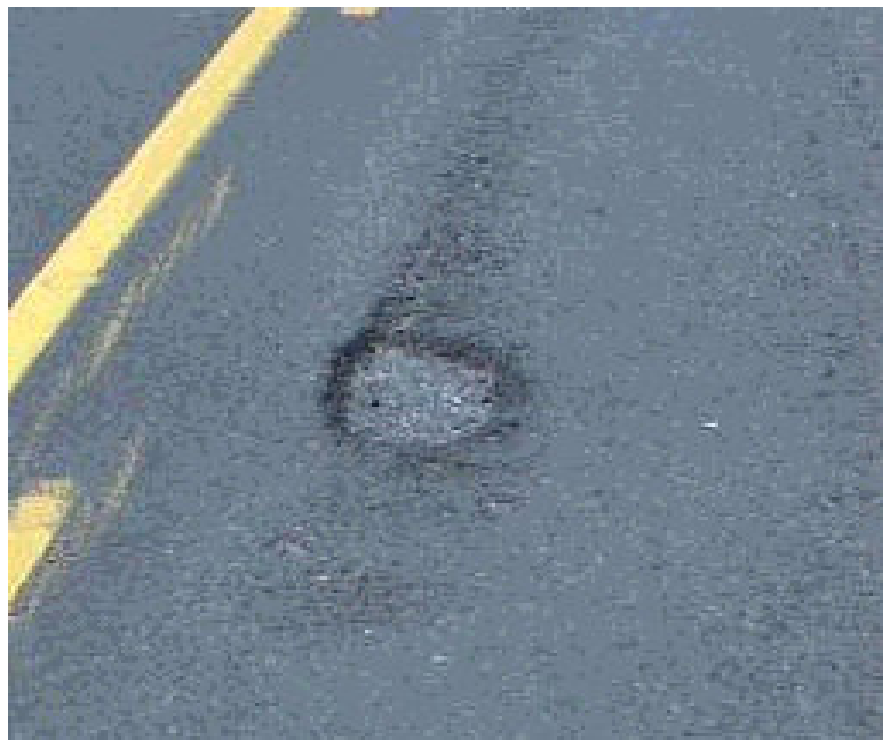
Figure 2.17 – Potholes:

- a) As a result of moisture entry due to fatigue cracking of the pavement surface**
- b) Occurring only in the surface course, with the pavement base still intact**

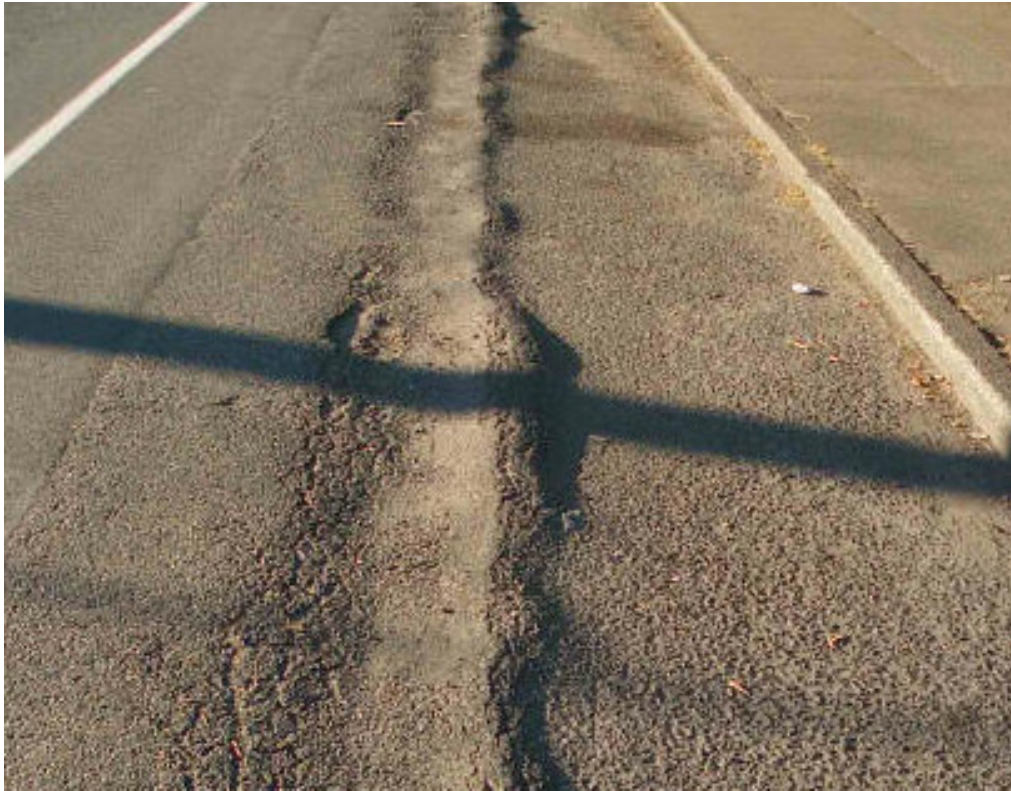
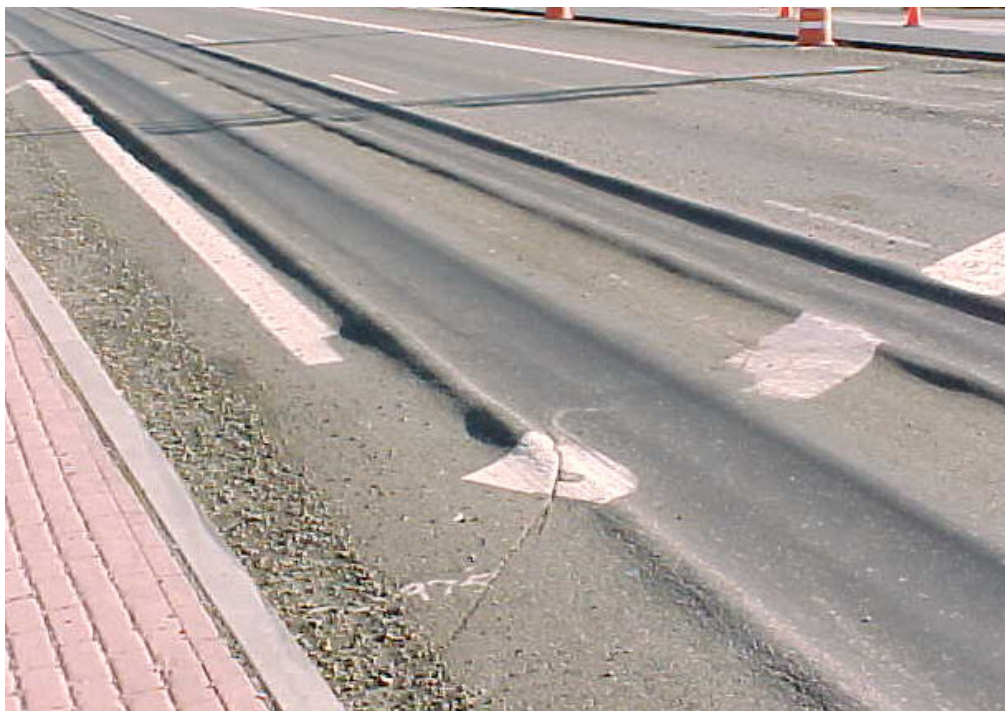
Figure 2.18 – Rutting:

Rutting may be caused by inadequate strength or stability of either the surfacing, pavement or subgrade, allowing deformation. This inadequate strength may be caused by poor material quality, inadequate pavement thickness or excessive moisture. Loss of strength may also occur due to interaction between layers e.g. cutter in a primer seal penetrating the overlying asphalt.

- a) On a road widening, caused by inadequate compaction of the affected area**
- b) On recently completed asphalt, probably due to instability and poor mix design**

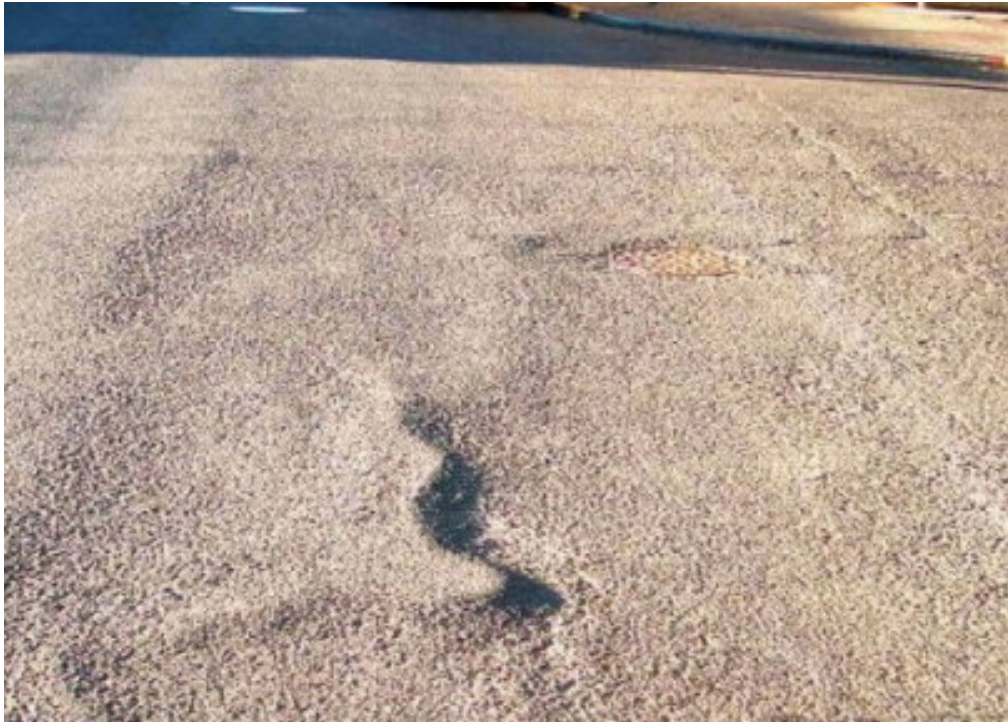
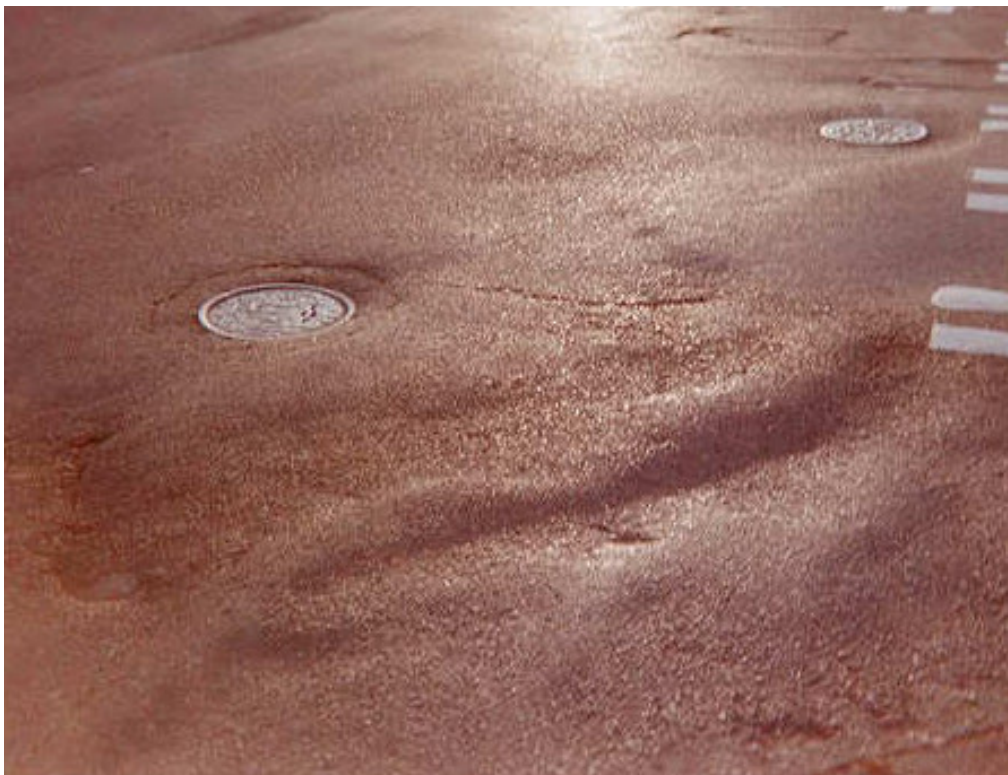
Figure 2.19 – Shoving:

An inadequate pavement thickness results in overstressing of the subgrade, and may lead to shoving. Loss of strength and stability may be caused by excessive moisture, contamination caused by oil spillage, or a lack of curing time between placing seal treatments.

In an asphalt layer, shoving may be caused by a mixture that is too rich in asphalt. There may be a lack of resistance to movement, because the asphalt has too much fine aggregate, too much aggregate that is rounded or smooth-textured, or binder that is too soft.

a) Major localised deformation

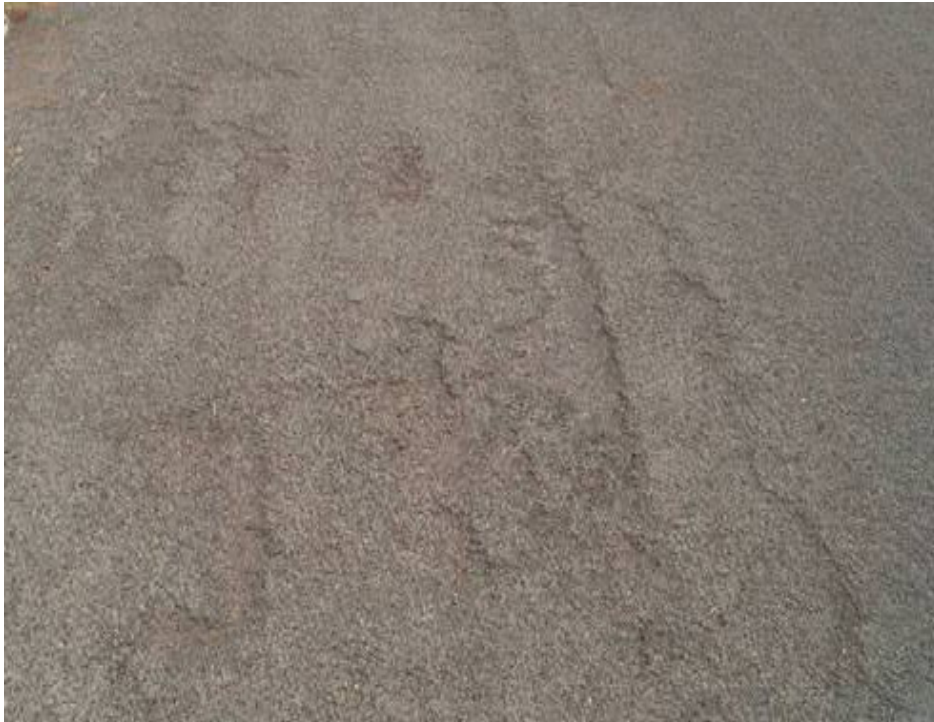
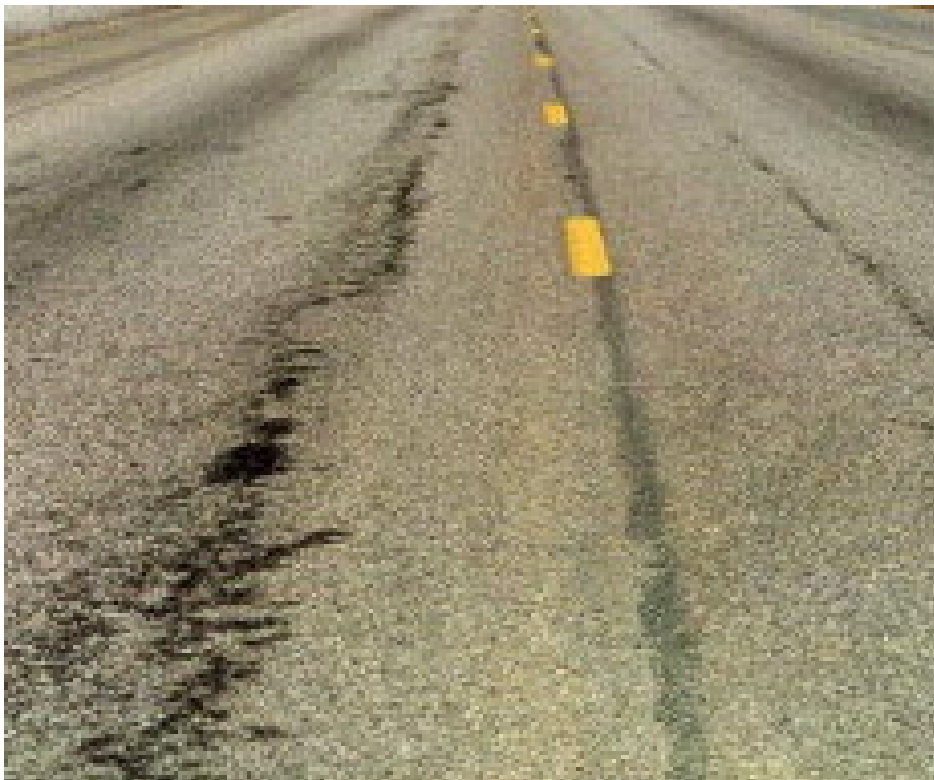
Figure 2.20 – Ravelling:

Insufficient cutter in the binder during spraying results in not enough wetting of the aggregate by the binder, and results in a poor bond. Conversely, excessive cutter means that the bitumen will often be too soft to adequately grip the particles. These effects may also occur if the cutter is not adequately blended into the binder.

An excessively open graded asphalt mix with many air voids is likely to result in ravelling due to the lack of binder. Poor mix design of any asphalt could also cause this.

- a) Of a 20 year old surfacing, due to ageing and embrittlement of the binder**
- b) Within the wheelpaths of a road**

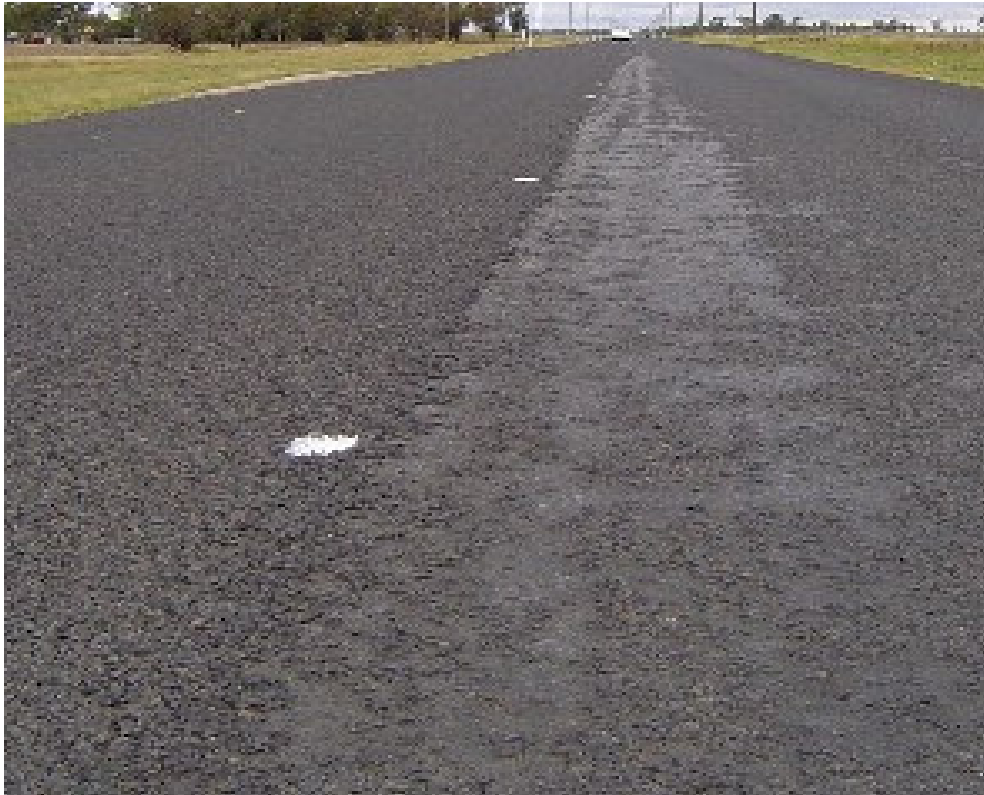
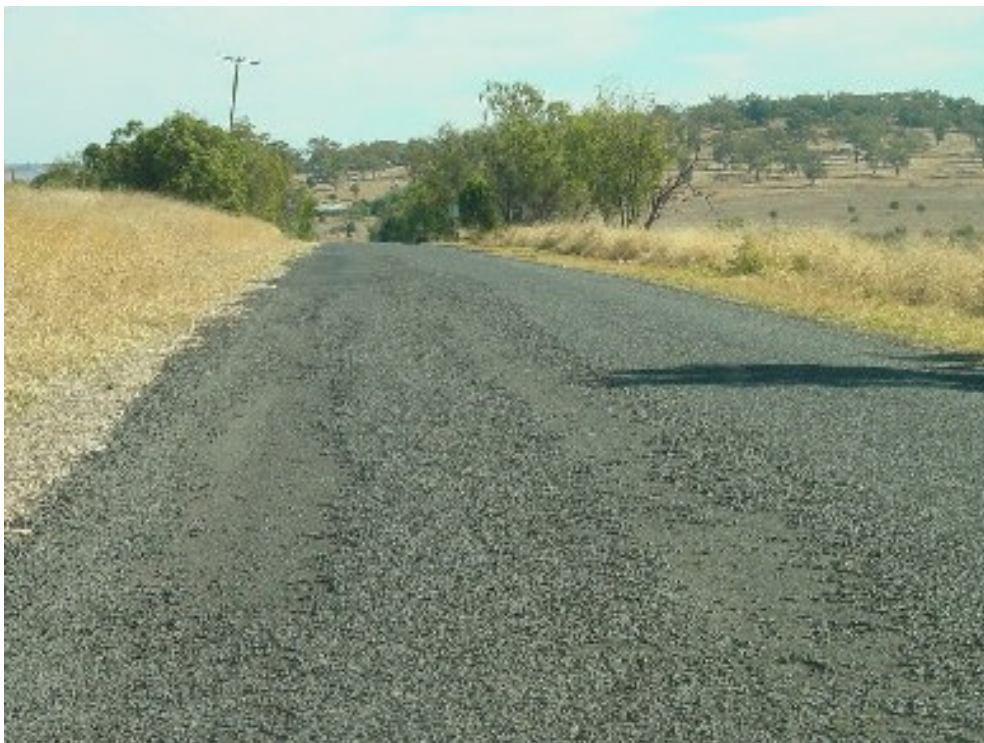
Figure 2.21 – Stripping:

- a) Of a recently completed seal**
- b) In both wheelpaths on an old seal**

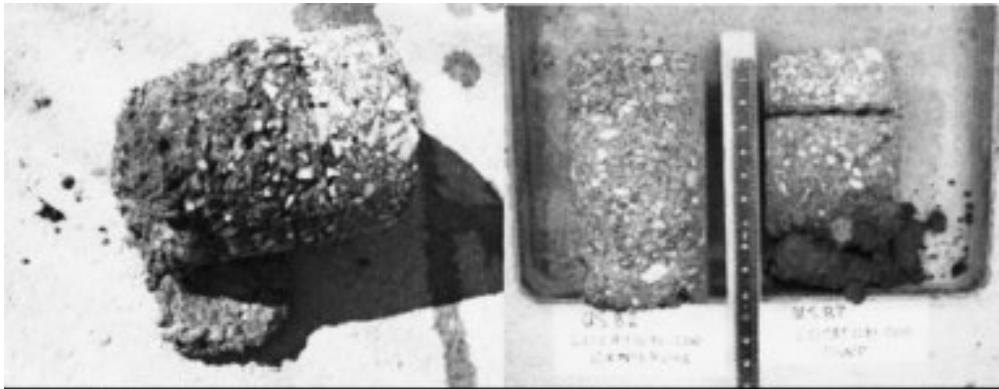
Figure 2.22 – A deteriorating pavement core, an intact core from the road centre, and a deteriorating core from the outer wheelpath

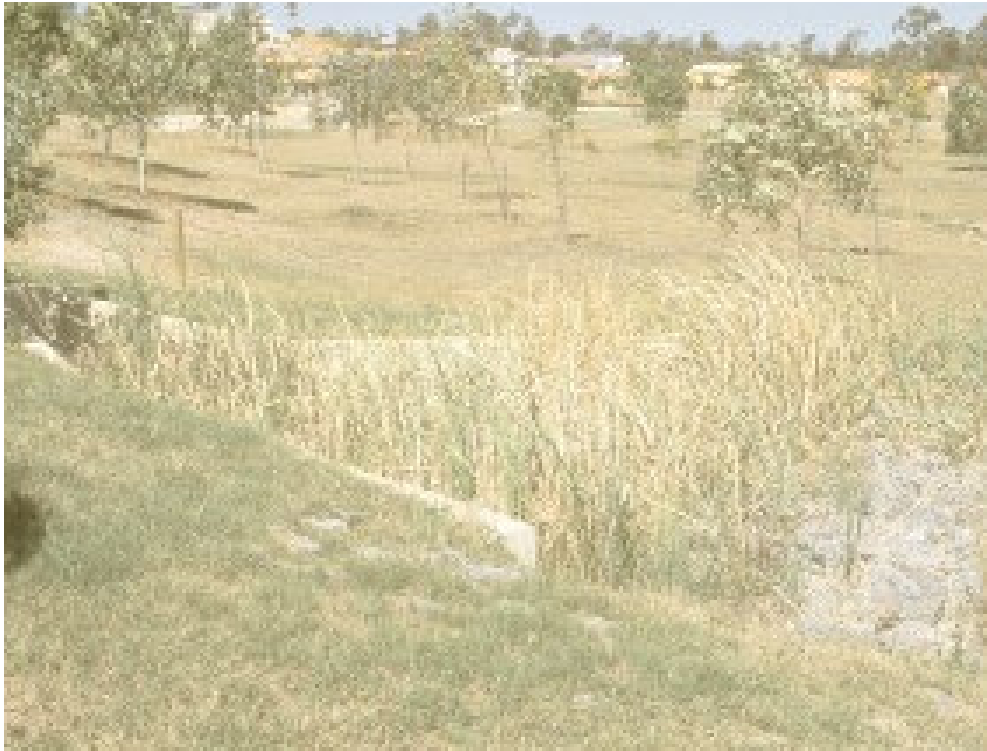
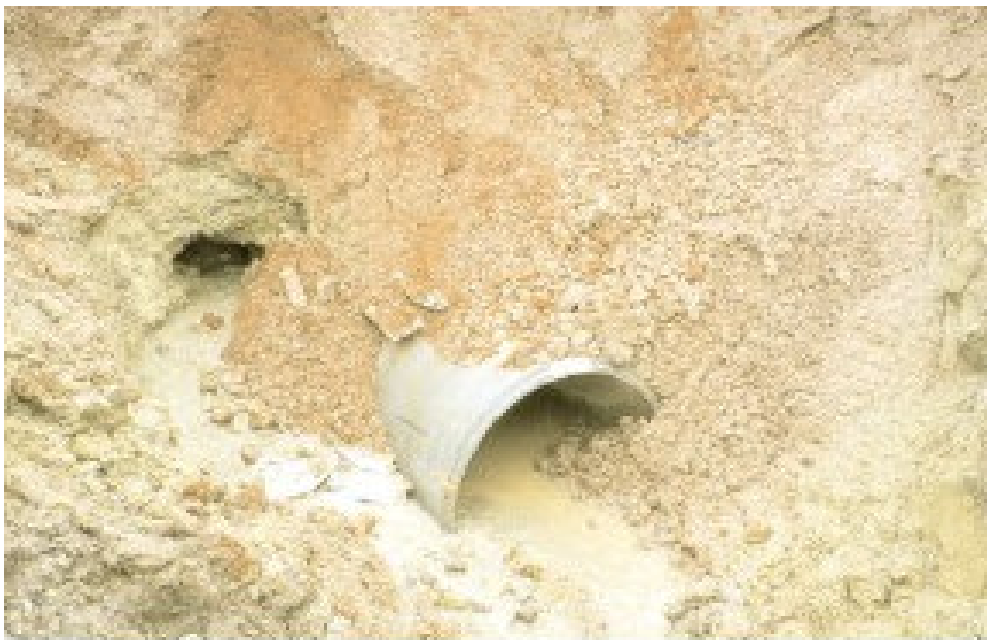
Figure 3.2 – Problems with the drainage system:
a) A culvert blocked by vegetation
b) A culvert that no longer functions effectively
