Forensic Investigation of Pavement Failures

Richard Boyd Smith

Bachelor of Engineering (Civil)

Submitted: October, 2004

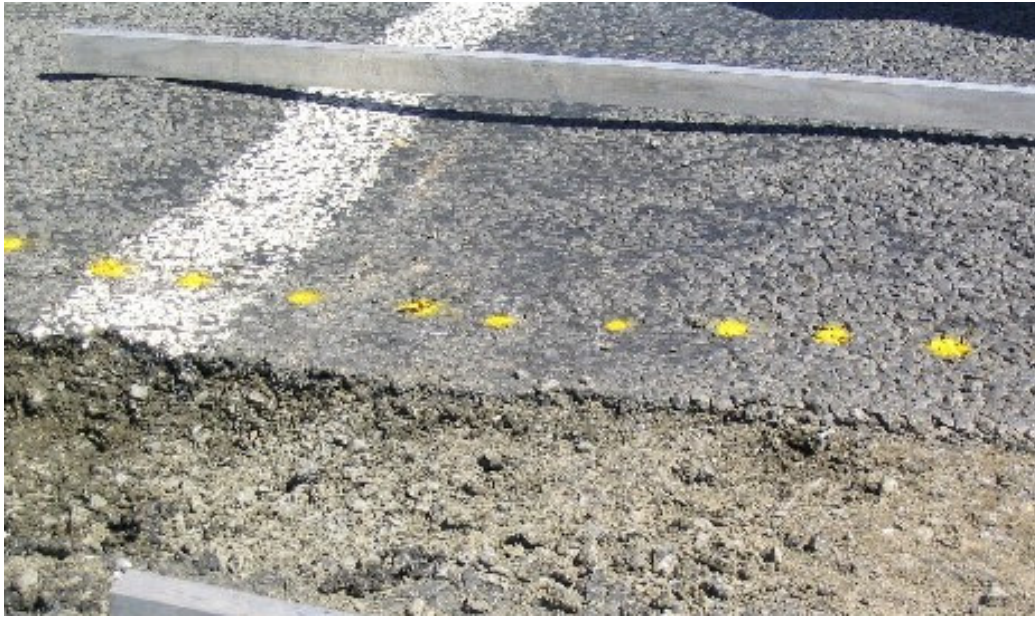
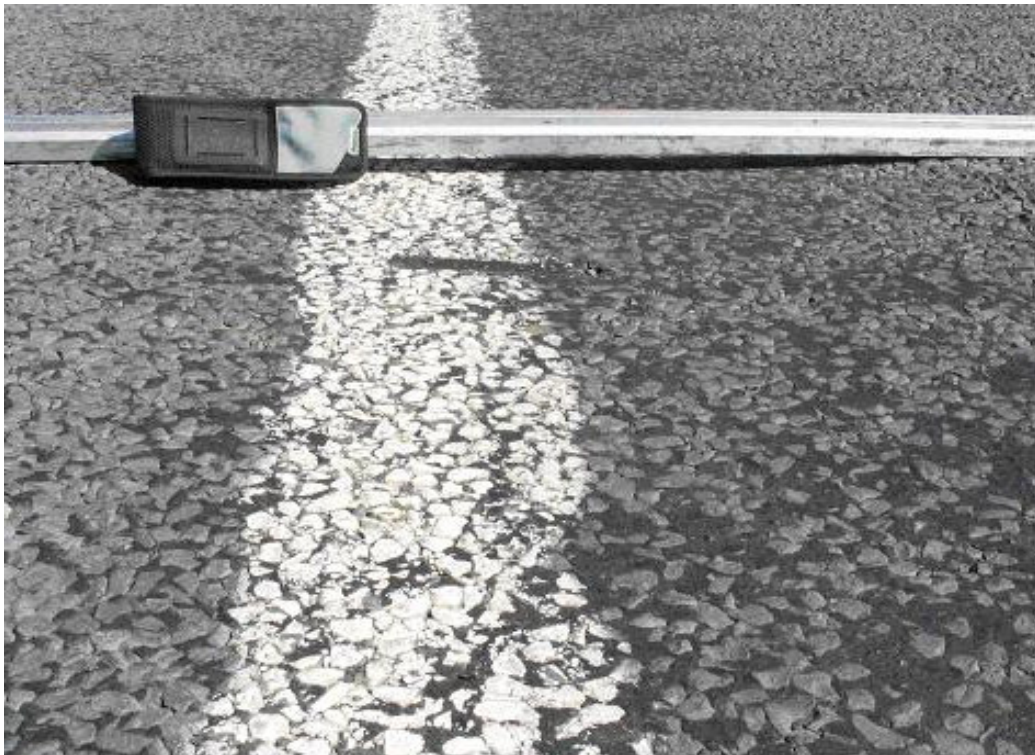
The deformation in the early stages occurred predominantly in the outer wheelpaths. A surface profile measurement was undertaken in October 2003 on the westbound lane at Ch. 75.55 km. This revealed that the deformation in the outer wheelpath was occurring to a depth of about 20 mm below the required level. However, this material was being pushed up to the outside, meaning the effective deformation was about 30-40mm.

Figure 4.2 – Rutting:

- a) Near the edgeline, with the material being displaced to the sides
- b) A view of rutting and the excess binder near the surface

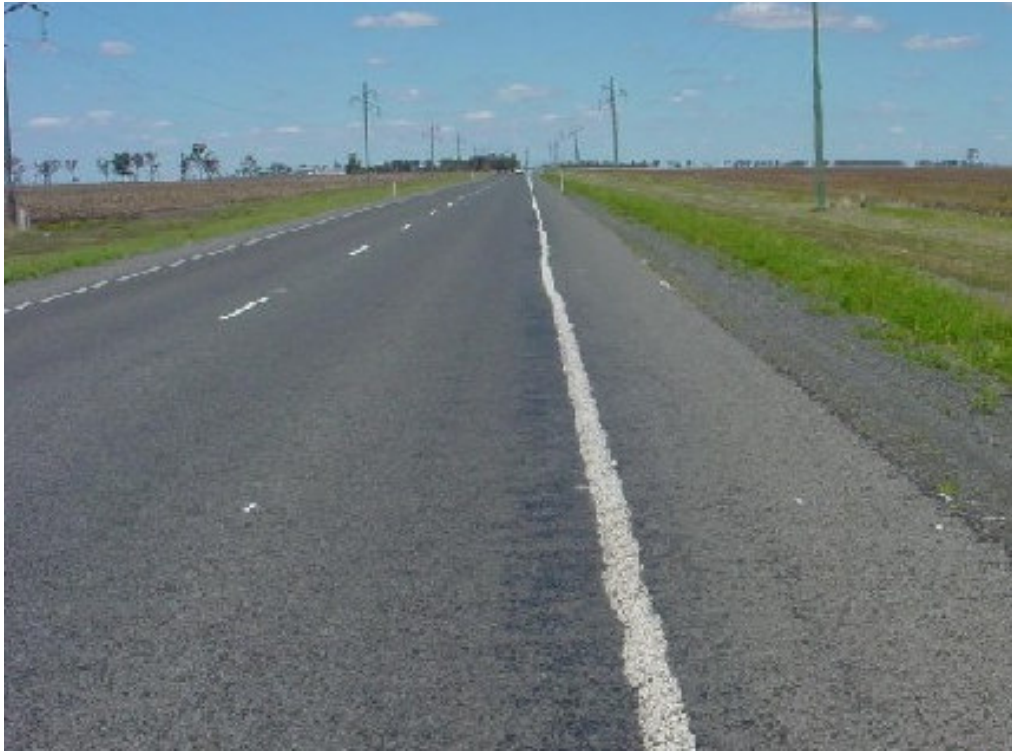
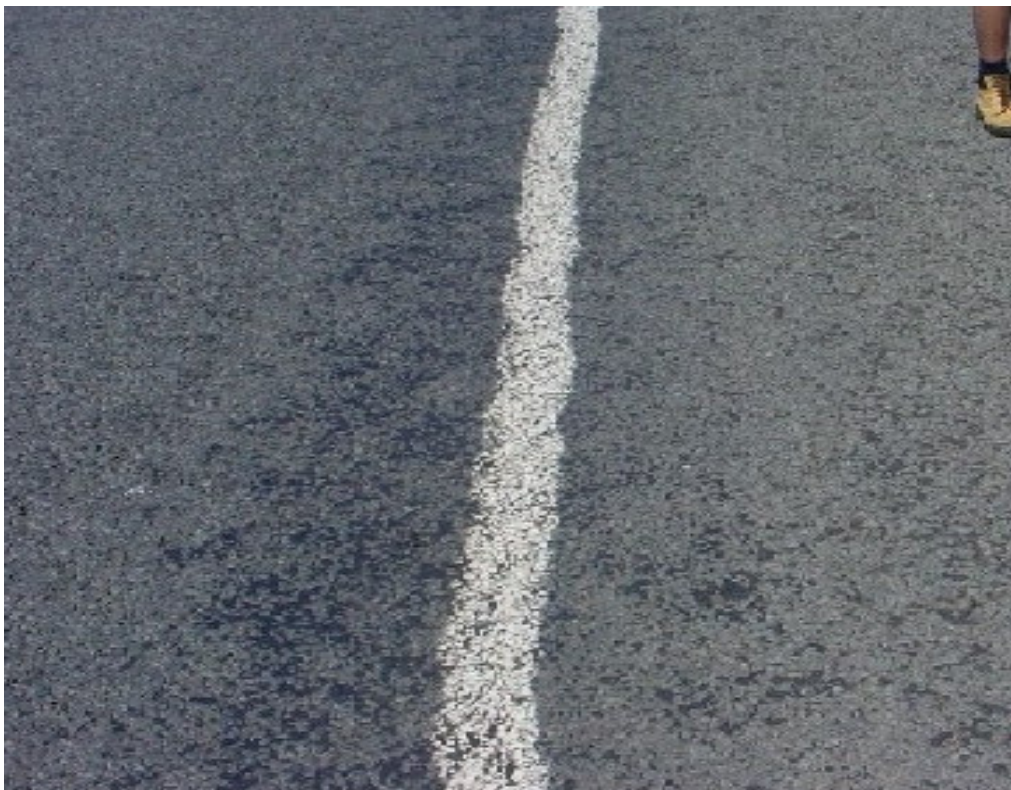
Figure 4.3 – Wavy edgeline:
a) A view along the length of the job
b) A closer view

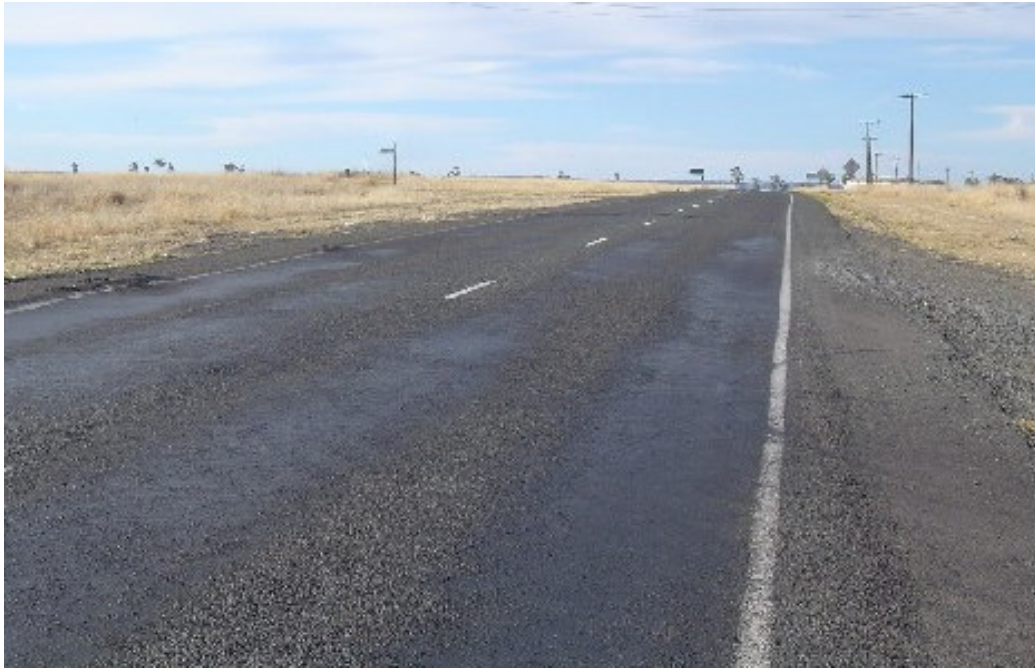
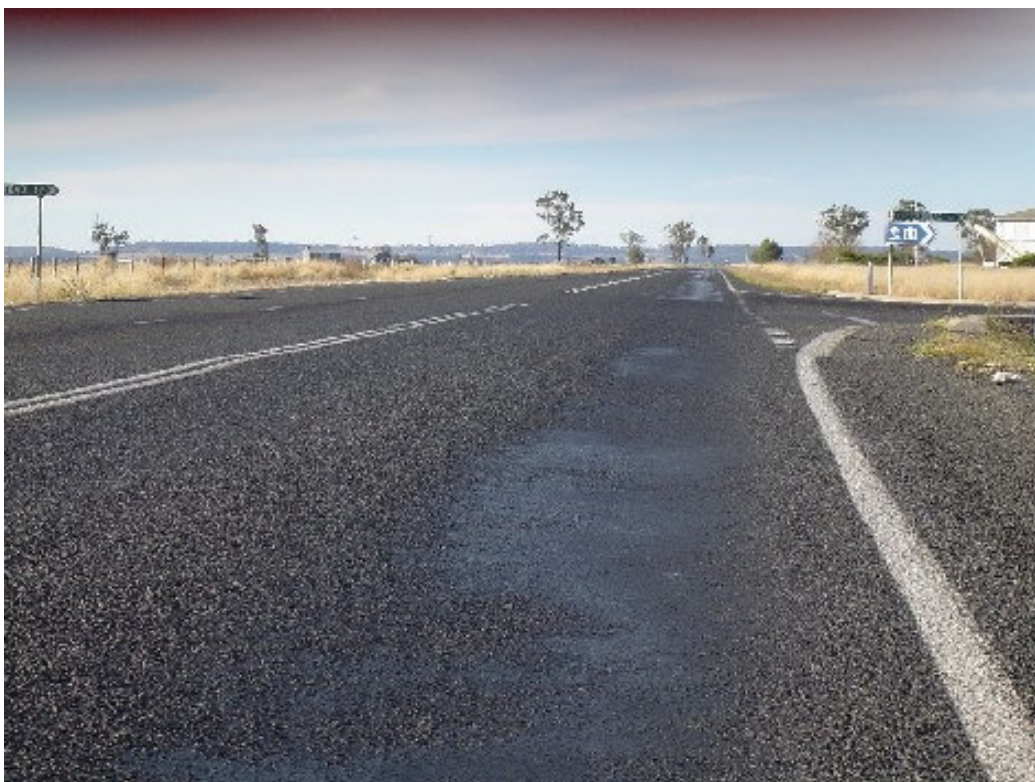
Figure 4.6 – Brookstead – Pampas:

- a) A view of the considerable bleeding in the wheelpaths**
- b) A closer view of some bleeding in the outer wheelpath. Rutting is also starting to occur.**

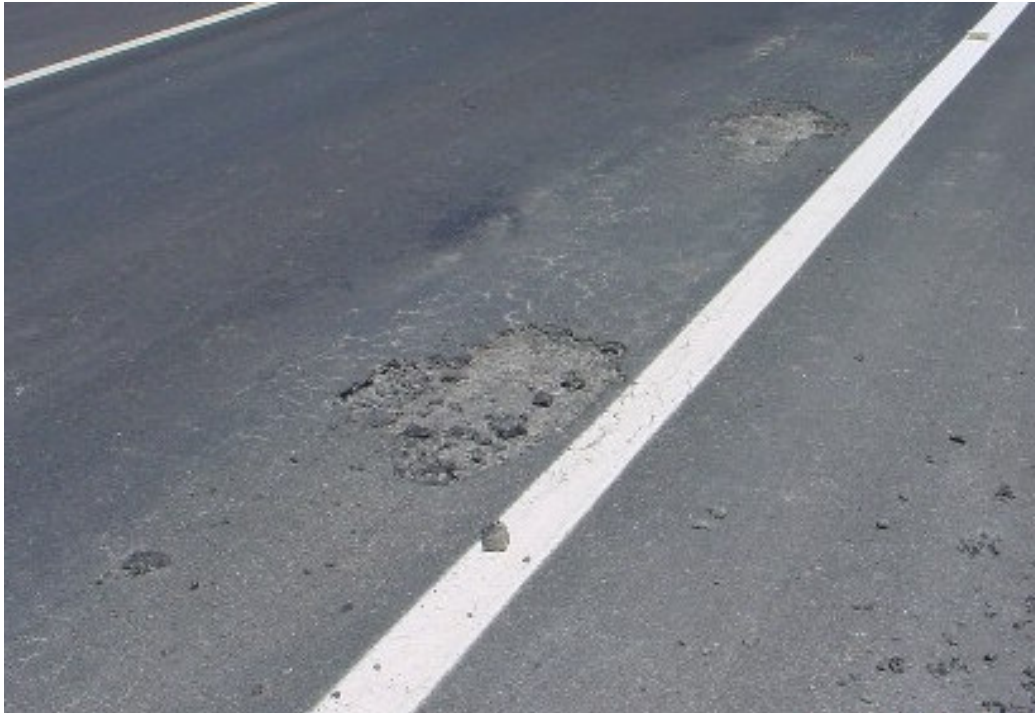
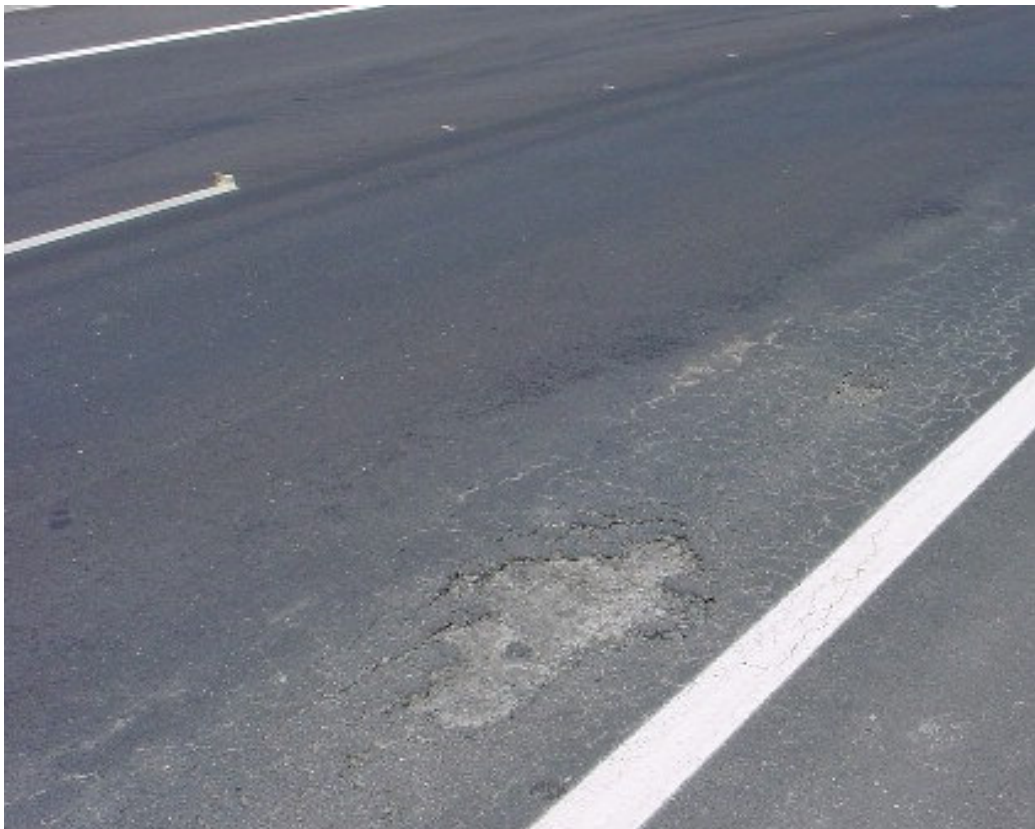
Figure 4.12 – Gatton Bypass:

- a) Isolated ravelling of the asphalt surfacing just west of the Sandy Creek Bridge**
- b) Another view of the failures. These were corrected using patching.**

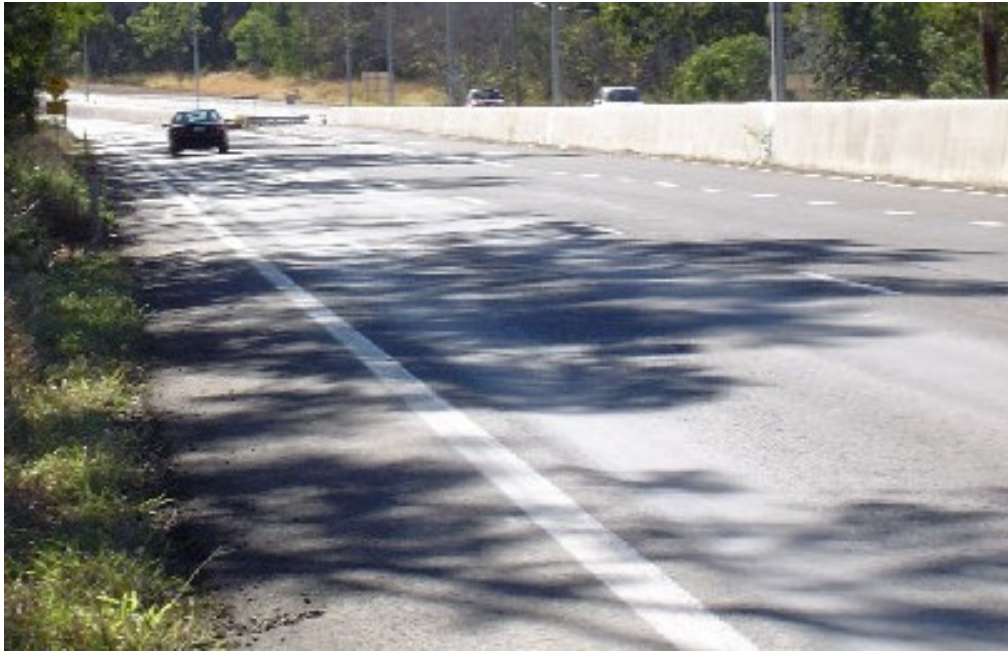
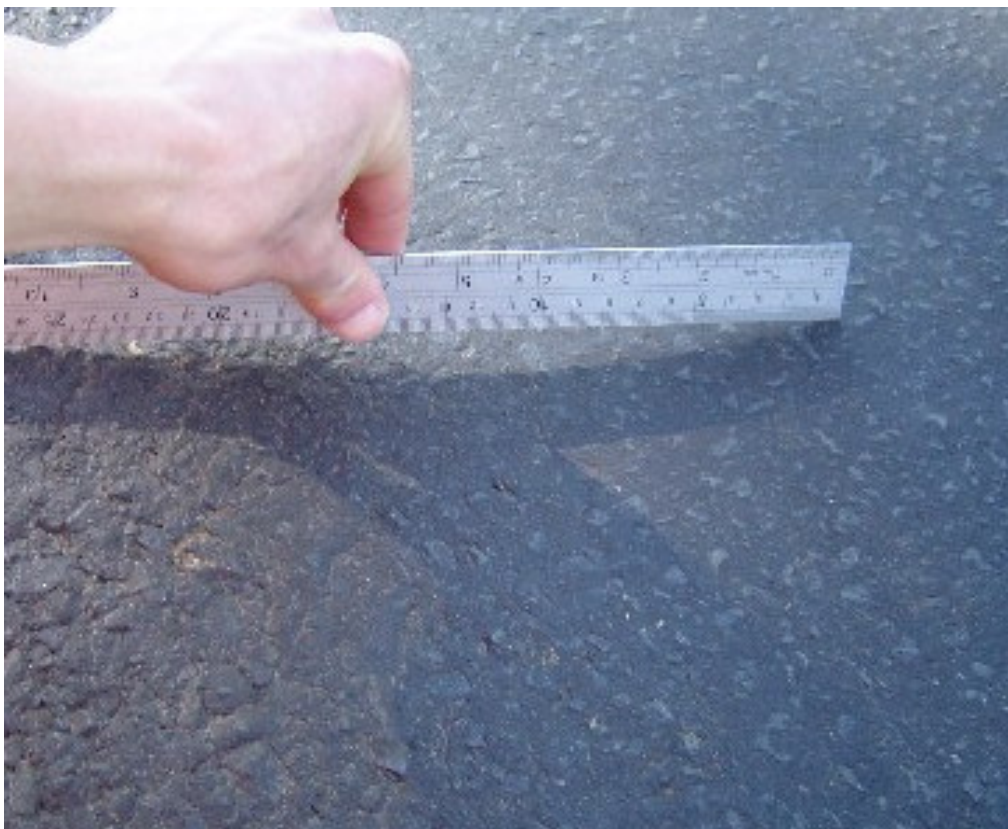
Figure 4.14 – Tabletop Turnoff:

- a) A view showing the location where rutting is occurring
- b) A closer view of the rutting that is occurring in the outer wheelpath of the eastbound outer lane, as well as a lack of surface texture

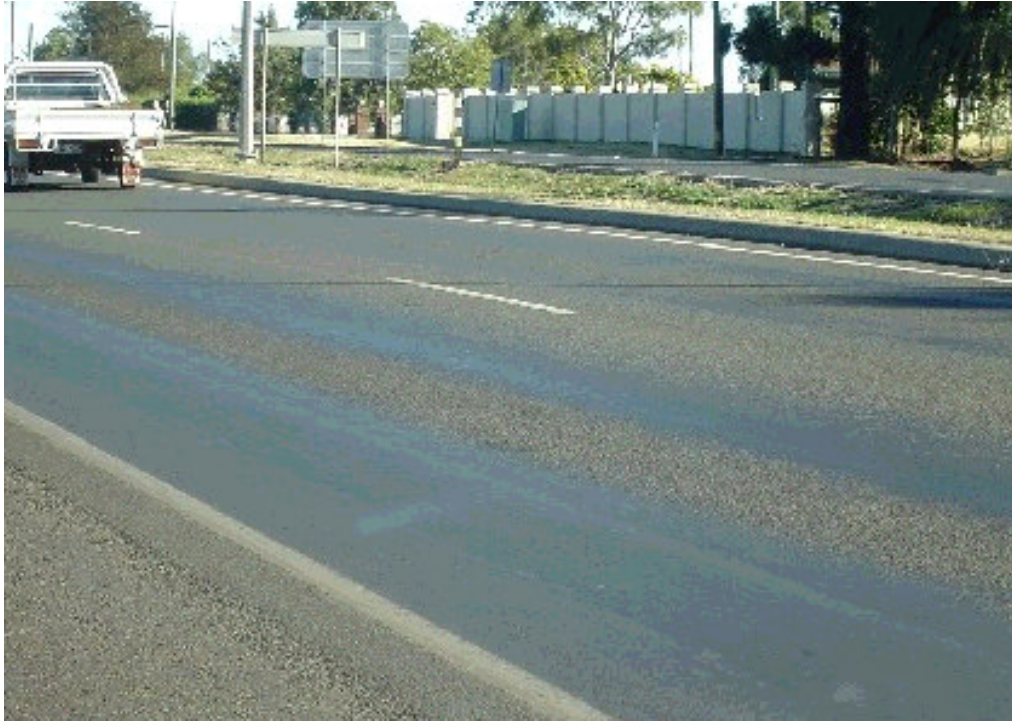
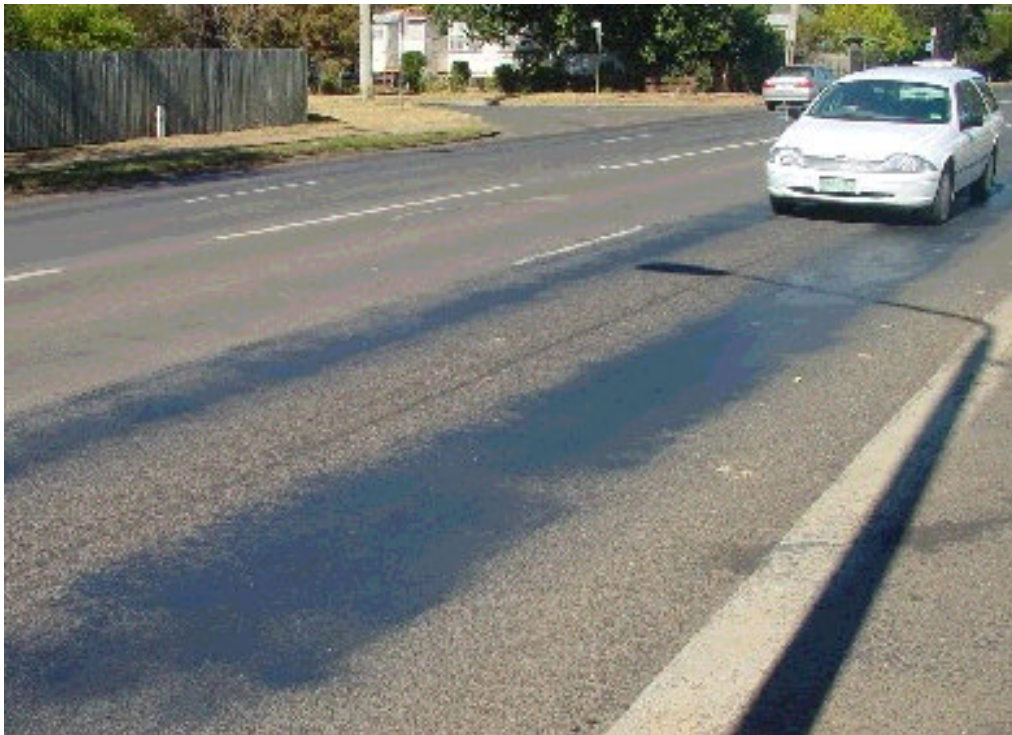
Another factor in urban areas is the potential loss of skid resistance, particularly near intersections and other locations where heavy braking may be required. Some sections of the Warrego Highway through Toowoomba are experiencing bleeding and flushing, leading to a possible reduction in skid resistance at these locations, and this problem may need to be examined further in the future.

Figure 4.17 – Warrego Highway through Toowoomba:

- a) Bleeding on Bridge Street west of Boundary Road**
- b) Bleeding on Taylor Street, north of the intersection with Hursley Road**

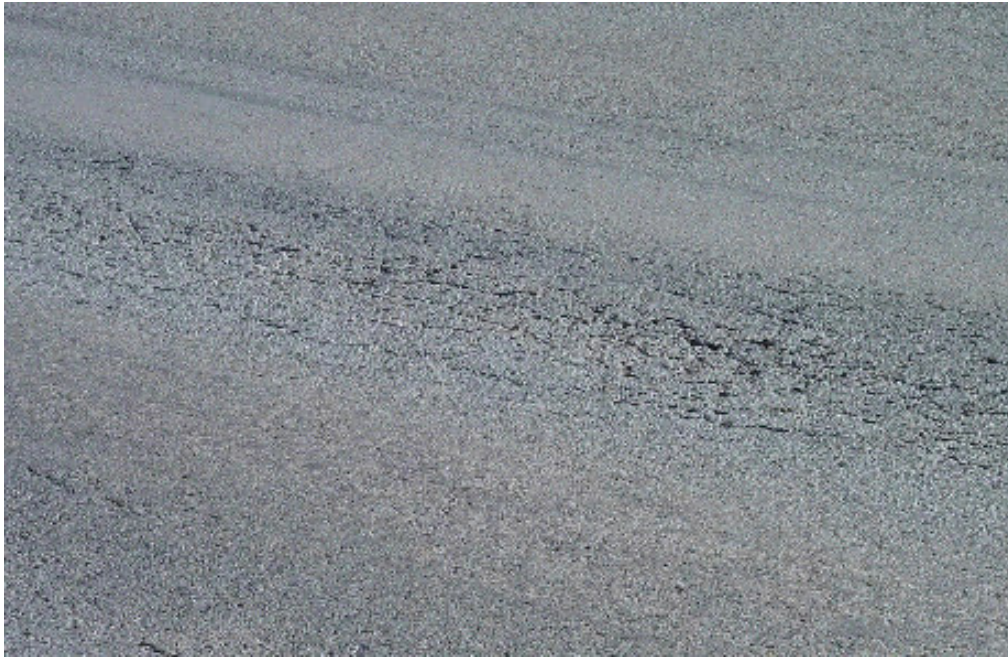
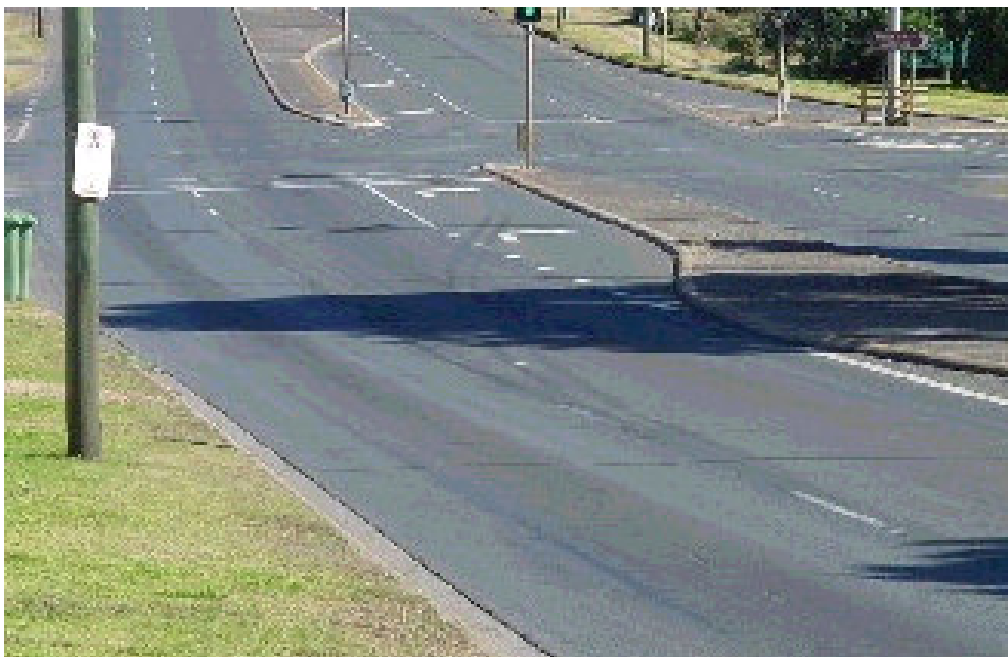
Figure 4.19 – Warrego Highway 18A, along James Street near Kitchener Street:

- a) Structural cracking in the outer westbound lane**
- b) View looking west towards Kitchener Street intersection**

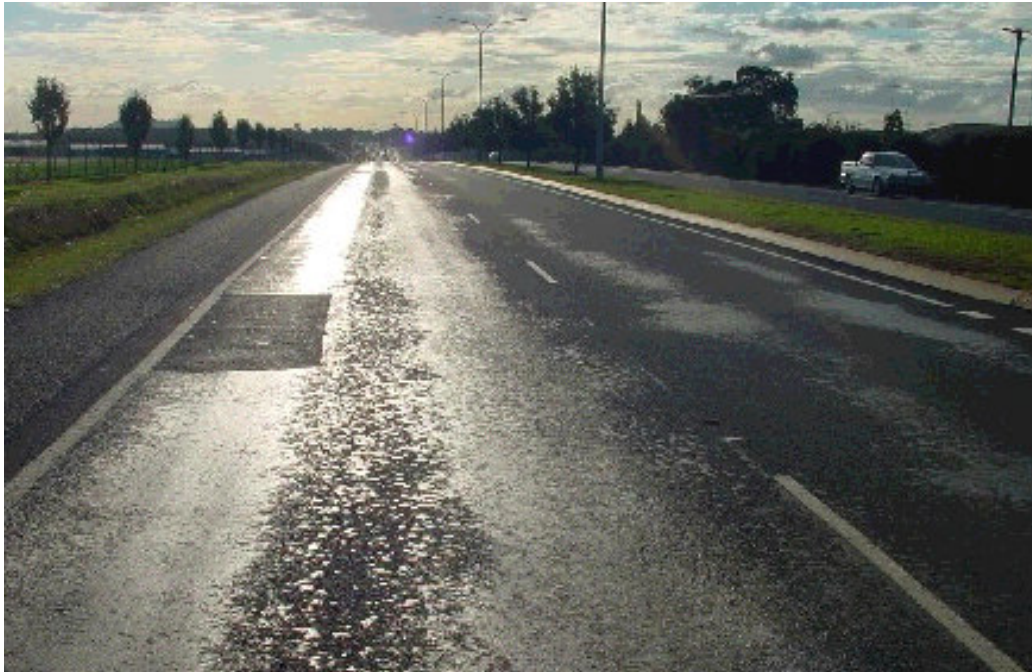
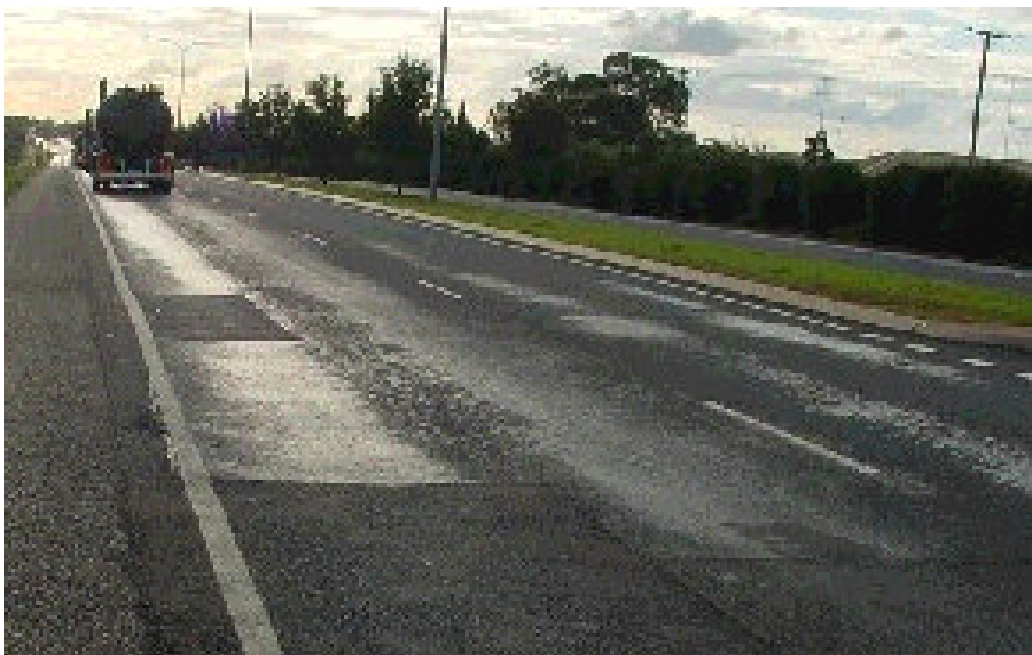
The westbound section was constructed in 1995. Major bleeding occurred in the wheelpaths soon after opening, due to the placement of the seal in winter followed by an early hot summer. The seal was overlaid with Novachip in November 1998, but by 1998 the excess bitumen had worked its way to the surface. Some small aggregate was applied to stop stickiness, and this had some short-term success.

Figure 4.22 – Warrego Highway 18B, along Bridge Street:

- a) Bleeding and roughness in westbound lanes leading to MacDougall Street**
- b) Bleeding and rutting in westbound lanes leading to MacDougall Street**

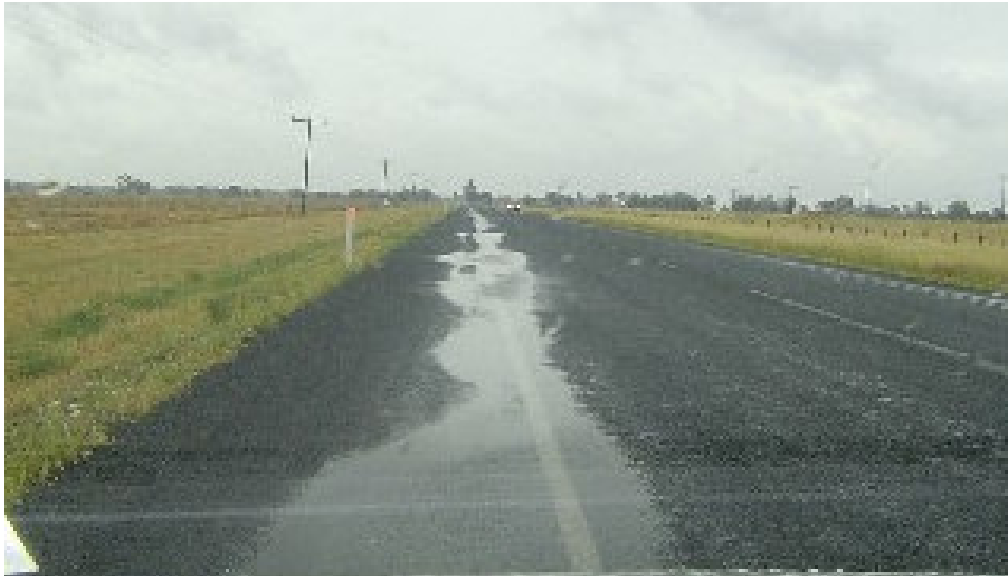
Figure 4.24 - Yaralla Deviation:

a) and b) Views of the water ponding occurring in the outer wheelpath due to rutting and changes in the crossfall of the pavement

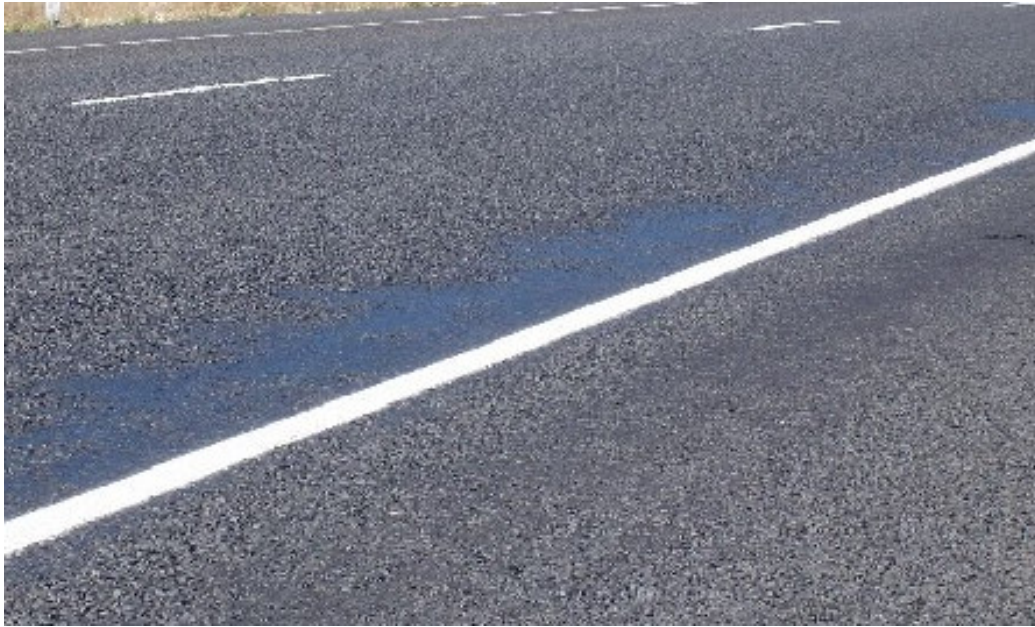
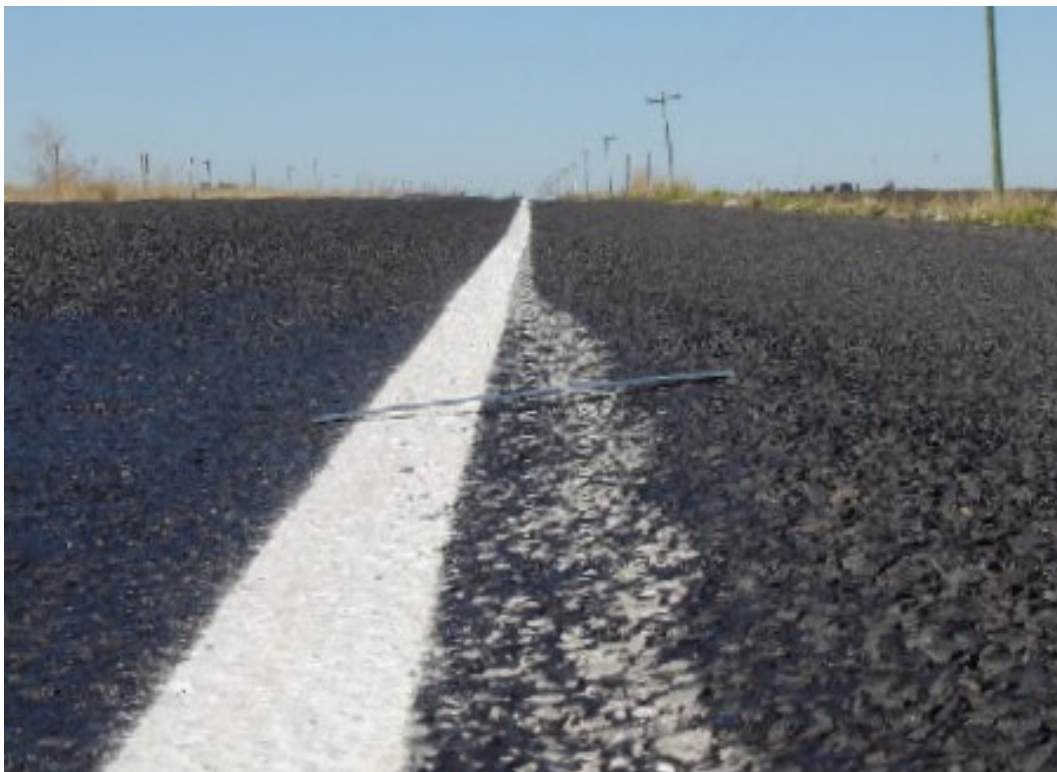
Figure 4.25 – Change in Pavement Crossfall:

- a) Location where crossfall had reduced from 3% down to 0.6%
- b) Level device is being held at design 3% crossfall, illustrating the reduced pavement crossfall, leading to water ponding

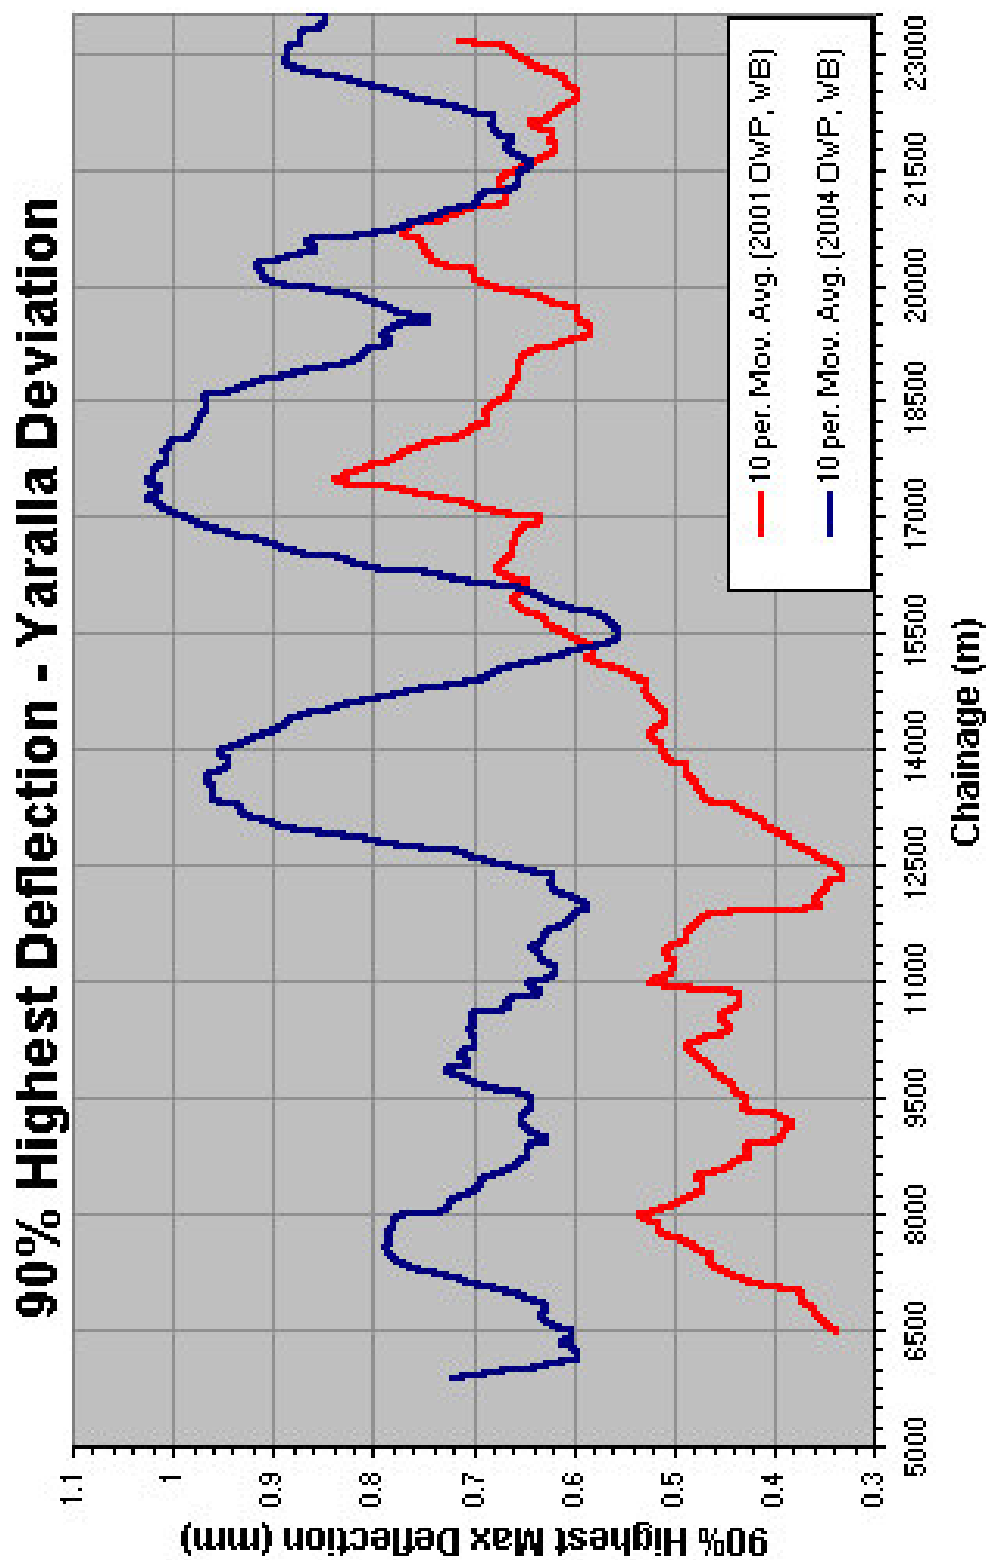
Figure I.1– 90 % Highest Maximum Deflection for Yaralla Deviation in 2001 and 2004

There are no currently available guidelines for this parameter, and it was found that this was strongly related to curvature. Therefore, this parameter will not be considered further, except to point out that the deflection has increased by about 30% from 2001 to 2004, possibly indicating a reduction in the strength of the pavement, especially near the surface.

Overall, the total pavement strength appears to have increased from 2001 to 2004, but the strength near the road surface, as measured by deflection and curvature, had decreased. This strength loss has been reflected in the failures that have been occurring along the road section, mostly confined to the upper pavement layers.

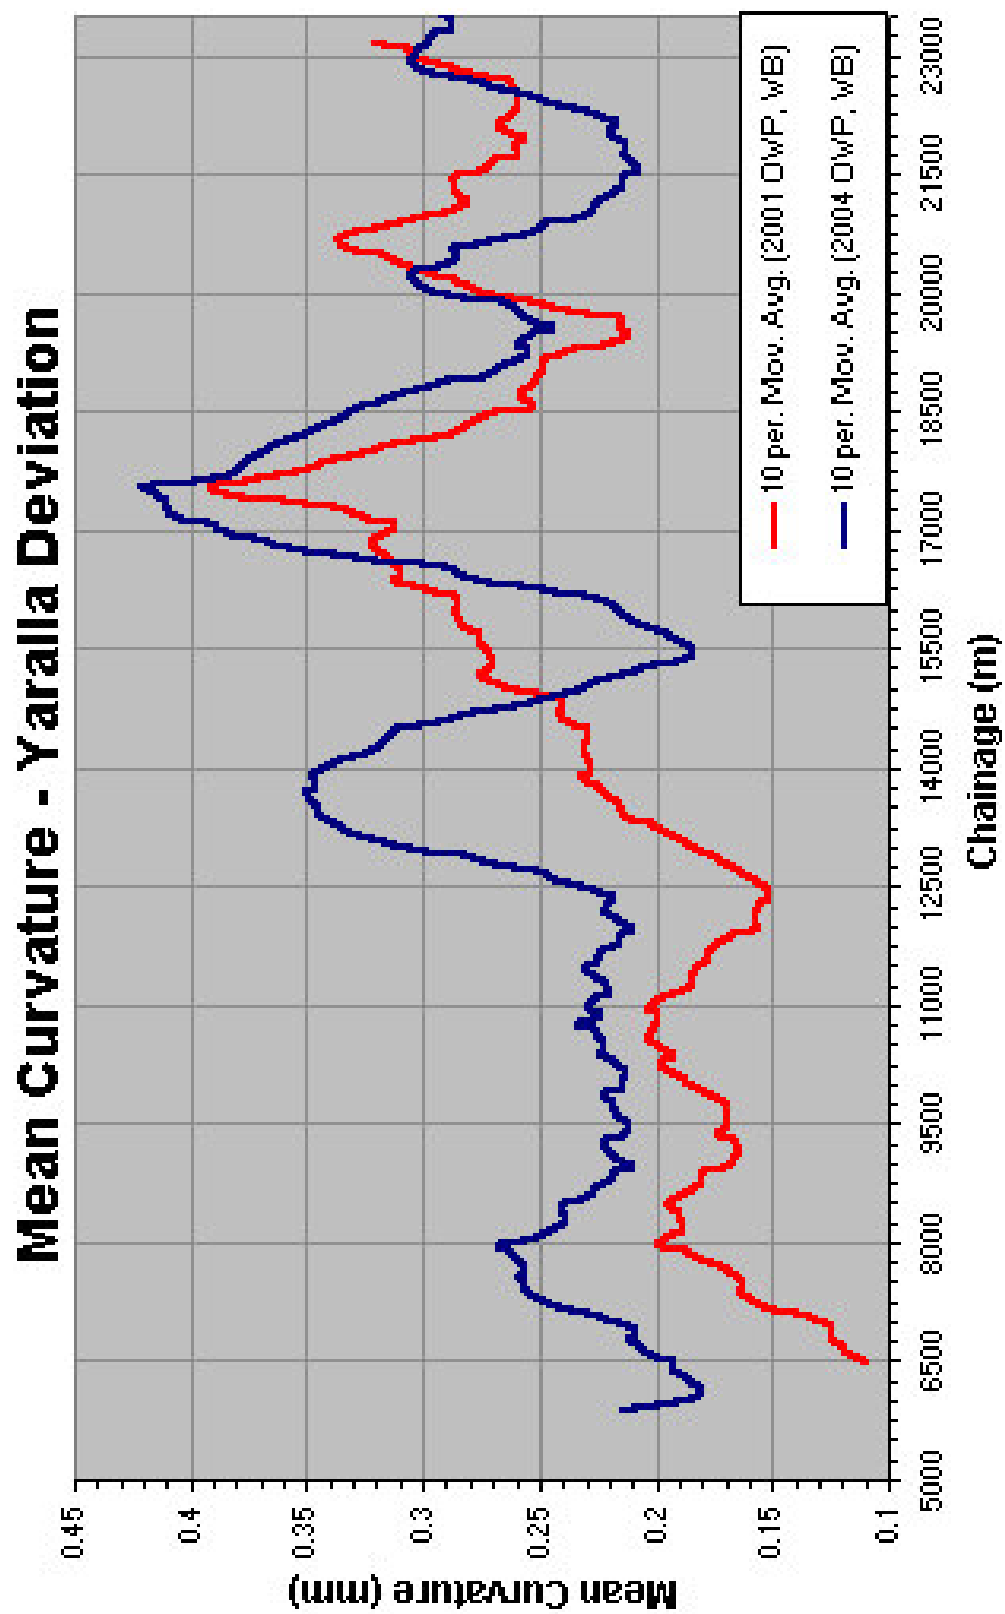
Figure I.2 – Mean Curvature for Yaralla Deviation in 2001 and 2004

The Pavement Rehabilitation Manual (Queensland Transport, 1992) states that values greater than 0.4 mm may suggest a lack of stiffness, a thin pavement or a cracked surface, while a value of less than 0.2 mm indicates a stiff pavement.

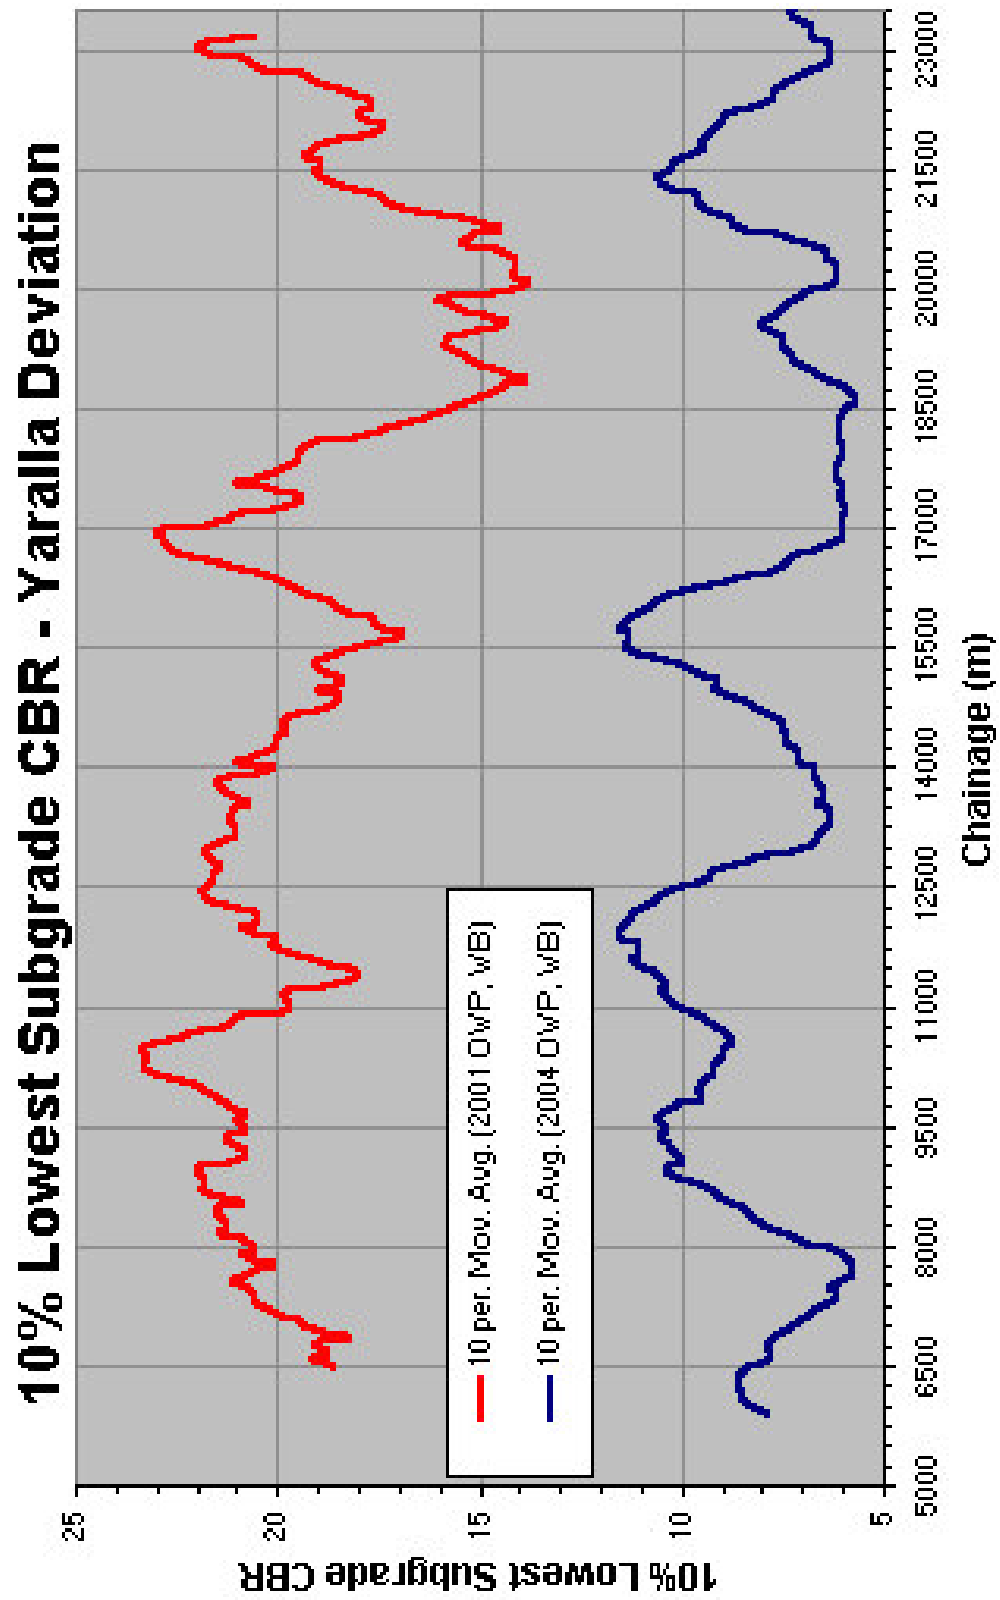
Figure I.3 – 10 % Lowest Subgrade CBR for Yaralla Deviation in 2001 and 2004

It can be seen that from 2001 to 2004, the estimated subgrade CBR has reduced by about 40 – 60%. It is possible that this is due to the uncertainty mentioned above, and also could have been due to differing conditions when the testing was carried out. The 2001 test was carried out in December, while the 2004 test was carried out in July, meaning that the soil moisture conditions may have been different, affecting the CBR value.

The estimated subgrade CBR values have markedly reduced from 2001 to 2004, although this is probably due to the differing soil moisture conditions at these times, and the uncertainty about the calculation of this value.

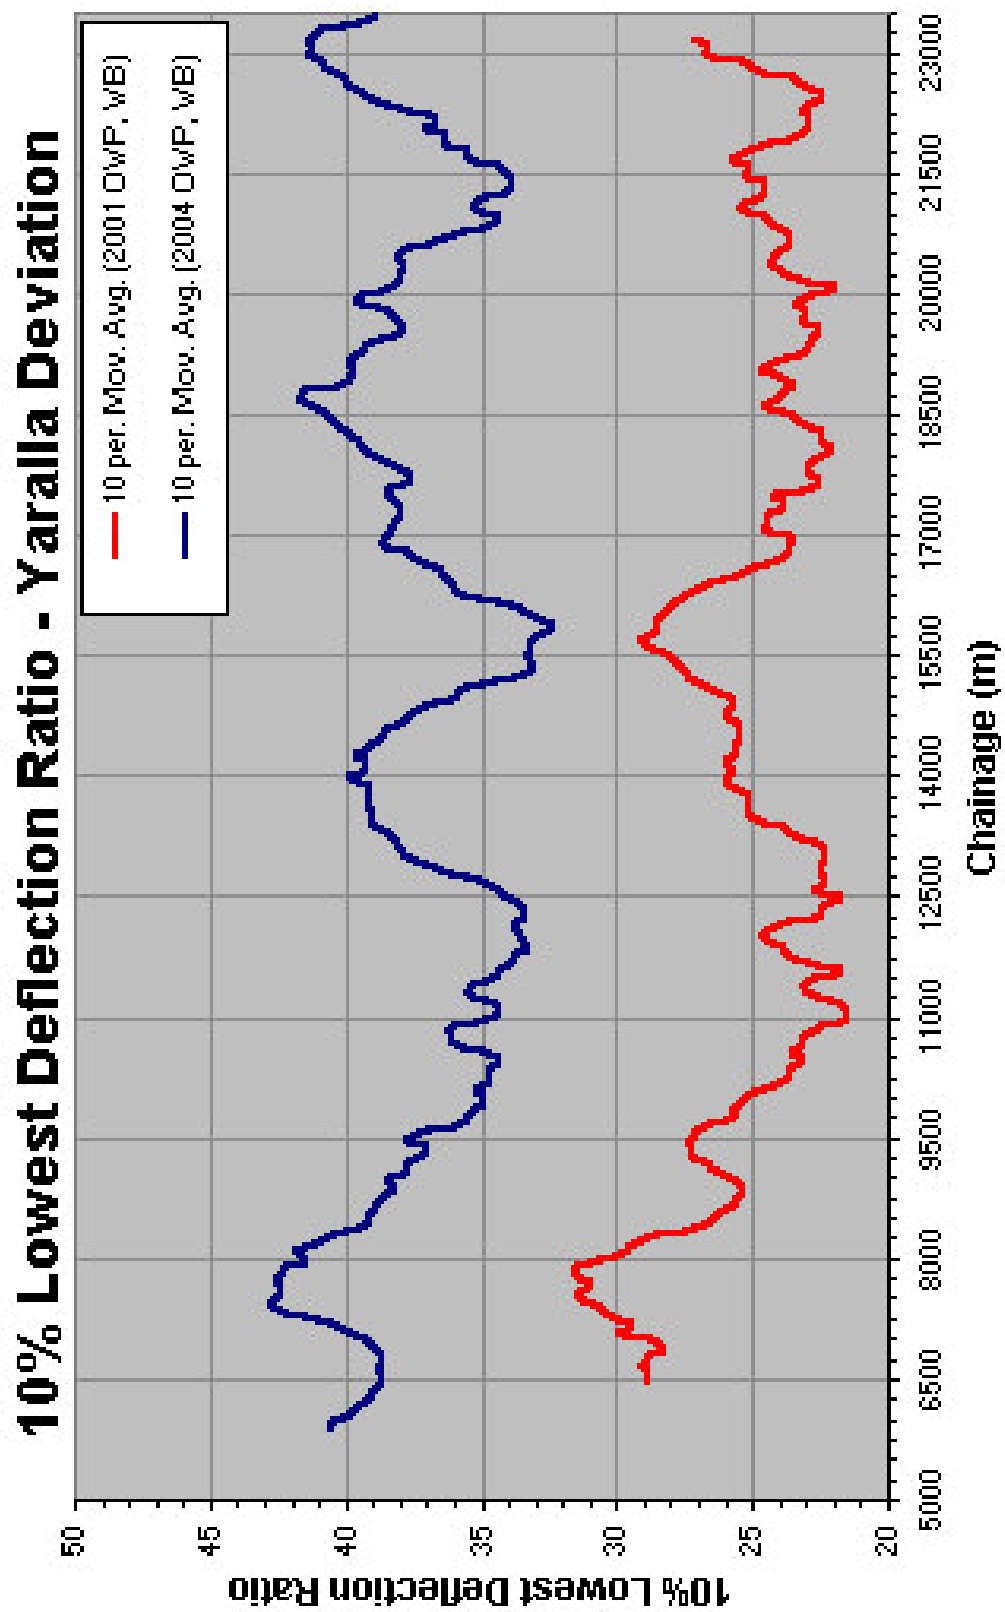
Figure I.4 – 10% Lowest Deflection Ratio for Yaralla Deviation in 2001 and 2004

As can be seen from the above table, the deflection ratio appears to almost satisfactory, with the median value being about 37 – 38 in 2004. It should be noted that there is some conservatism in the results, and that there is no really precise relationship between the value of this parameter and the pavement integrity.
