ABANDONED SHAFTS STUDY

(Charters Towers) A Spatial Solution

A dissertation submitted by

Bachelor of Spatial Science Technology (GIS)

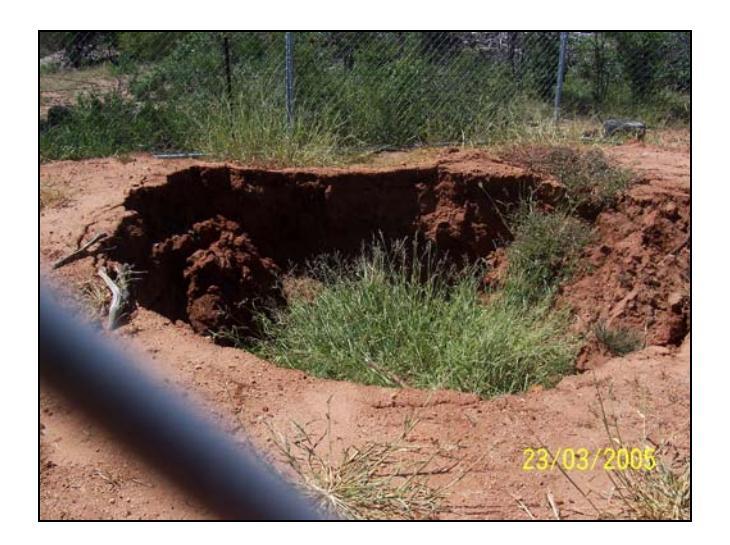
Figure 1.4 Mine Subsidence (SH10717) (NR&M, 2005)

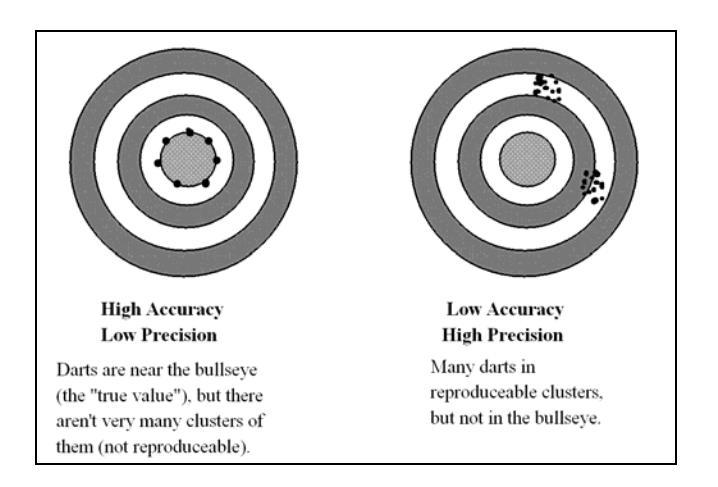
Accuracy, defined as the displacement of a plotted point (usually coordinates) from its true position in relation to an established standard, while precision is the degree of perfection or repeatability of a measurement (LEMBO, circa 2000).

Figure 2.1 Explanation of Accuracy verses Precision (Source: http://dusk2.geo.orst.edu/gis/PPTs/8-9map_in_comp2.ppt)

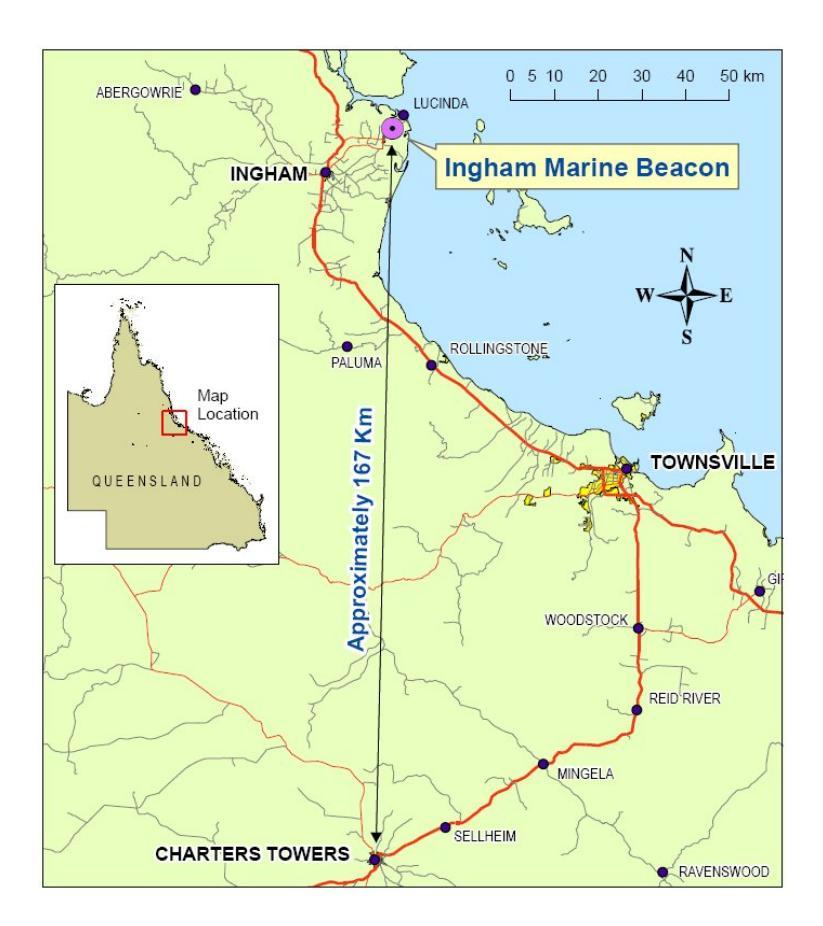
Figure 2.2 Proximity of Ingham Beacon to Charters Towers

As Charters Towers is approximately 160 kilometres from the Ingham beacon it was important to ascertain the possible effect that this distance would have on the DGPS results. The broadcast standards for DGPS navigational service (USCG, 1993) stated that the achievable accuracy degrades at an approximate rate of 0.67m per 100 kilometres from the broadcast site (e.g. Ingham). Monteiro *et al.*, 2004 makes note that this was based on a theoretical prediction made in 1993 prior to the USCG DGPS network becoming completely operational. The study conducted by Monteiro has revealed by correctly evaluating the decorrelations with time that geographic decorrelation of the differential corrections is less than 0.22 metres for every 100 kilometres separation (1 σ estimate). Based on this premis it is possible to obtain positional accuracy in the sub-metre range.

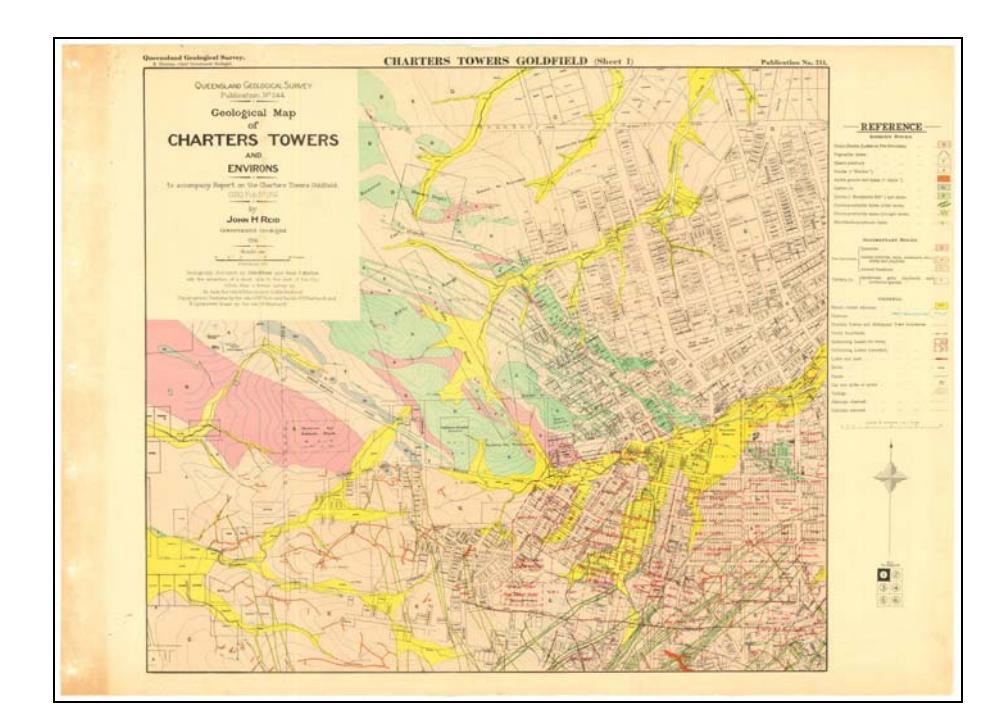
A more detailed mapping program was performed by the Government Geologist J.H.Reid in 1916 during the height of the Great War (see Figure 2.3). This was the last significant mapping activity that is of benefit to the project.

Figure 2.3 Reid - geological map - sheet 1 (1916) (NR&M 2005)

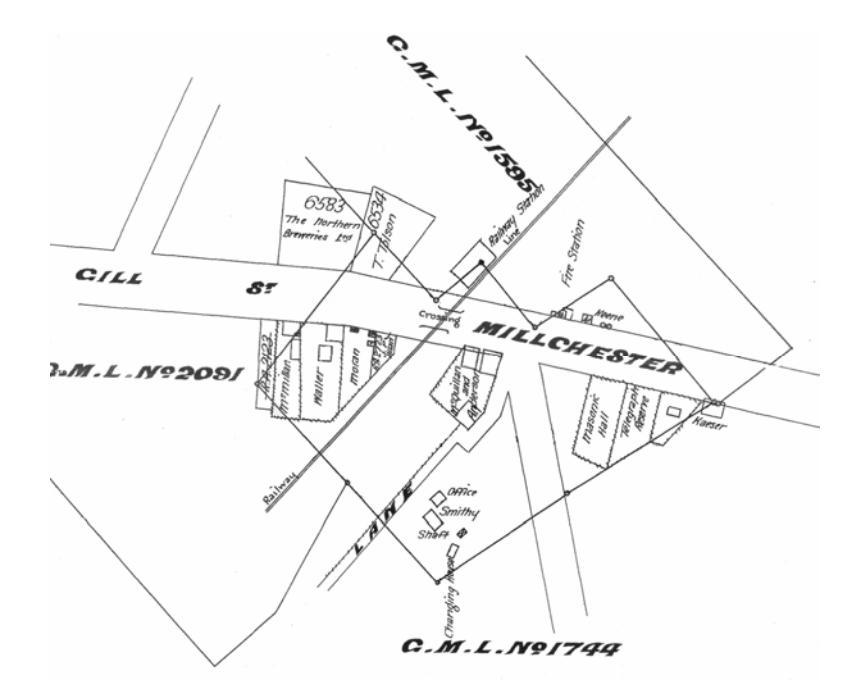
Figure 2.4 GML Plan (part) showing Lease boundary and Cadastre (NR&M 2005)

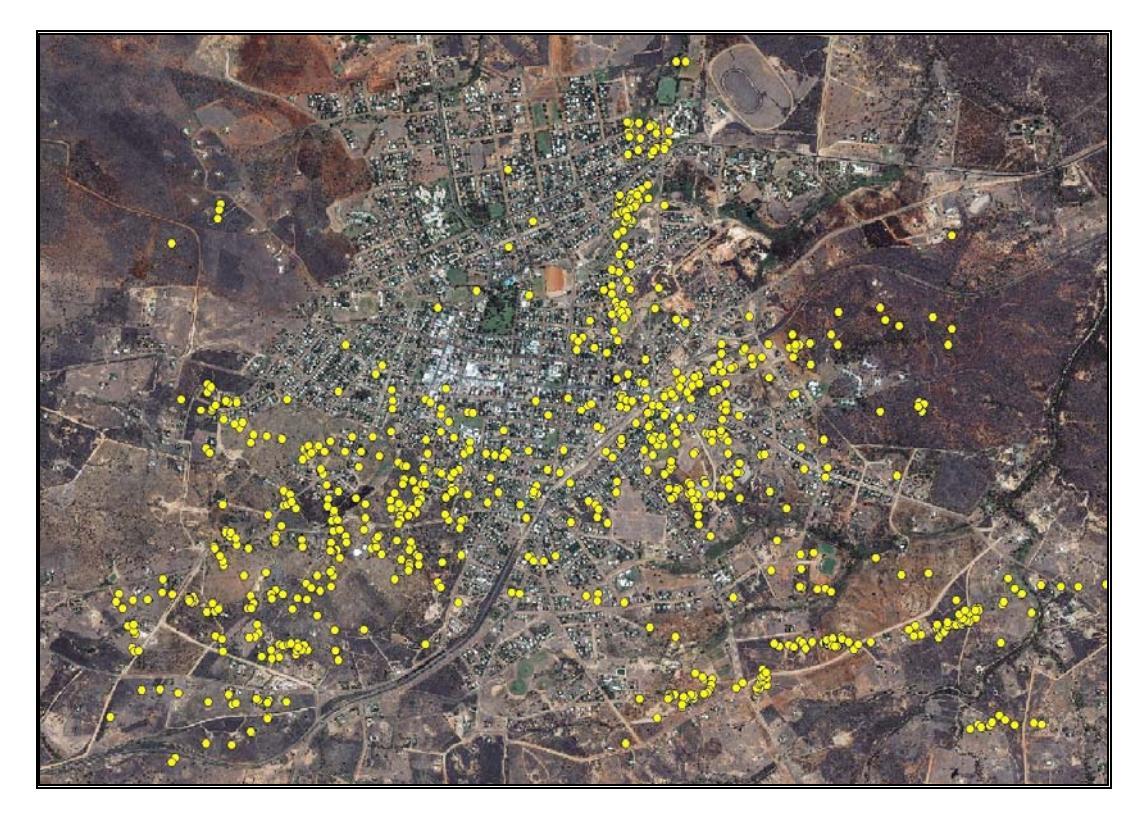
Figure 3.1 Project Area showing Abandoned Shaft Distribution (GEOIMAGE, NR&M 2005)

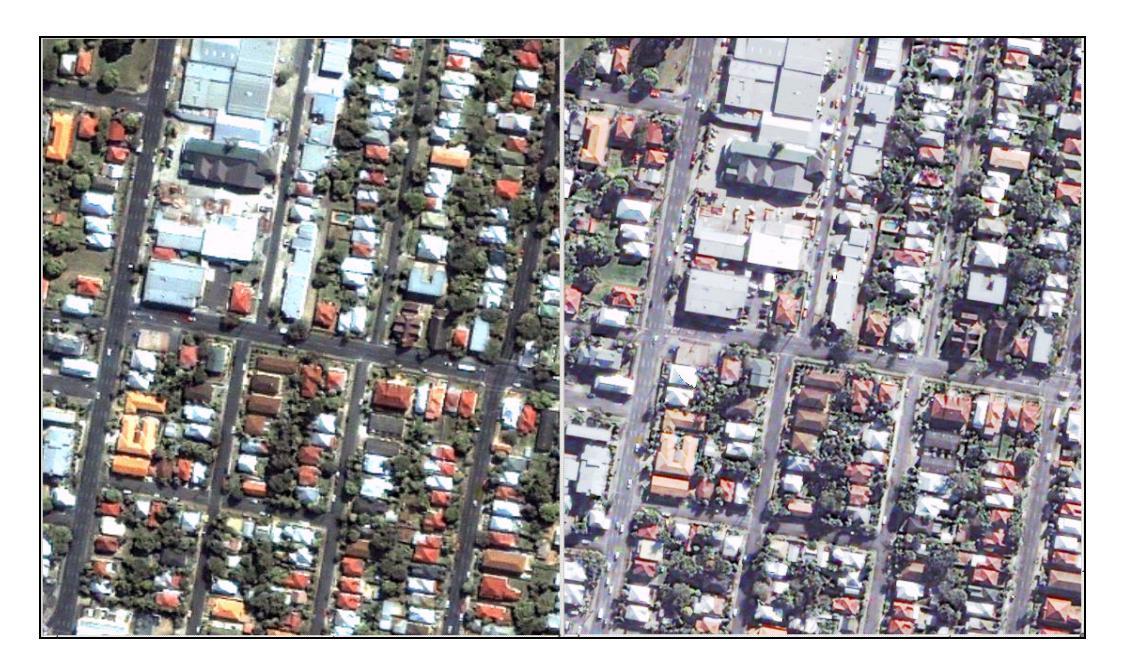
There are two satellite products to choose from over the city, QuickBird and IKONOS. Although the QuickBird product was of a higher resolution (0.61m), no scene existed over the project area. The Department did have under licence the IKONOS combined 1-metre multispectral imagery. The resolution between the two products were of little difference visually and therefore the IKONOS product was chosen (see Figure 3.2). The scene area covers 50 km² with a pixel resolution of approximately 0.91m. Reasonable image rectification was achieved however a RMSE result of 1.3 metres fell outside the project specification for sub-metre accuracy. To improve the ortho-rectification accuracy to sub-metre the services of an external provider will need to be sought.

Figure 3.2 IKONOS vs QuickBird IKONOS product to the left and QuickBird to the right (GEOIMAGE Pty Ltd, 2005)

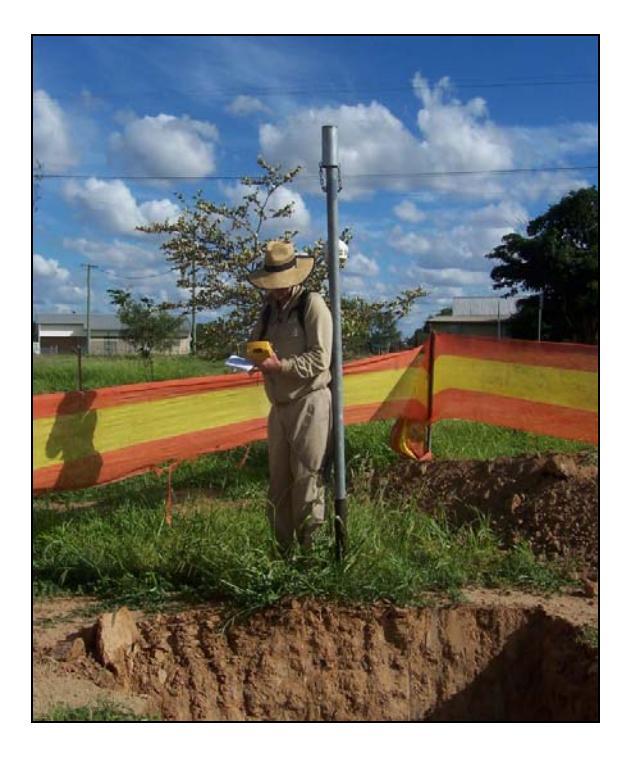
A primary field component of the study was the Differential Global Positioning System (DGPS) survey of capped shafts and related cadastral survey control (see Figure 3.3). The survey included control positions for the cadastre and permanent survey marks (PSM) control points. This was required to maintain sub-metre accuracy across all the spatial themes and to verify existing DCDB accuracies.

Figure 3.3 DGPS Surveying - SH10777 Note: breather pipe, (Source: NR&M 2005)

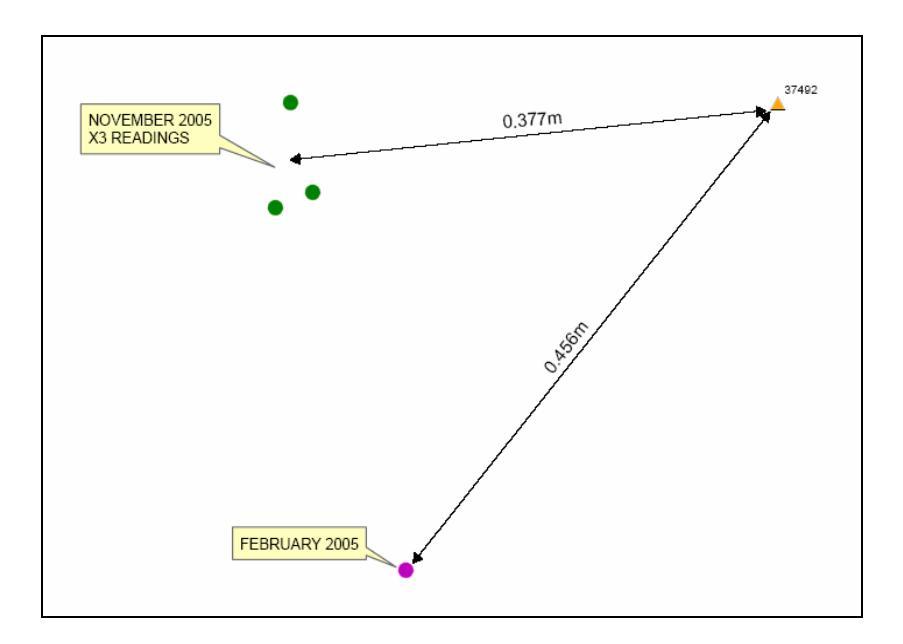
To obtain a check on the possible accuracies and precision, readings were taken at a first order control point (37492) on Buckland Hill to the north west of the CBD in February and November (see Figure 3.4). The horizontal point precisions were 0.33m and 0.31m respectively and both results were sub-metre. These results show that the DGPS was able to obtain good precision however accuracy will differ from one epoch to the next. Additional tests at similar locations, has shown that sub-metre accuracies could be achieved with using the Ingham beacon and the Pro XR receiver.

Figure 3.4 DGPS Control - Accuracy and Precision Example

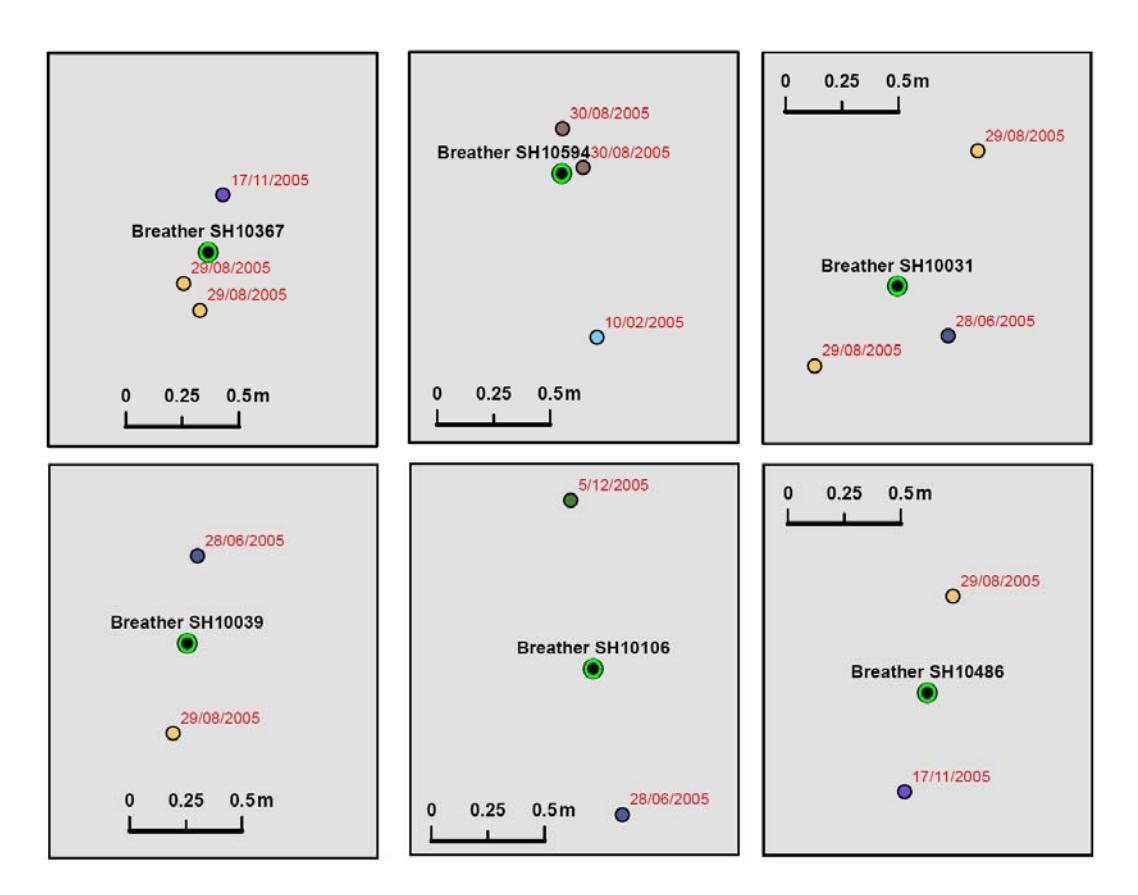
As an additional check on the relative accuracies at different epochs, some positions (e.g. breather pipes) were revisited up to three separate occasions. In most cases, the resultant relative position was within 0.6 metres or less. However, in some instance the results showed a large than normal discrepancy to the previous survey and a third check was done, usually on a separate survey trip to the city. The discrepancy may have occurred due to operational conditions as described in section 2.6.1 (pp.32) of the literature research. The most likely contributing factor would most probably be attributed to poor PDOP. Some examples of these revisited sites are shown in Figure 3.5.

Figure 3.5 DGPS Survey Check Locations (Breather Pipes)

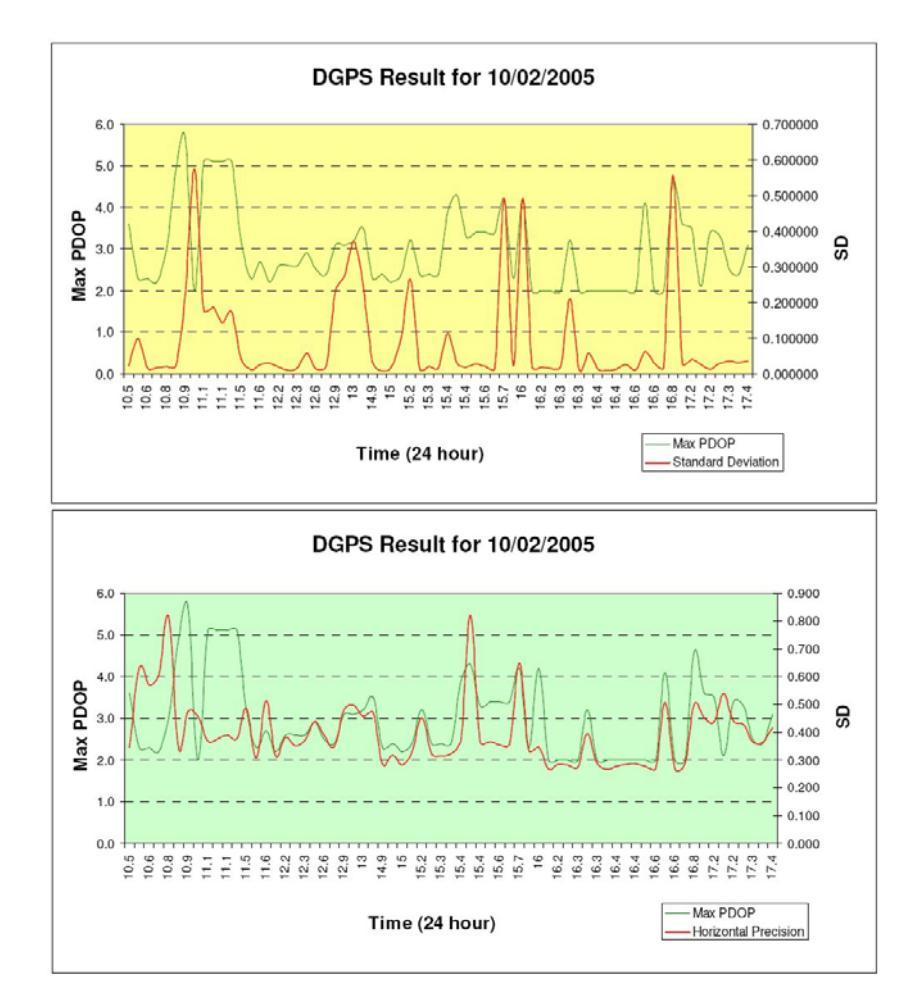
The DGPS surveys were conducted in the months of February, June, November and December of 2005 and each survey consisted of either two to three days duration. It was also evident during the field survey and further supported by the results that the certain times of the day were more favourable to take readings that at other times. The best DGPS results were obtained before noon followed by a period in the middle afternoon. The periods, where the PDOP⁴ reflected poor geometry with the satellites, were generally in the early morning and the middle of the day and to some extent, in the latter portion of the afternoon. (see Figures 3.6 and 3.7).

Figure 3.6 DGPS Results for 2nd October 2005

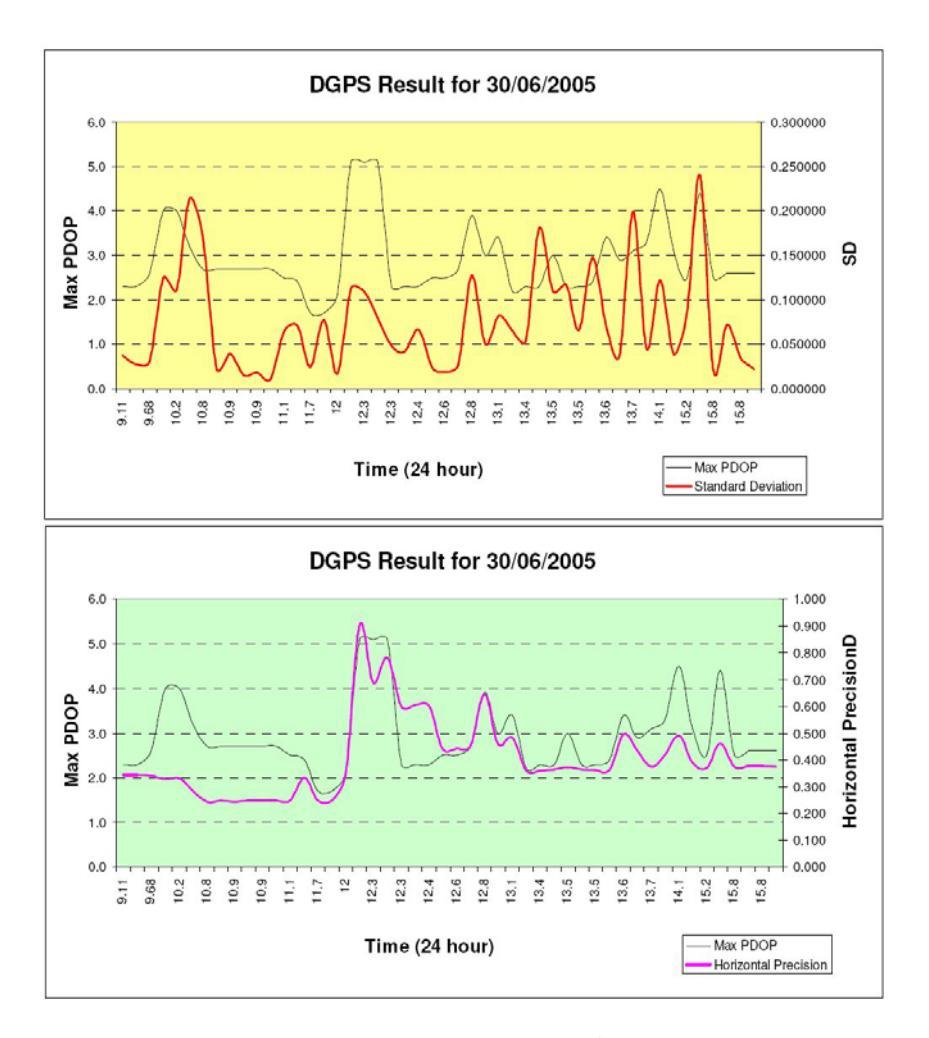
Figure 3.7 DGPS Results for 30th June 2005

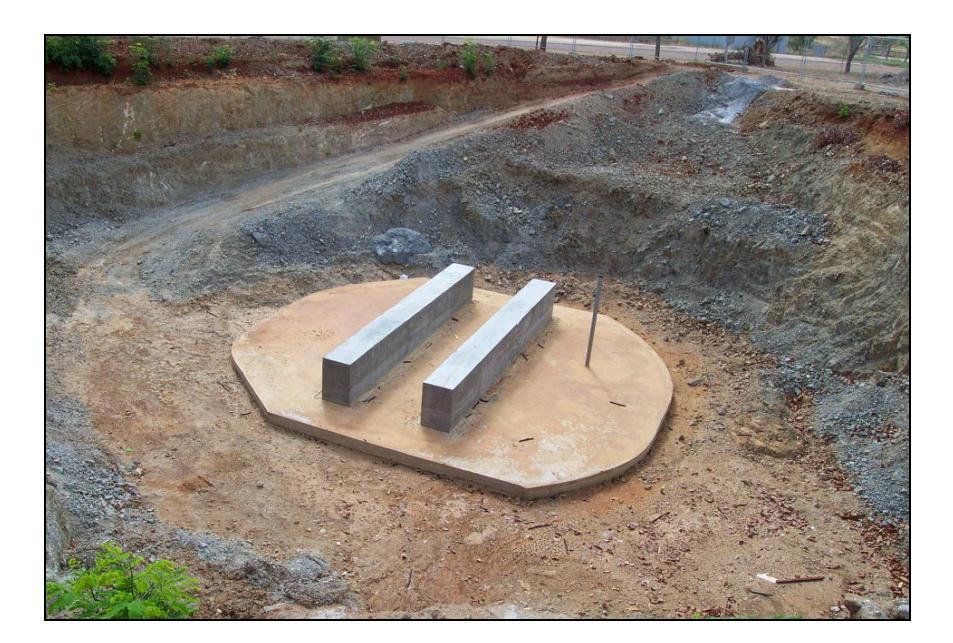
The survey pickup of the concrete cap and breather is an important function of the program as it maintains the relationship between the real property boundaries and the buried remediation work. This is especially important for any future works or infrastructure programs.

Figure 3.8 Columbia College - Concrete Cap Note position of vent pipe (NR&M 2005)

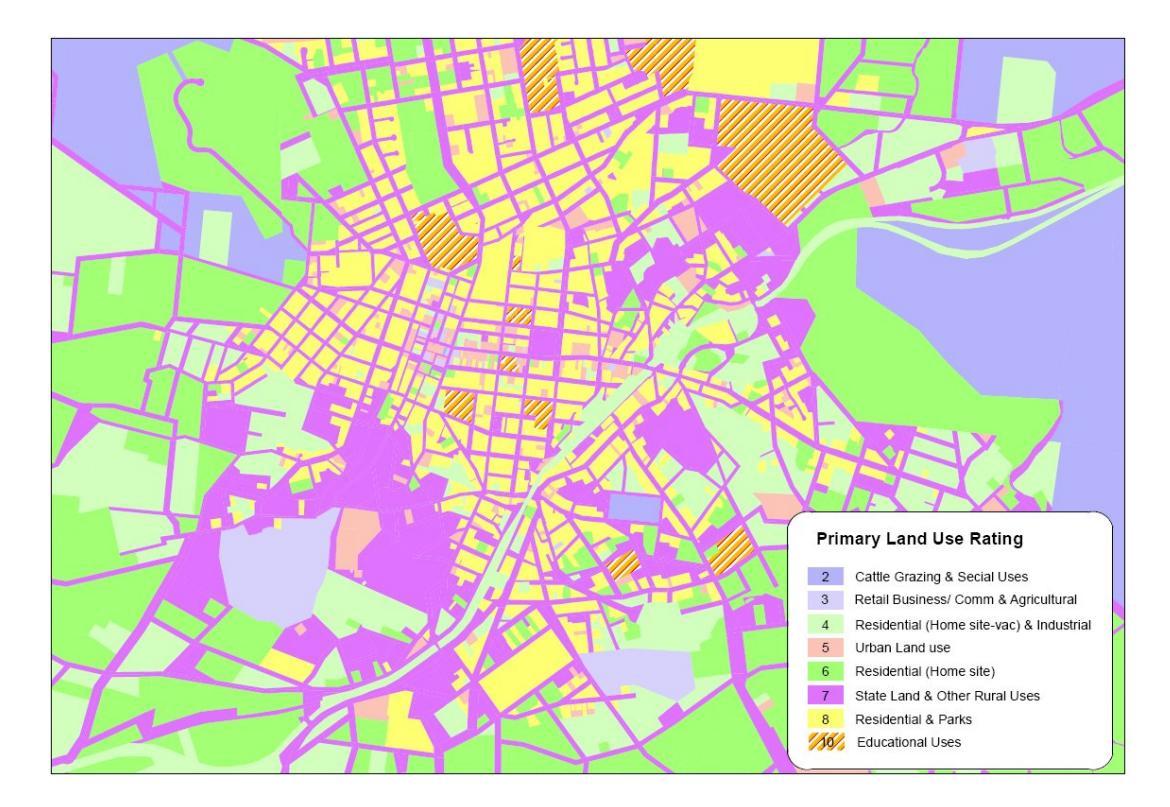
The criteria for applying an inferred risk factor to land is not always obvious as other relationships can occur. Within the study area, State land (inc. road and rail) comprises 43% of the total area and therefore should not be ignored (see Table 3.4).

Figure 3.9 Map showing the Derived Primary Land Use

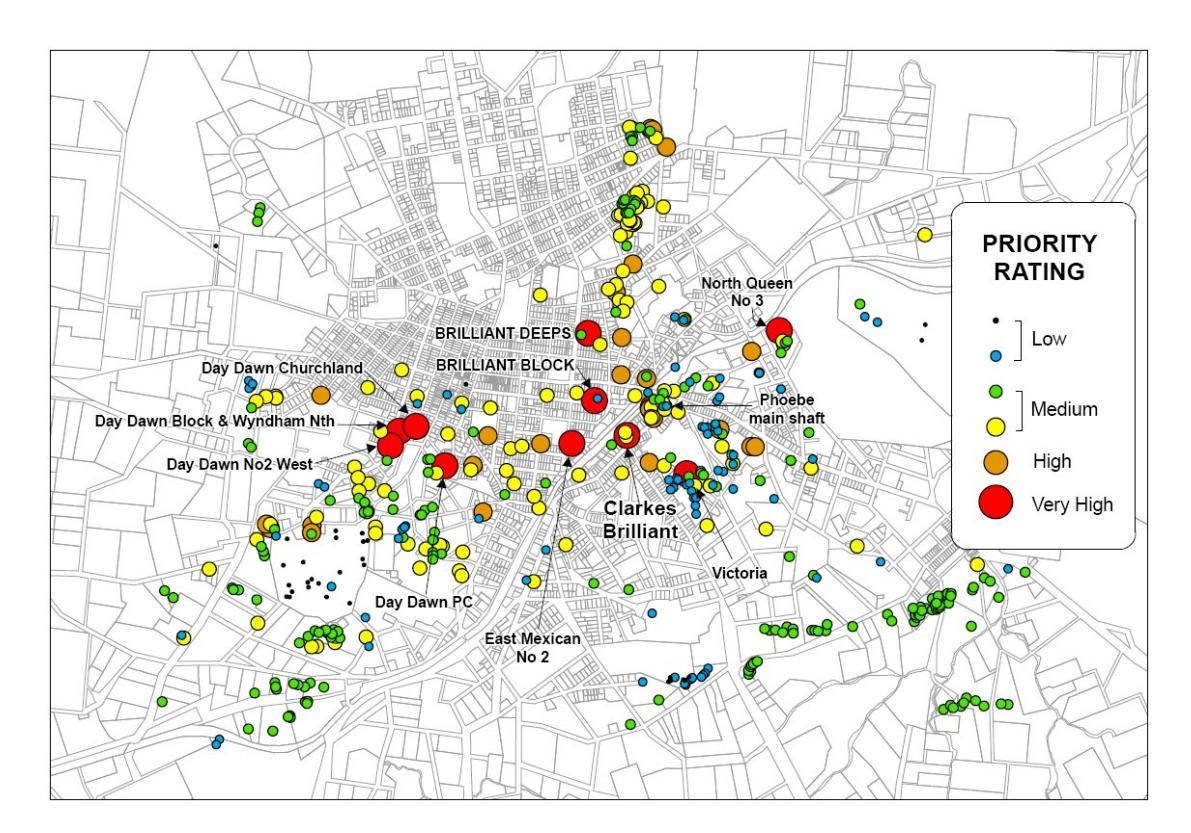
Calculation of a prioritisation value was achieved by simply summing each of the derived values: [PLU index + mine type + shaft depth = Priority]. The prioritisation index was classified into low (3-6), medium (7-10), high (11-12) and very high (13-15). The priority 1 results, although crude in its application did reveal known priority sites either listed for future investigation or cultural significance i.e. Phoebe and Day Dawn PC (see Figure 3.10).

Figure 3.10 Priority Sites (undiscovered and non-remediated)

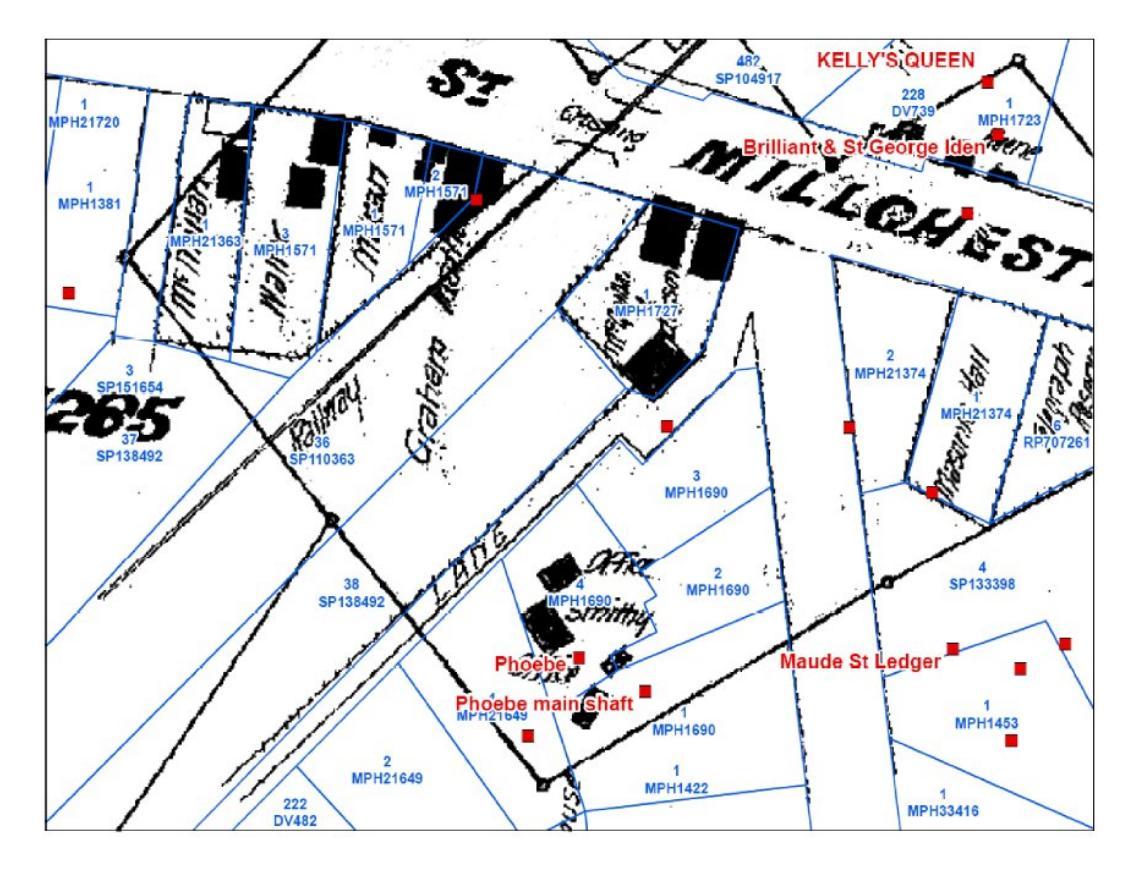
Figure 4.1 GML position of the 'Phoebe' main shaft (between the two assumed positions for the Phoebe shaft)

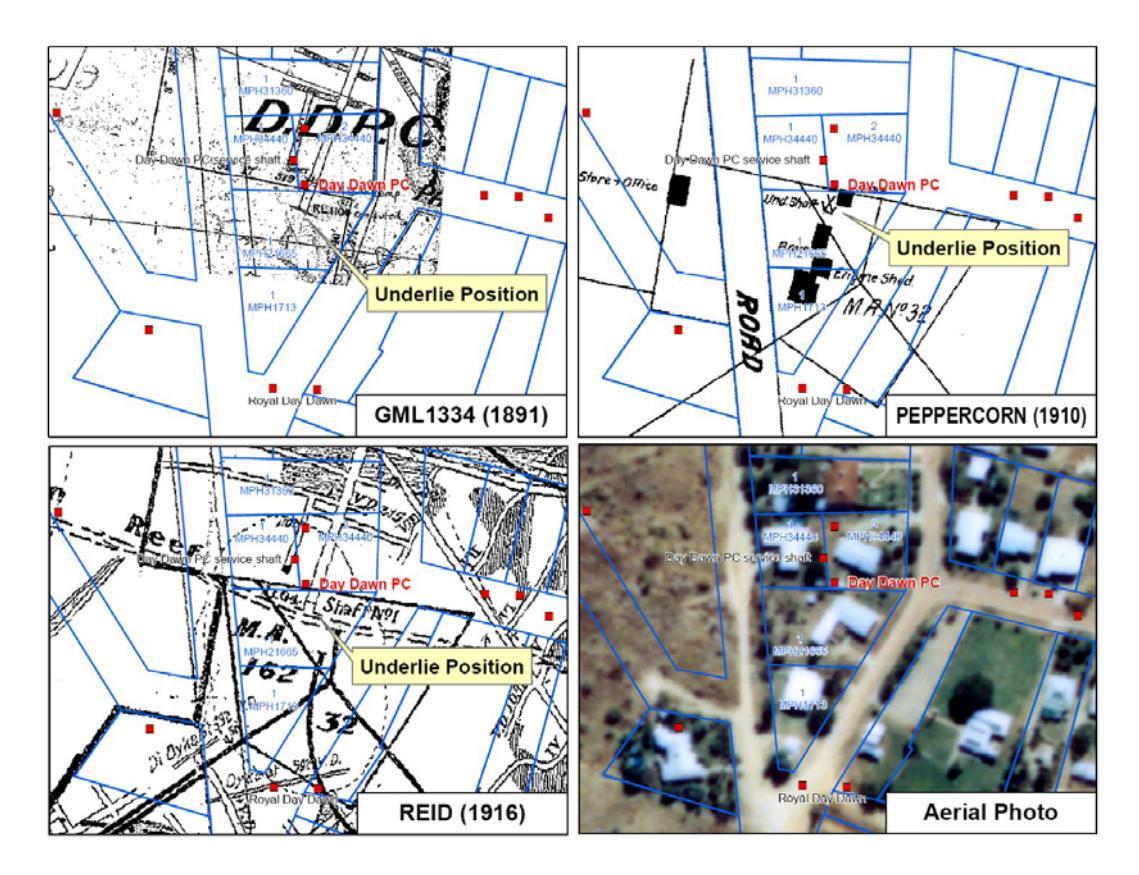
The 1996 inventory field inspection mentions that there was no visible sign of the shaft. The historic mapping assessment showed that the Day Dawn PC Mine Under-Shaft was shown on a number of GML plans and geological maps (see appendix D). These were georectified to their best fit using the adjusted DCDB and the DGPS as control. There was a reasonable correlation between the datasets with a spread of 4m E-W and 3m N-S. The new averaged position of 422256 E and 7,779237 N (MGA94, zone 55) put the under-shaft approximately 12 metres due south of the original position (see Figure 4.2). This is sufficient grounds to revisit the location and conduct a test drilling to verify the shaft position.

Figure 4.2 Day Dawn P.C. Mine Under-Shaft Assessment

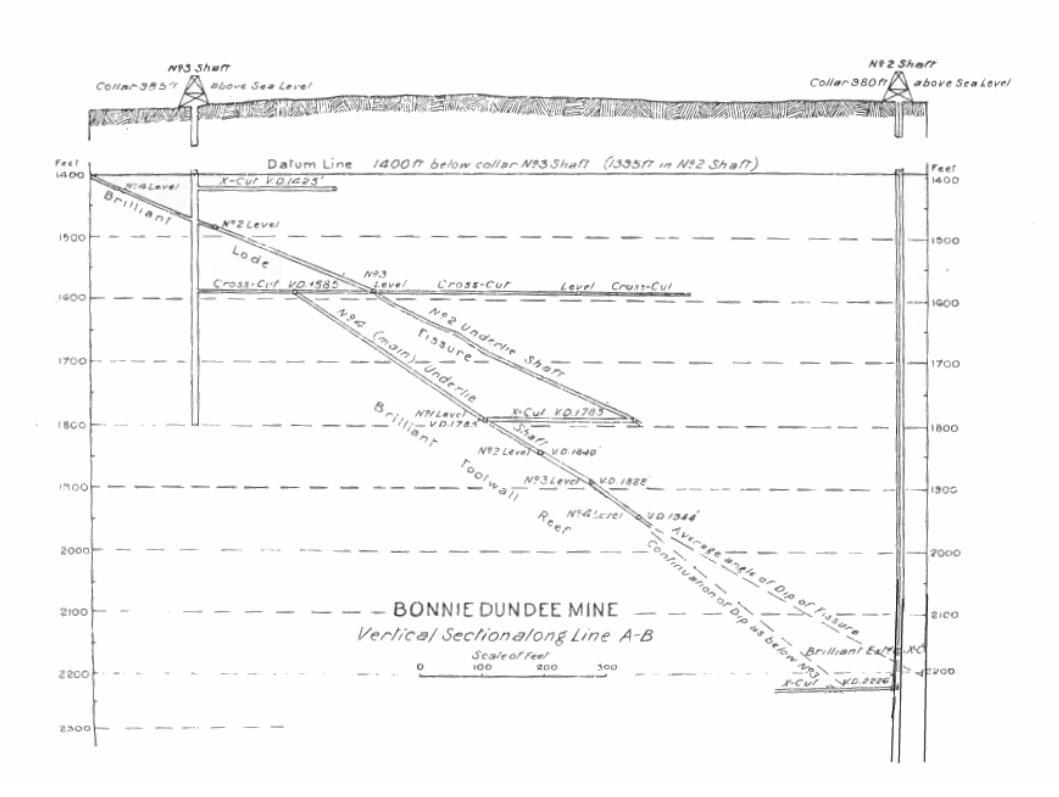
Figure 4.3 Bonnie Dundee Long Section showing No.2 Shaft

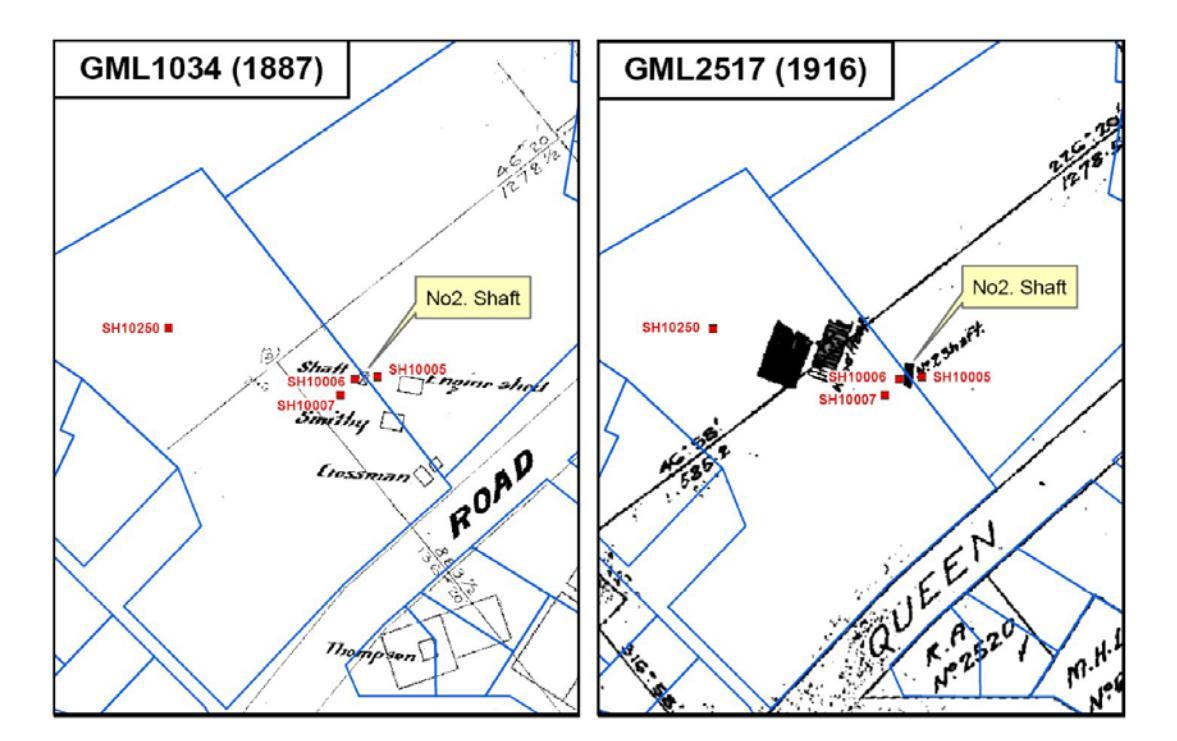
This case study shows that using historic mapping with DGPS controlled accuracy has confirmed the inventory position within a high confidence level.

Figure 4.4 Bonnie Dundee No2. Shaft Assessment (The GML assessed position lies between inventory sites 5 & 6)

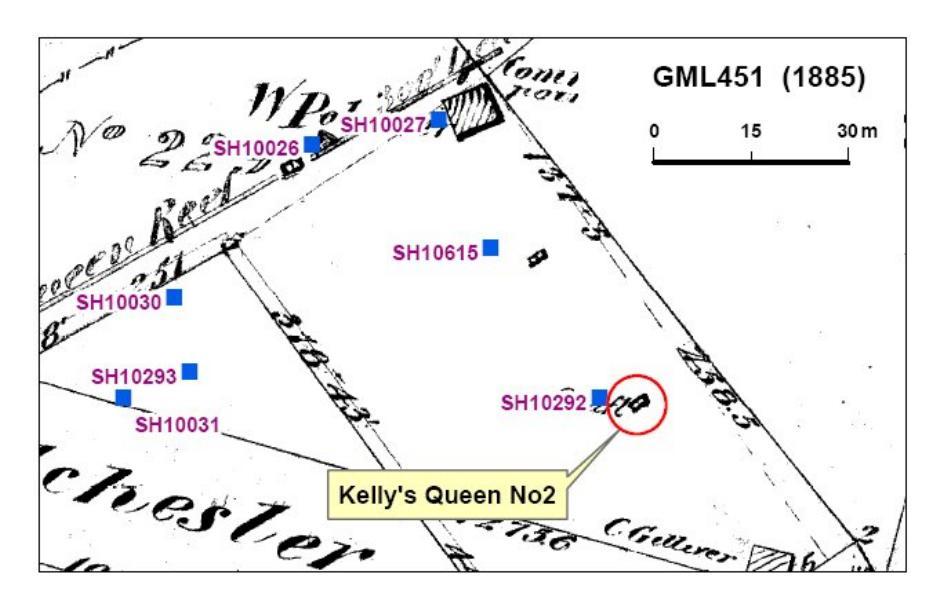
Both GML images were georeferenced using the DGPS corrected DCDB. The resultant RMS errors using the 3rd order polynomial transformation option were less than 1 metre (0.7m and 0.8m). A comparison of the shaft positions revealed only a 1m displacement between the georeferenced GML images. The GML shaft position shows the shaft to be approximately 6.5m east of the inventory position (see Figure 4.5). The averaged coordinates of these positions put the shaft from this assessment at 423884.7E and 7779767.8N.

Figure 4.5 GML451 position of Kelly's Queen No1 Shaft

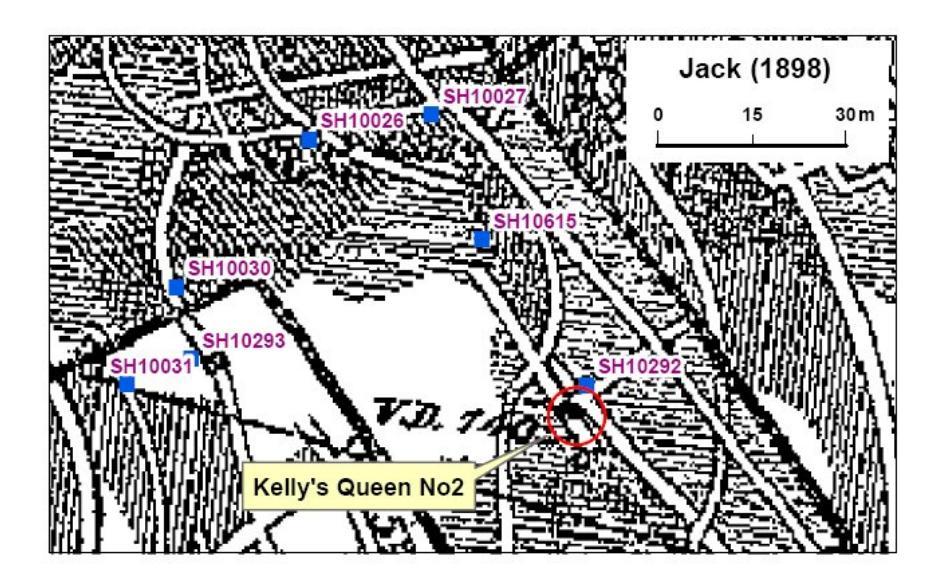
The only old geology series map to depict the shaft was the Logan Jack map. The position derived from the Jack map shows the shaft to be approximately 4m southwest of the inventory position at 4238875.5E, 7779764.5N (see Figure 4.6).

Figure 4.6 R.L. Jack position of Kelly's Queen No1 Shaft

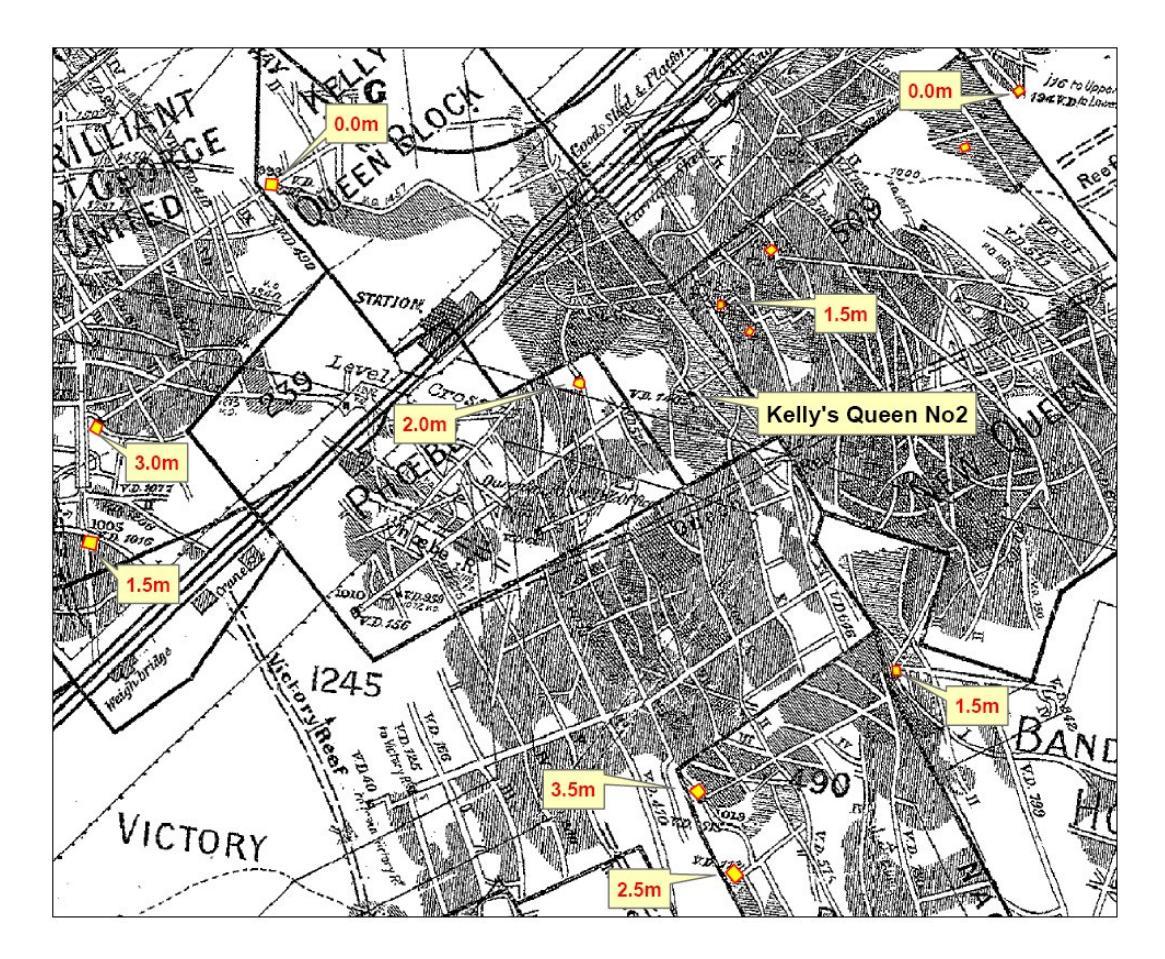
The two spatially derived positions differ substantially in respect to each other by approximately 9 metres. The difficulty lies in the fact that both locations are supported by the information presented. The Jack map position is plausible because there is substantial evidence from the strong correlation between the rectified Jack image and the surveyed shaft positions (see Figure 4.7). The GML position is also supported by the correlation between the both georeferenced images.

Figure 4.7 Shaft Survey v's Jack Map - Vector Displacement Comparison

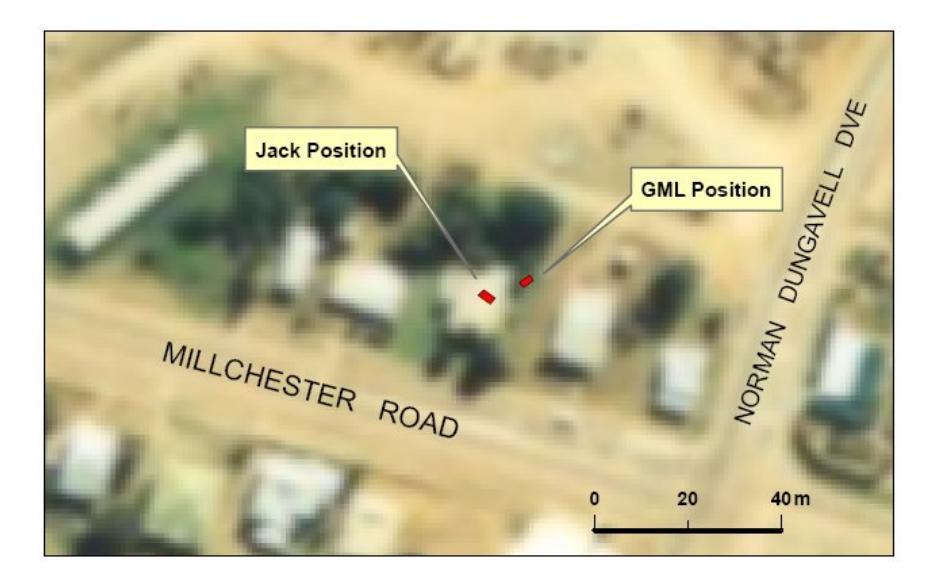
To determine the most probable location to carry out a field investigation the 1999 aerial photograph layer was included to visualise any existing nearby structures i.e. residences. The Jack position lies directly under the residence and may explain why there has not previously been a comprehensive site investigation. The GML derived location however, is situated between the house and the property boundary (see Figure 4.8) and would be the primary site to investigate due to easier access and being less invasive.

Figure 4.8 Location of Kelly's Queen No1 Derived Shaft Positions to Residence

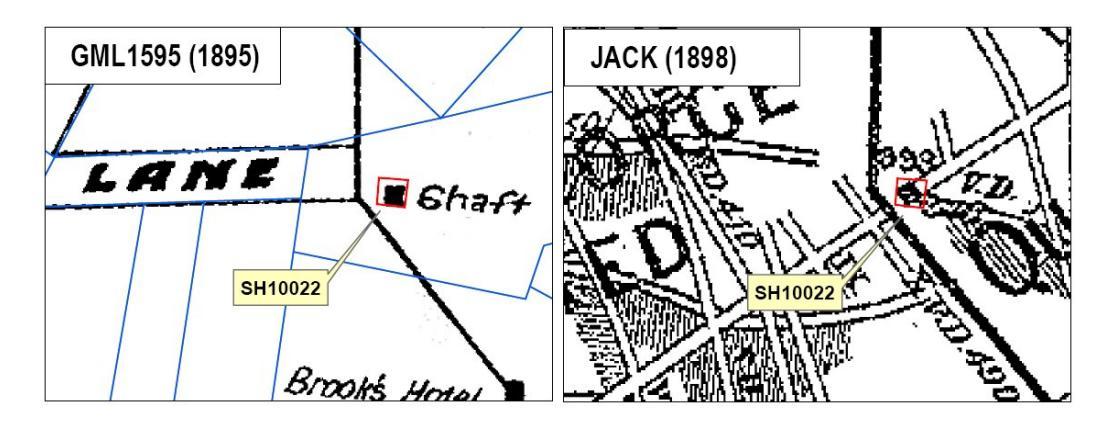
As shown in Figure 4.9 there is good correlation between the historic references and the DGPS controlled cap survey in this location. The DGPS results for this shaft survey returned an averaged precision for all points of 0.27m and the PDOP was 1.7. The image RMSE is as previously stated.

Figure 4.9 Survey Position of SH10022 in relation to Historic Mapping

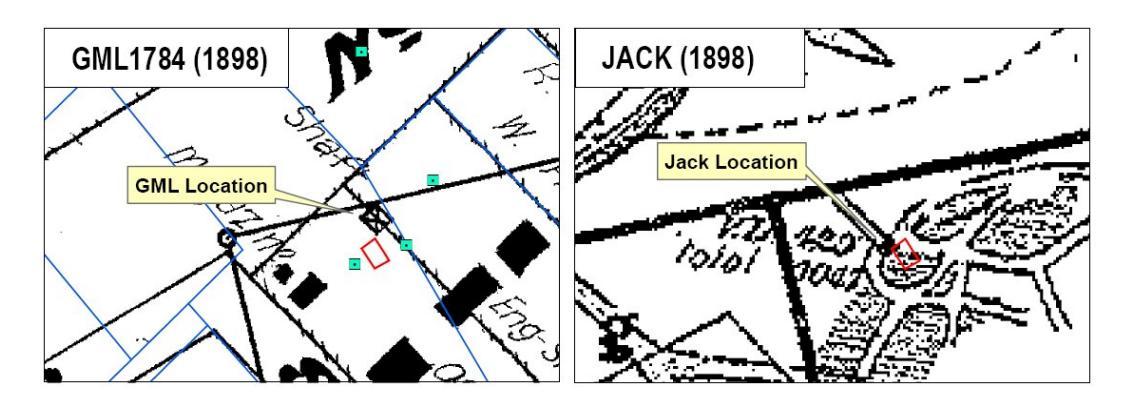
As shown in Figure 4.10 the correlation between the Jack map and GML1784 is poor with the distance between the two positions approximately 6 metres. The excavation however would not be restricted by its location as it is situated in road reserve. The DGPS results for this shaft survey returned an averaged precision for all points of 0.37m and the PDOP was 3.4.

Figure 4.10 Survey Position of SH10095 in relation to Historic Mapping

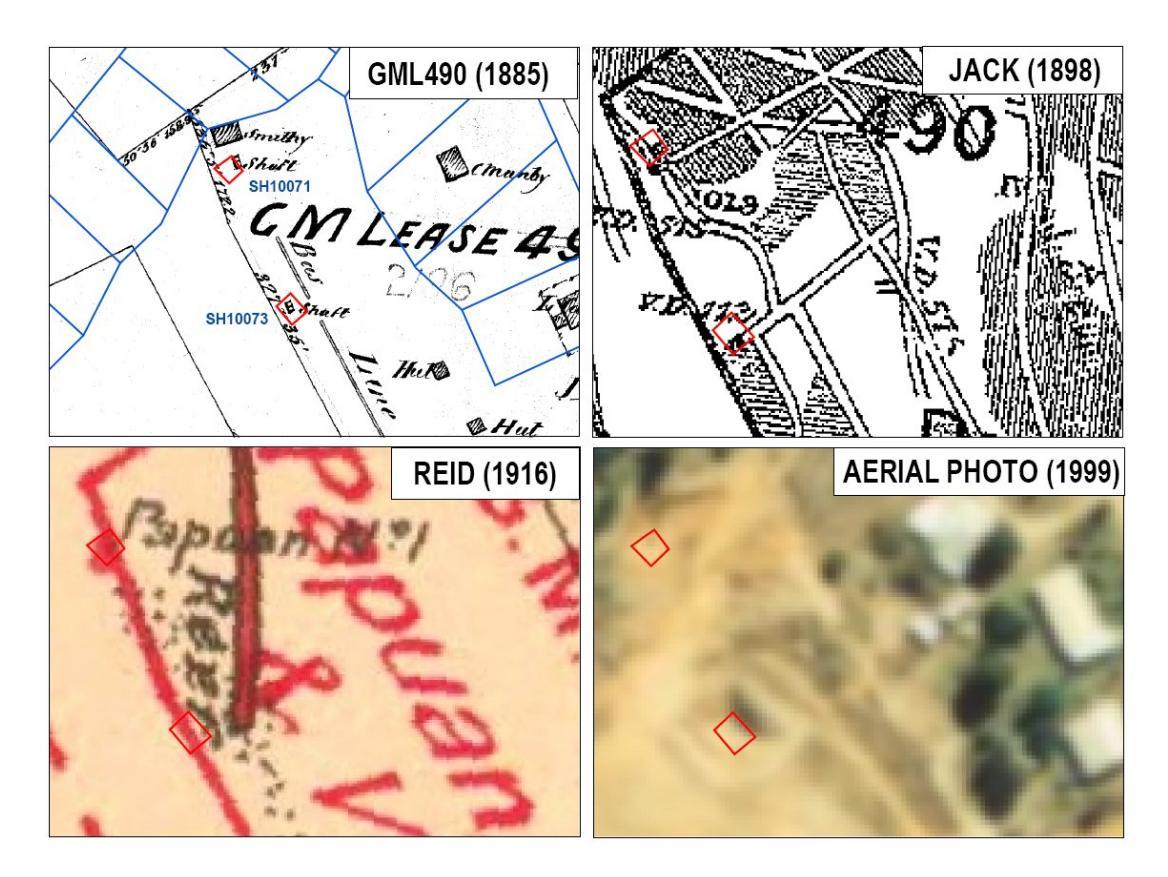
As shown in Figure 4.11 the correlation between the survey positions and the georeferenced imagery are good. On GML490 the survey position for SH10073 is the coincident and SH10071 differs by 2 metres. On the Jack map the shaft positions also agree favourably with the survey positions with SH10073 within 3.5m and SH10071 within 2m. The Reid map only shows SH10071 and this position also agrees within the survey position. The 1999 aerial photography shows the shaft repair process during the excavation stage. In this image the surveyed shaft cap positions are coincident with the excavation shaft pad location.

Figure 4.11 Survey Position of SH10071 & SH10073 in relation to Historic Mapping
